Post-Fire Structural Evaluation

Queensborough National Bank
20-28 N Main St.
Metter, GA 30439

Client File No.: FWG6889
SFE File No.: 240019GA1

November 4, 2024

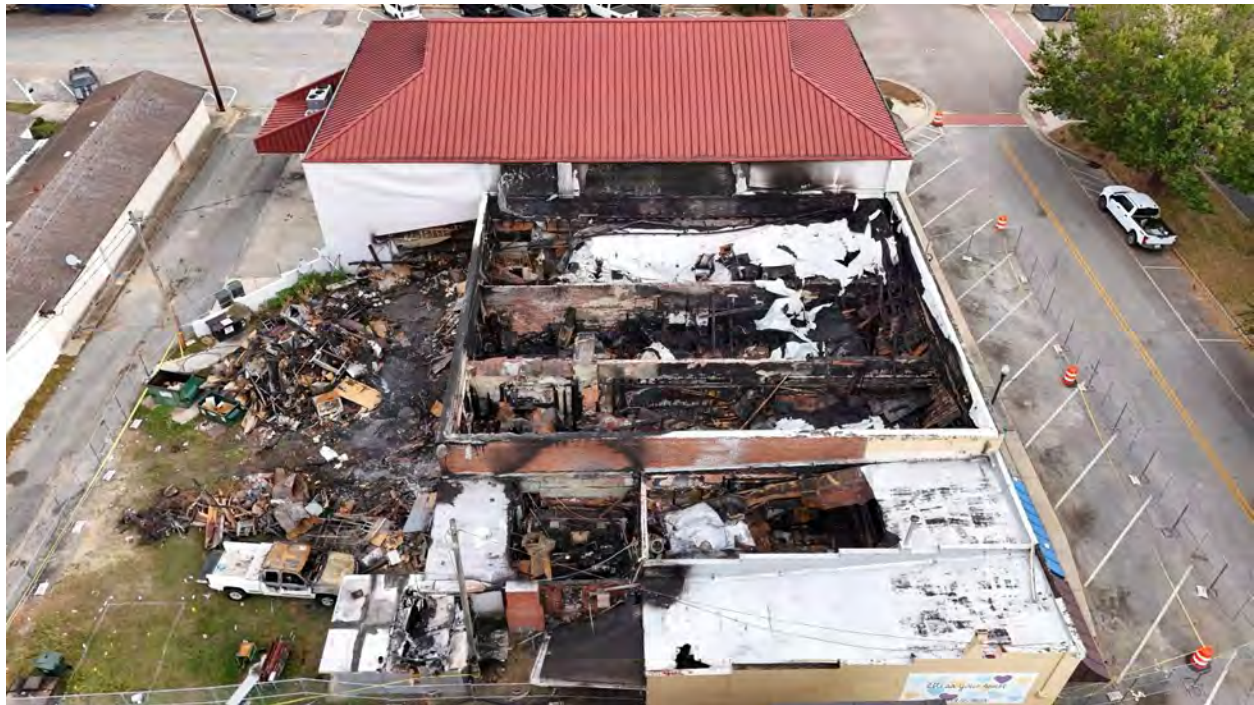
Figure 3. Fire overview.

We were aware of the concerns regarding fire-related damage to the western portion of the building, from a fire event that occurred in the adjacent buildings on October 5, 2024. Mr. Allen expressed concerns regarding the structural integrity of the western walls of the building and the roof structure. Refer to Figure 3 below for an overview of the fire damage that occurred in the adjacent stores to the west of the building.

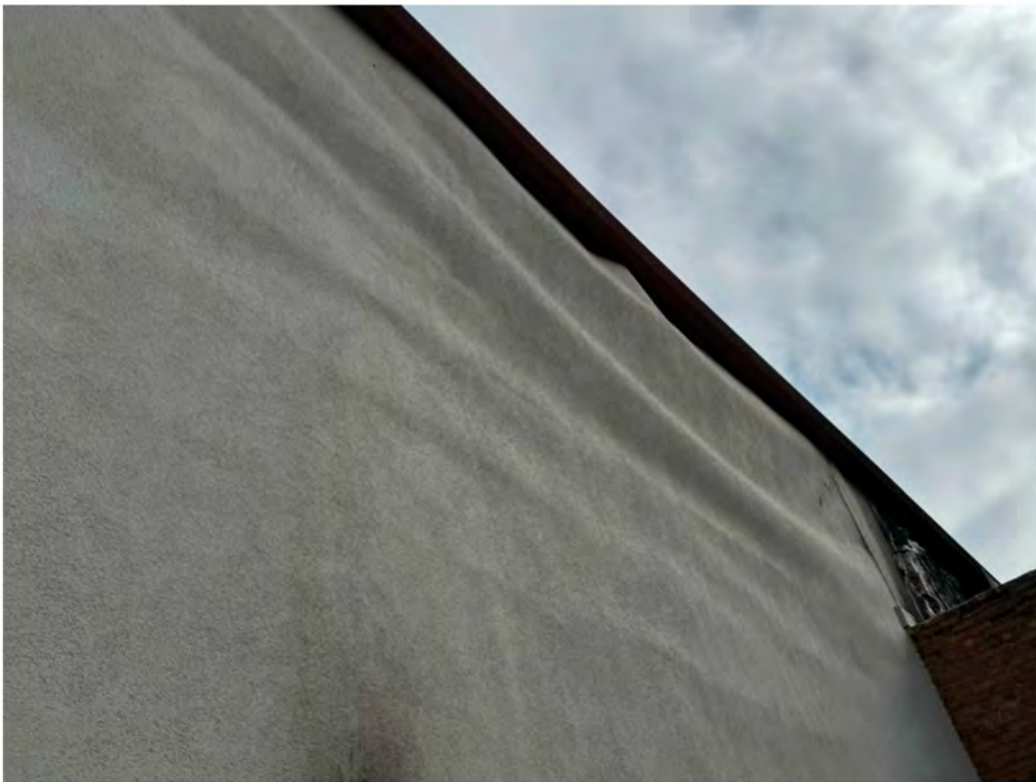
We inspected the western exterior wall, starting with the fiberglass-reinforced plaster exterior wall finish. The majority of the siding had either burned away or had melted and become deformed from the heat of the fire event.

7. Melted fiberglass reinforced plaster siding.

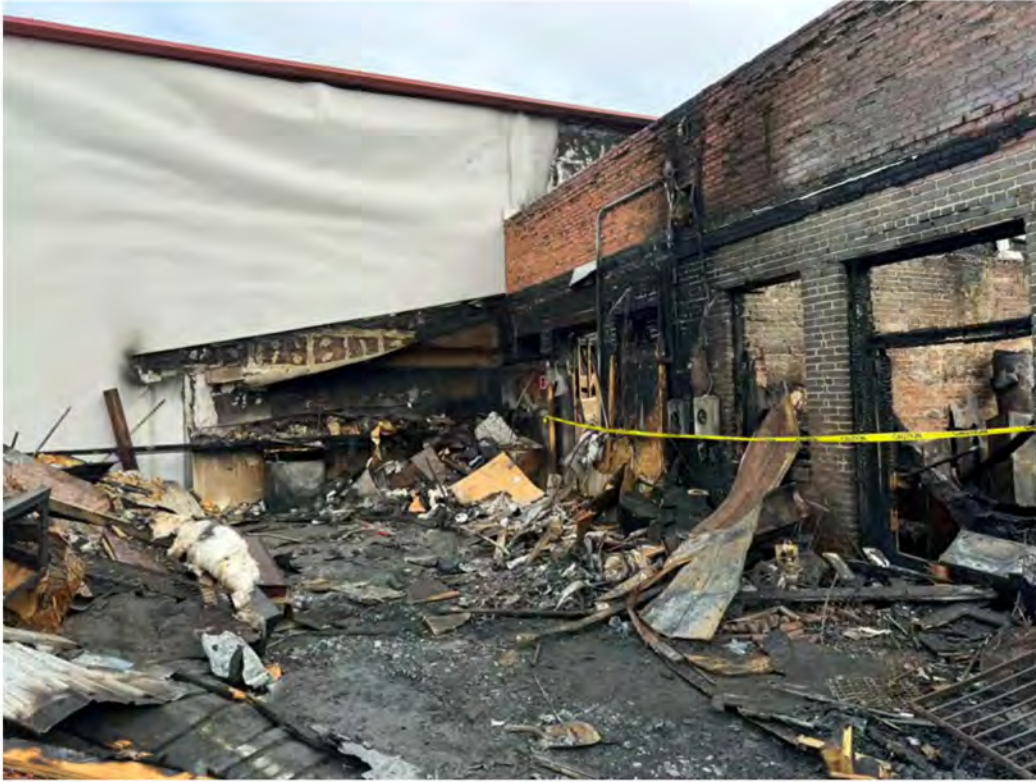
8. Melted fiberglass reinforced plaster siding.

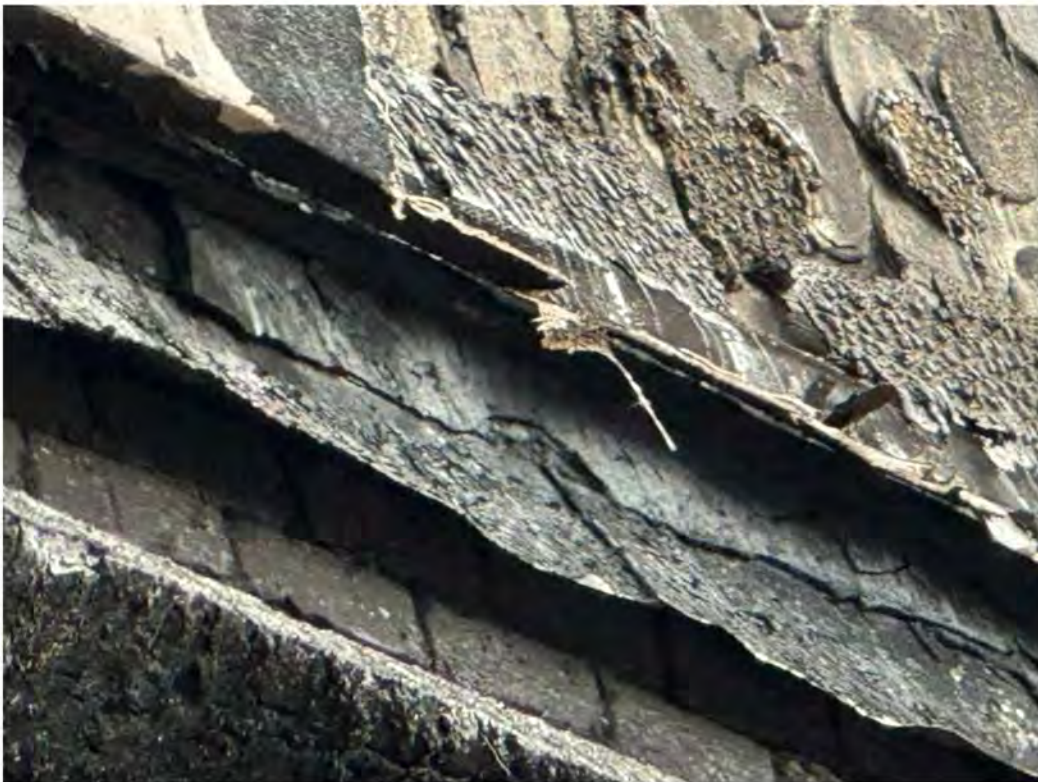
Below the concrete block wall, we closely observed the first-floor shared clay brick wall that of the building. We observed a charred roof framing ledger for the adjacent building, as well as counter flashing details for the adjacent roof that were discolored and deformed. The clay brick wall was also covered in soot. Inspection of the brick wall showed approximately 16 bricks that were spalled, consistent with heat from the fire event. These damaged clay bricks were clearly visible due to the lack of soot accumulation at the areas where the spalling had

15. Flashing from the adjacent building.

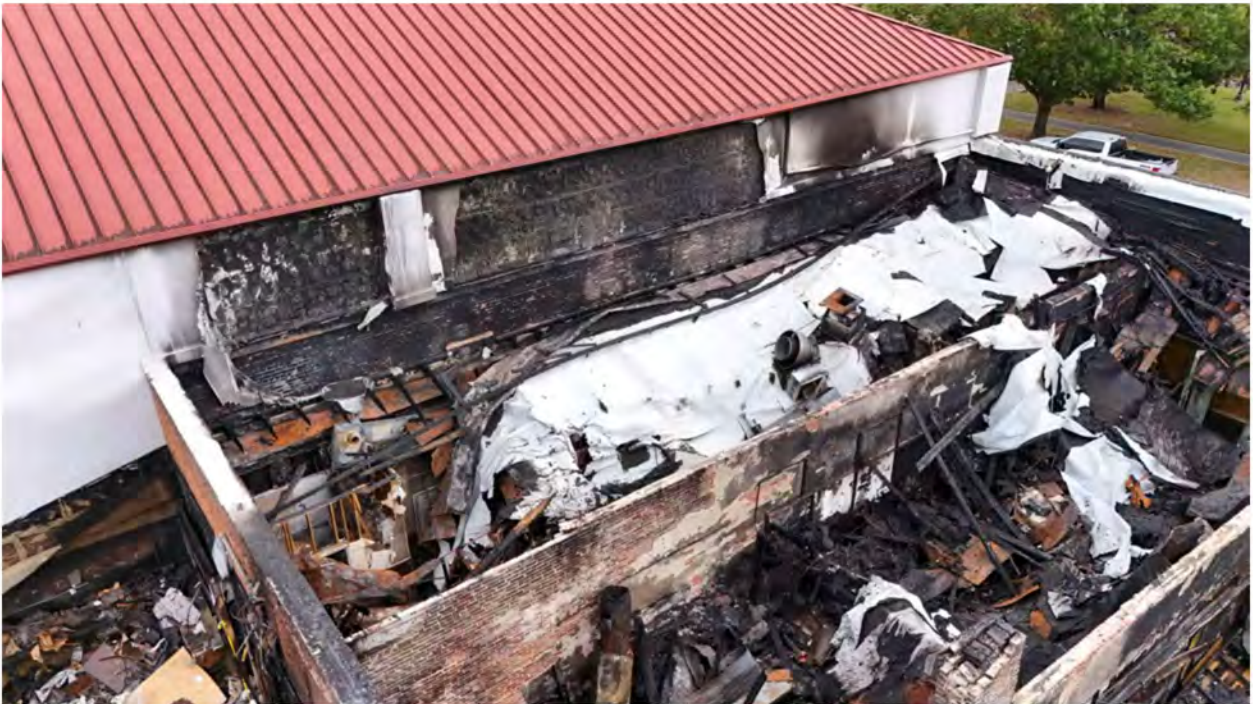
27. Melted reinforced plaster siding.

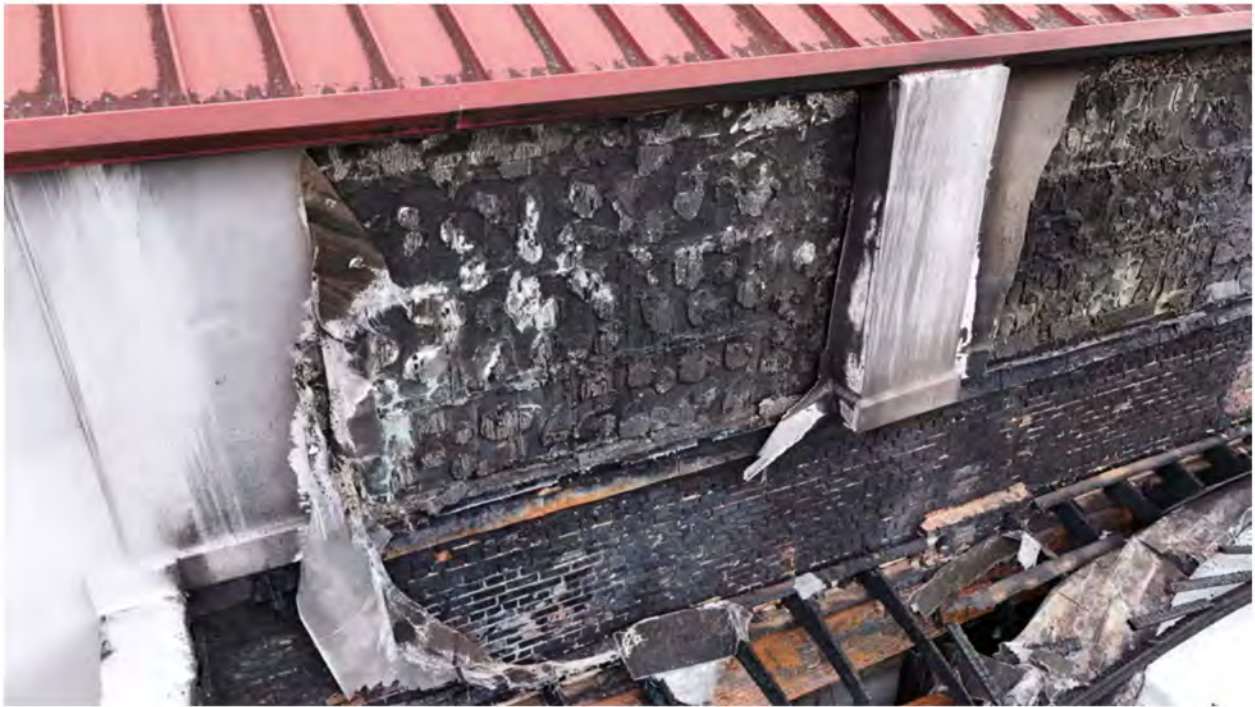
28. Missing siding and exposed masonry walls.

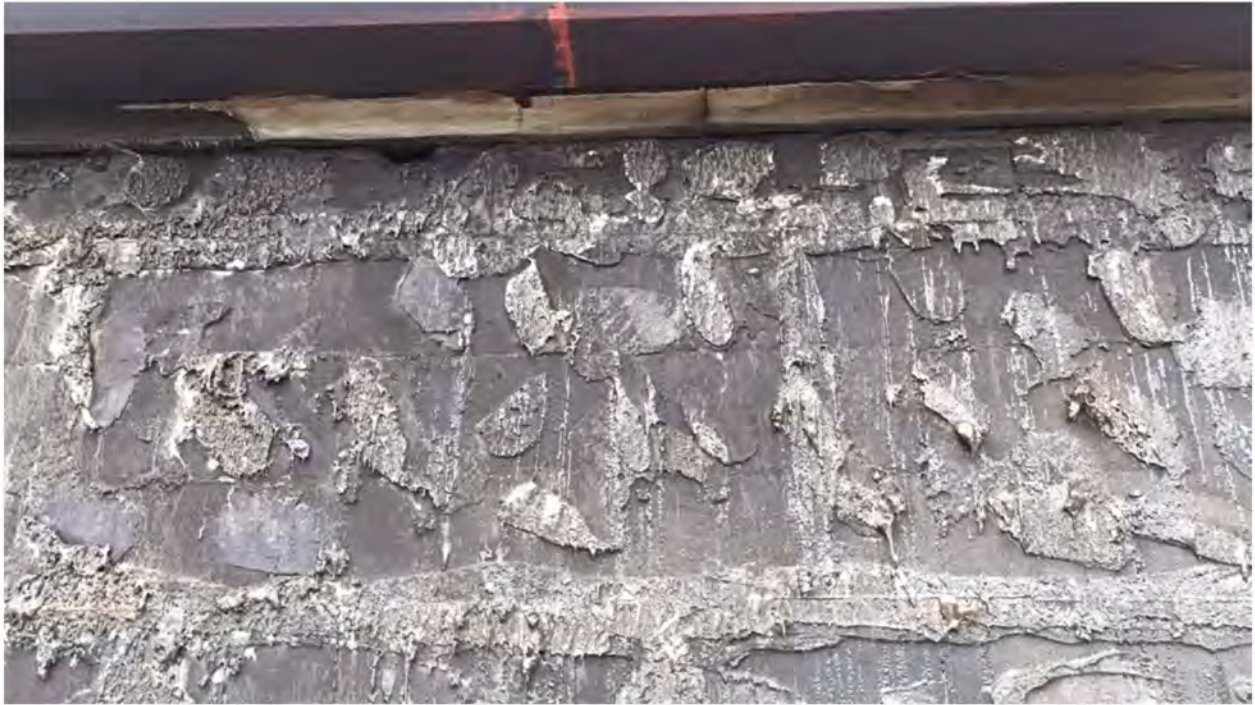
Approximately 50 feet of sub fascia framing was exposed where the plaster siding burned and melted. We observed charring on approximately 25 feet of the sub fascia boards along the west elevation. The remaining portions of the exposed sub fascia framing did not appear to be charred, but were soot-covered.

35. Wood sub-facia member below the gutter.

Inspection of the roof framing system at the Queensborough National Bank showed that approximately 20 linear feet of sub fascia were charred from the October 5, 2024 fire event. This sub fascia can be removed and replaced in kind without removal of the roof trusses, and the decking, or framing, after removal of the deformed western gutter. Additionally, the PVC downspouts can be replaced in kind prior to the removal and replacement of the fiberglass-reinforced plaster siding on the west elevation. It should be noted that upon removal of the sub fascia member, additional replacement considerations should be made for any roof framing members that show charring, which were not visible beforehand.

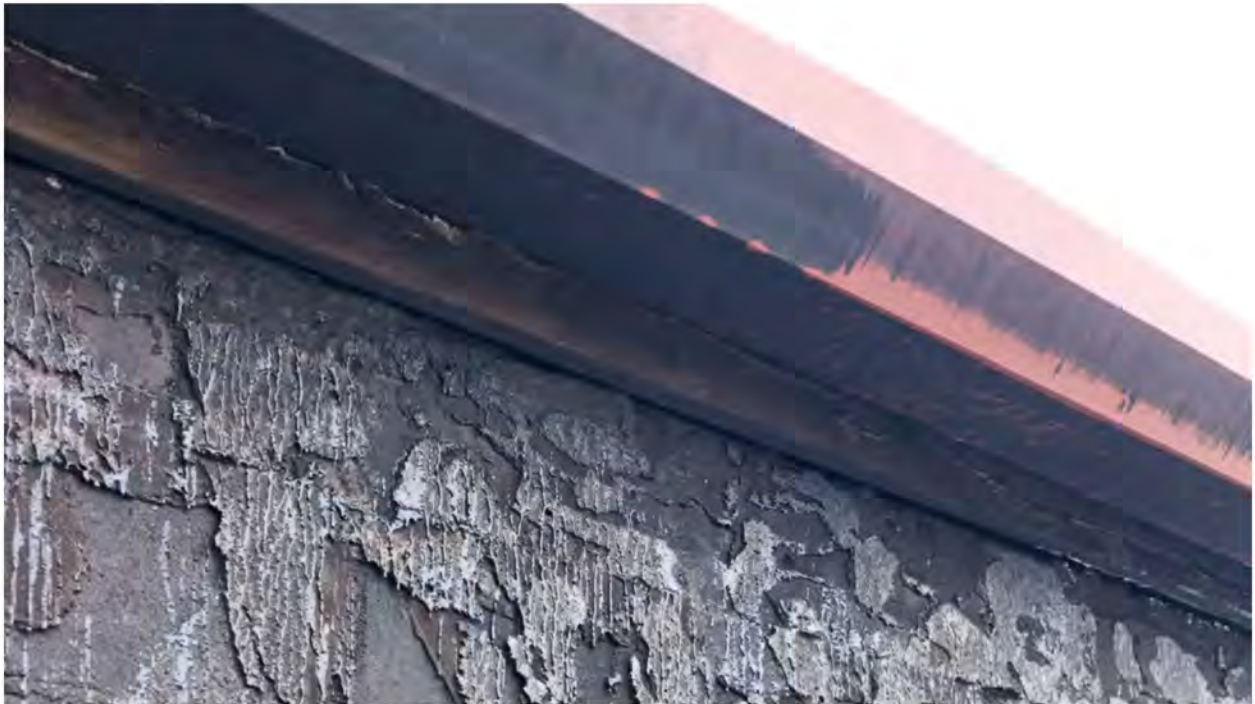
36. Wood sub-facia member below the gutter.

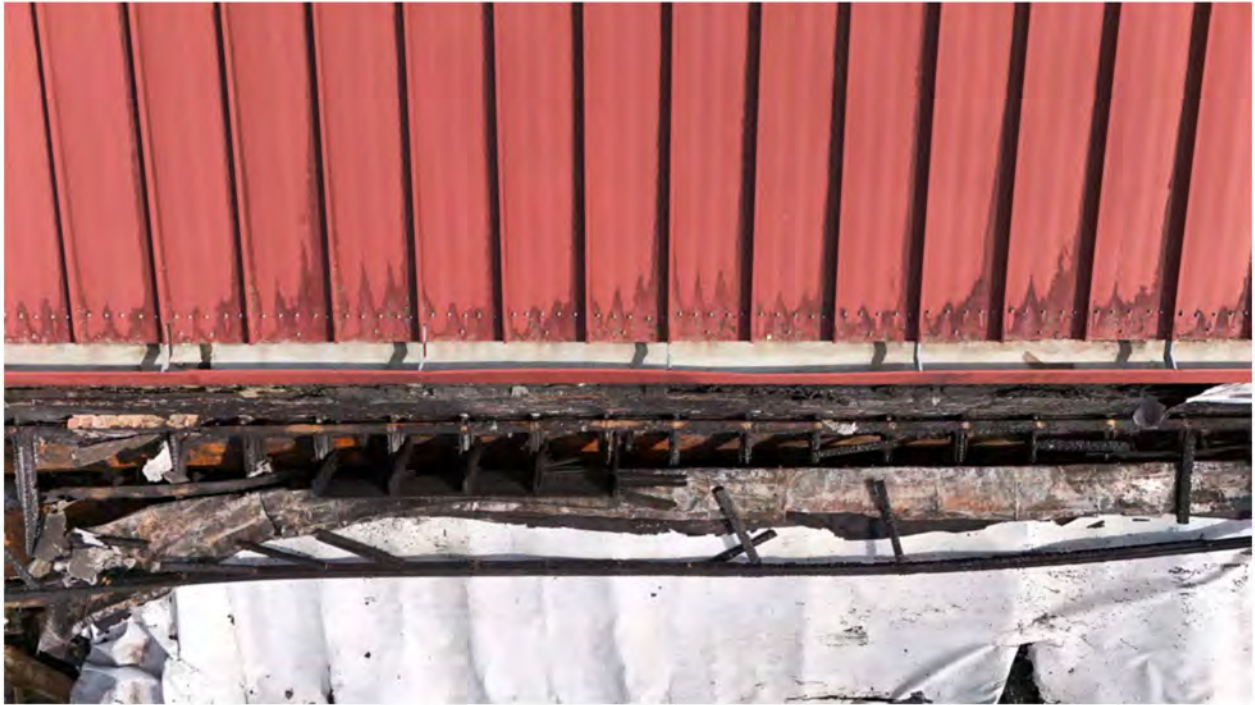
The roof system on the building was intact. There were no missing, deformed, or collapsed roof components observed on the Queensborough National Bank at the time of our inspection. We noted algae growth on the roof panels near standing seams, and isolated areas where the roof paint had peeled or was deteriorated from UV radiation. These instances were observed on all of the roof slopes of the building, and were not concentrated on the western side of the building where the fire event occurred. During our inspection, we noted that approximately 50 linear feet of the gutter along the western elevation of the building was deformed.

37. Deformed gutter.

- Approximately 30 linear feet of PVC downspout along the western elevation
2. The charred sub-fascia can be removed and replaced upon removal of the deformed gutter, and the spalled and cracked bricks can be removed and replaced in kind by a licensed and experienced mason.

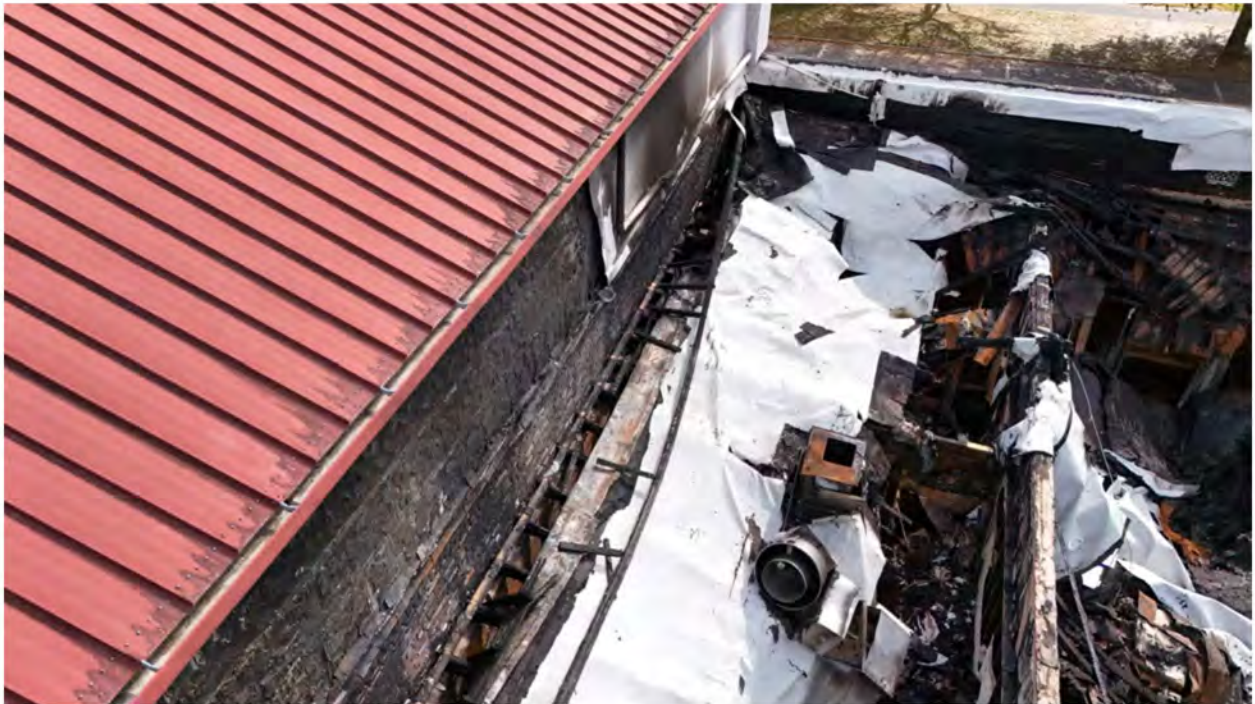
38. Deformed gutter.

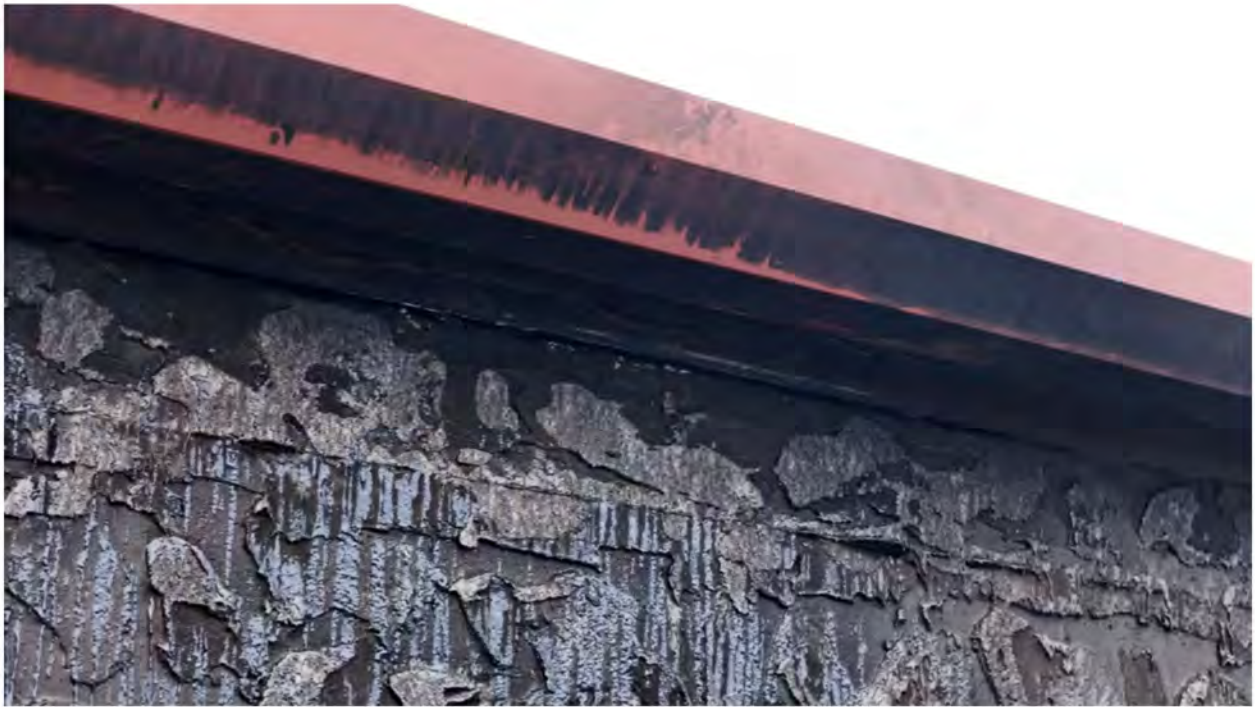
39. Deformed gutter.

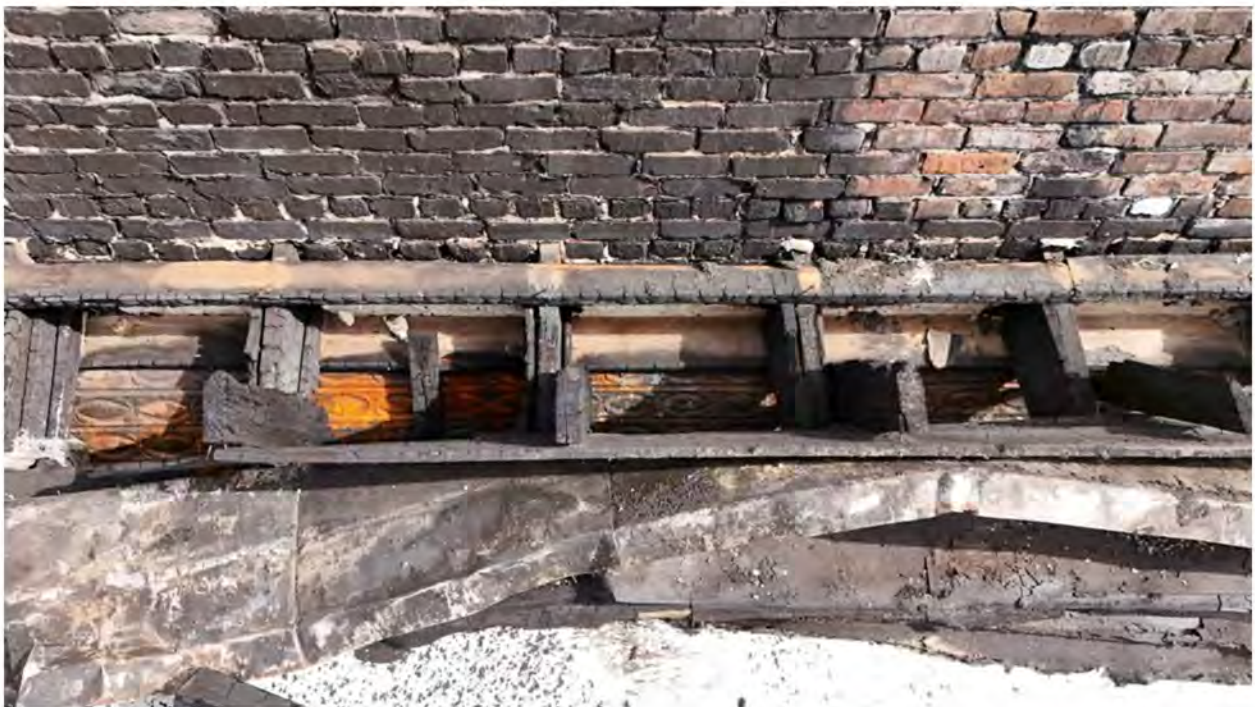
52. Charred framing from the adjacent building.

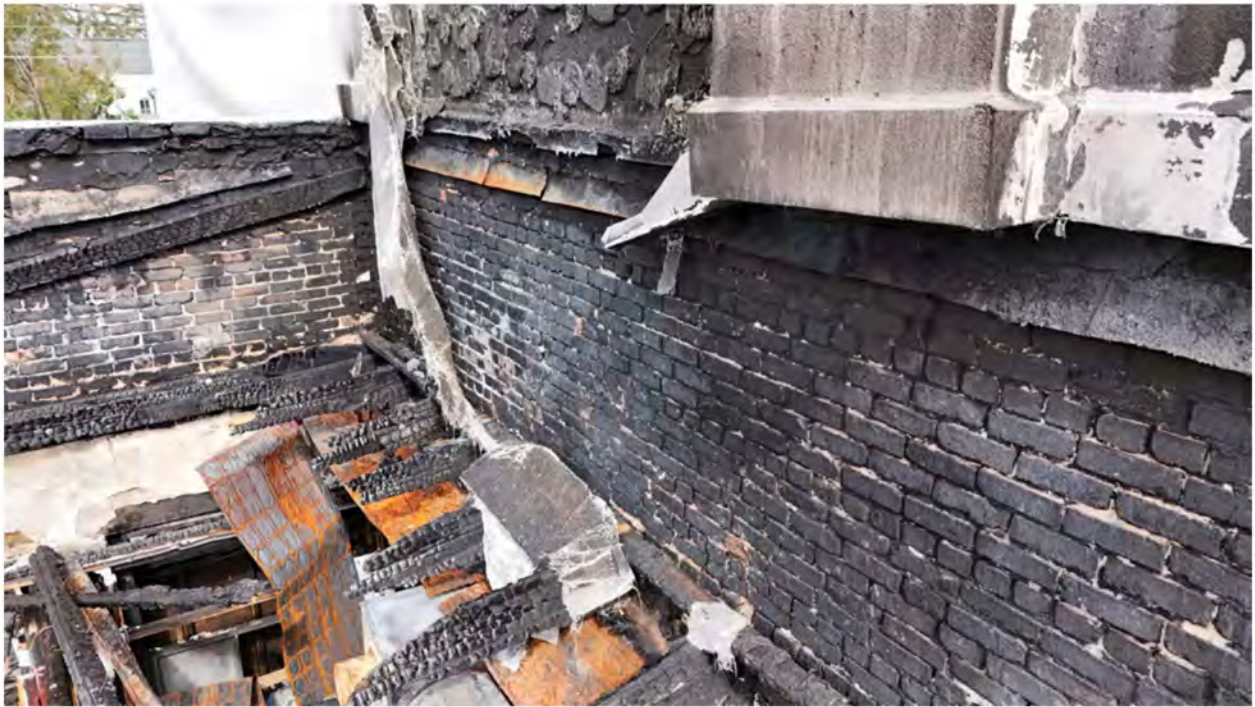
53. Brick wall of the building.

Inspection of the Queensborough National Bank showed that approximately 16 clay bricks on the west side of the first-floor exterior wall were spalled, consistent with exposure to heat from the October 5, 2024 fire event. These bricks can be removed and replaced by a licensed and experienced mason. It should be noted that upon removal of the debris from the adjacent storefront, additional spalled or cracked bricks may be discovered. These bricks can also be replaced.

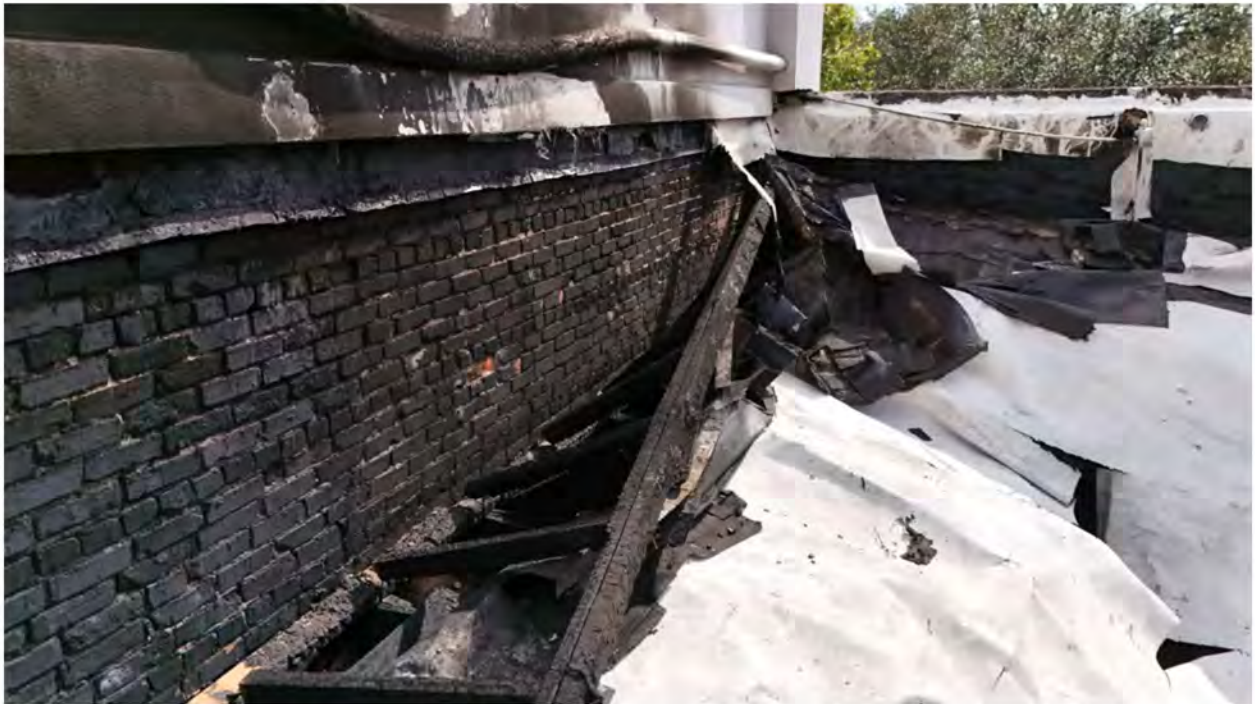
54. Brick wall of the building.

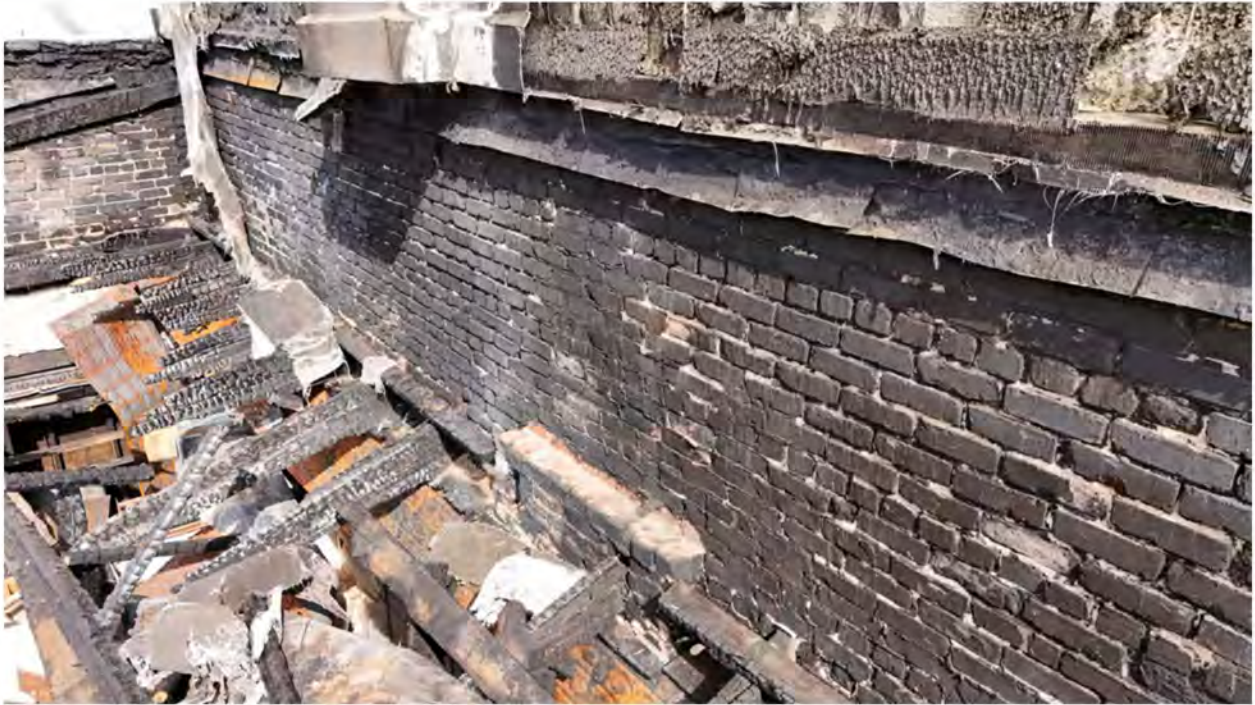
55. Brick wall of the building.

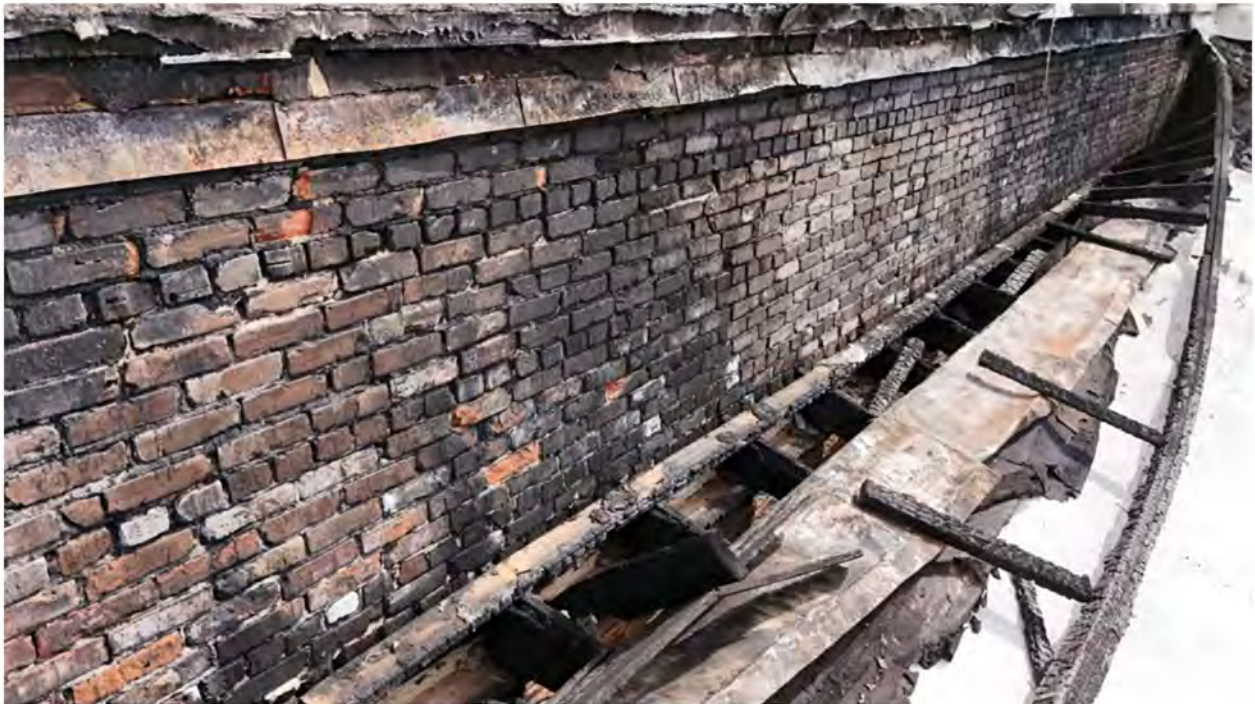
56. Brick wall of the building.

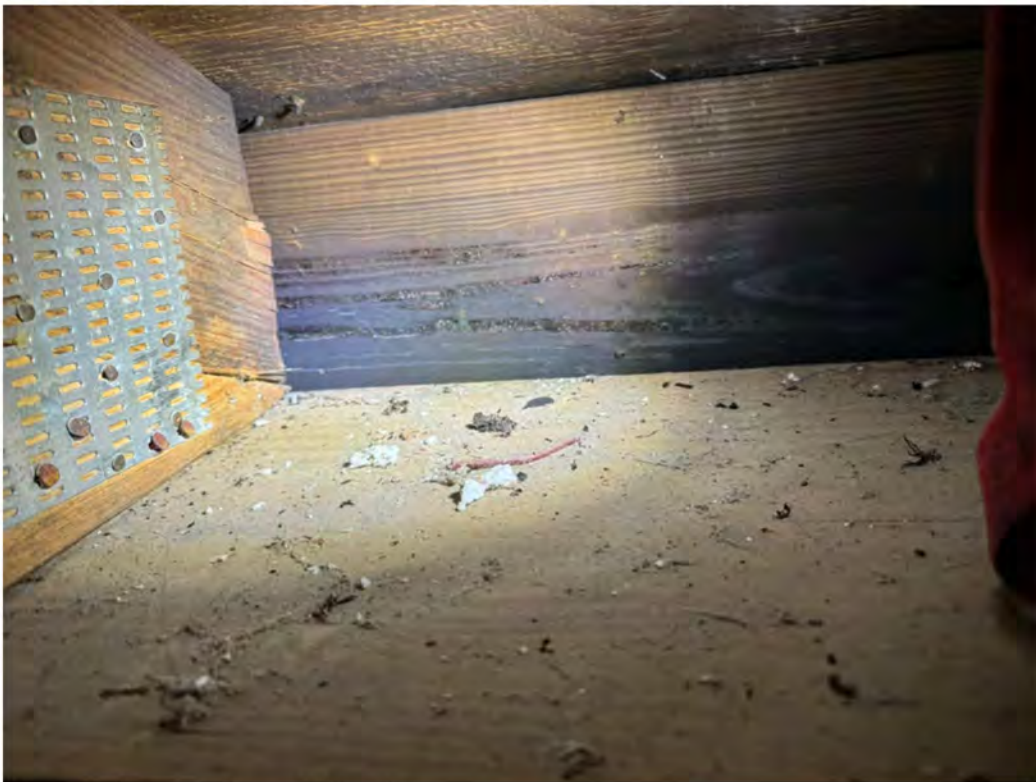
Inspection of the attic space of the Queensborough National Bank showed soot accumulation on the roof decking and on the tips of the roof trusses along the entire western wall. Closer inspection of the roof framing showed small areas where the interior side of the sub fascia was charred. These charred locations were near the center of the 20 linear feet of visible charring on the exterior elevation. We closely examined the tips of the roof trusses at these locations, where there was soot buildup, and found no charring. While it is possible that there was minimal charring in the tips of the trusses not visible during our inspection, we found no charred truss members that would compromise the structural integrity of the roof system. Approximately 20 linear feet of sub-fascia was damaged by the October 5, 2024 fire event. The roof trusses and the roof decking at the Queensborough National Bank were not damaged by the October 5, 2024 fire event.

86. Light charring on the sub-fascia.
