## **Fire Damage Assessment and Restoration Scope of Work**

**Property damage assessment and restoration scope of work following a fire loss within the Queensborough National Bank located at 20 NW Broad Street in Metter, GA 30439.**

*Date:* November 13, 2024

*Prepared By:* National Environmental Solutions, Inc.  
P.O. Box 220  
Sautee, Georgia 30571  
NESI Project Number: 23-8318

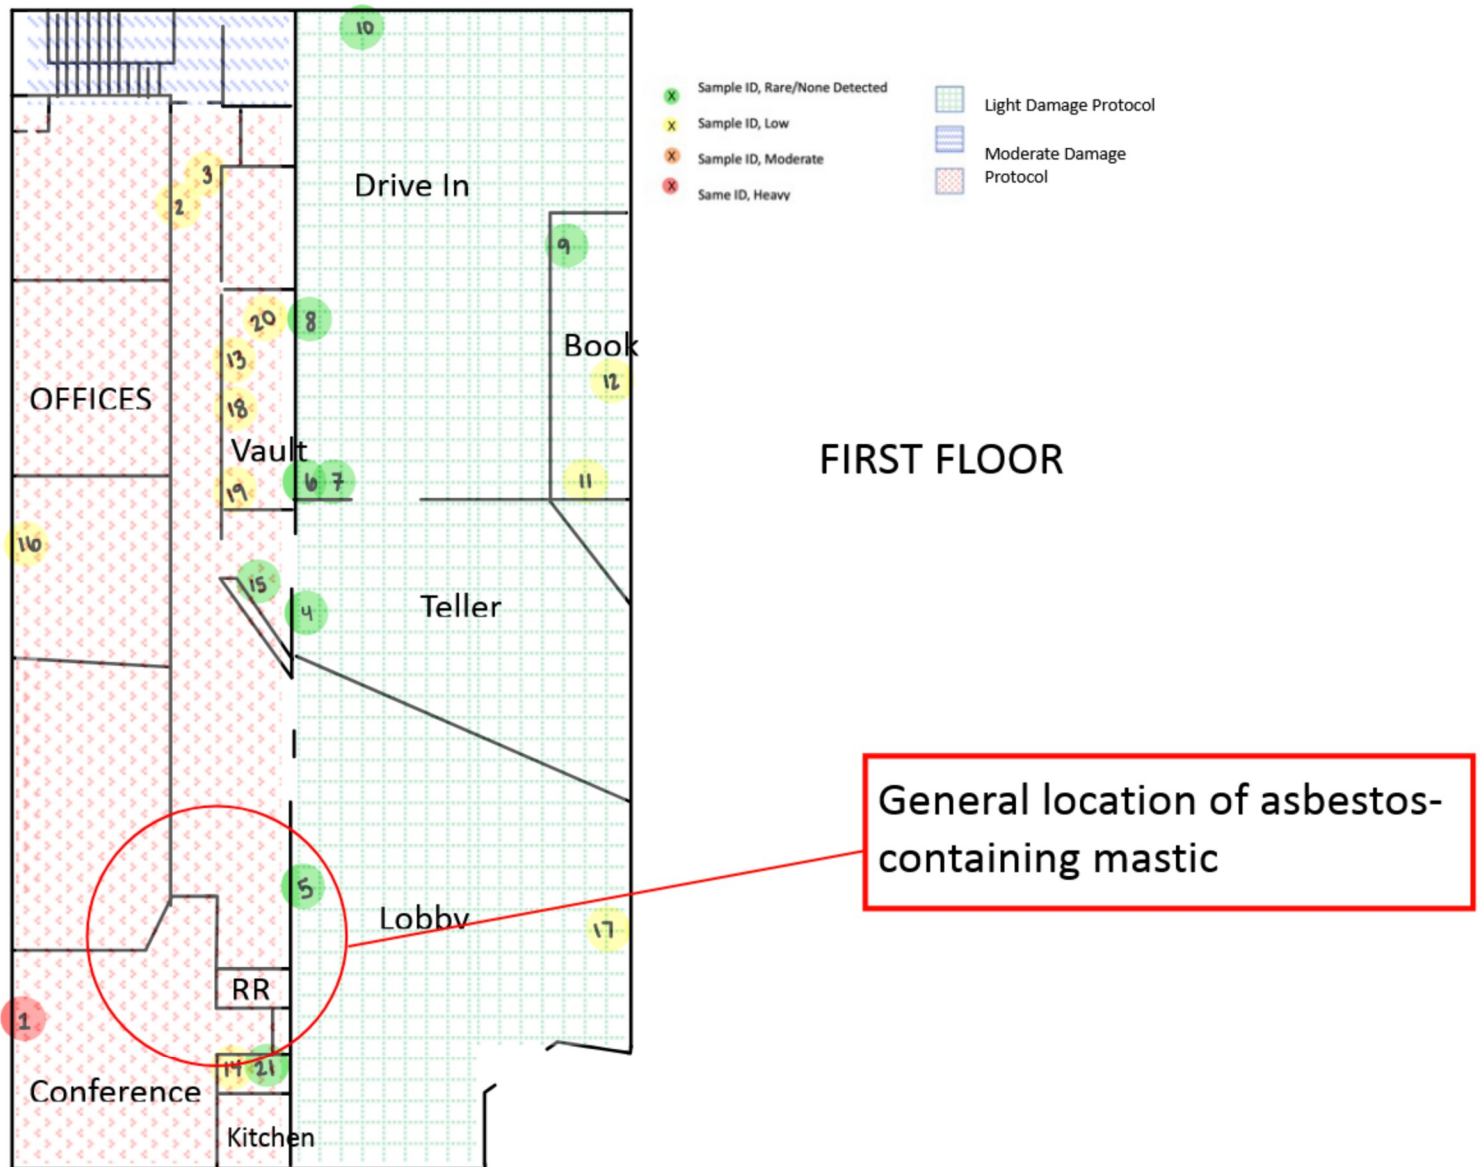
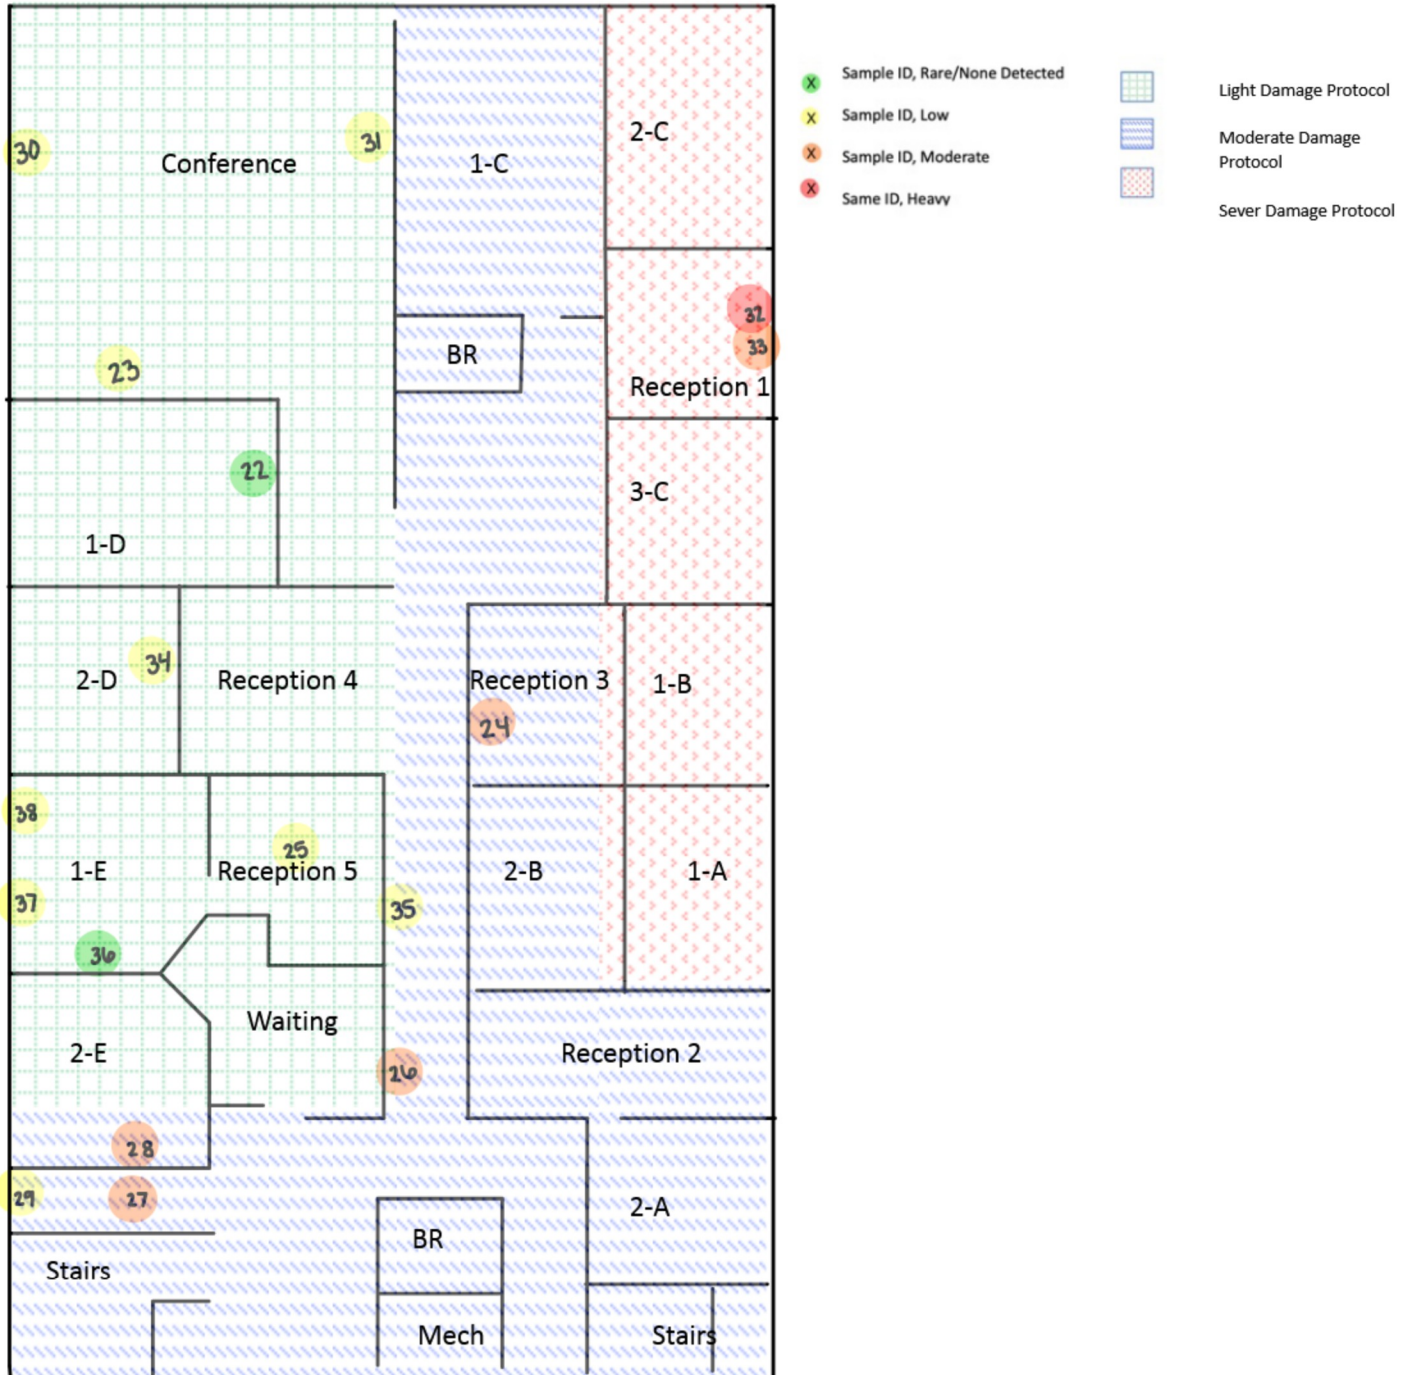
## 7. – SCHEMATIC DRAWINGS

- (1) The offices, hallways, bathrooms, closets, etc., on the west side 1st level of the building are moderately to severely impacted and will require full component removal, treatment, and cleaning [See Drawings in Section 7—Schematic Drawings].

- (2) All remaining rooms and plenums on the east side of the building (past the demarcating wall) are lightly impacted by soot residues and will require HEPA vacuuming, wet-wiping, and odor removal [See Drawings].

- (3) The offices on the west side 2nd level of the building are moderately to severely impacted and will require full component removal, treatment, and cleaning [See Drawings].

- (4) The remaining rooms are lightly to moderately impacted by soot residues and will require HEPA vacuuming, wet-wiping, and odor removal [See Drawings].

The rooms demarcated in **RED** all have had heavy fire impact and, therefore, shall be considered severely damaged. These locations shall be “gutted” and removed of all wallboard, carpeting, ceramic floor tile, ceiling tiles, insulation and other finishes to expose the wall and ceiling cavity and slab. In areas closest to the fire's origin, wood beams, joists, and other structural components may be charred and unstable. All damaged items

All areas marked in **BLUE** shall be cleaned, treated, and painted. Cleaning and treatment consists of surface cleaning to remove grease, oils, fats, and soot particles from floors, walls, and ceilings. Oxidizing agents, followed by a neutralizing agent (if required), shall then be used to remove odors from the surface. Finally, a smoke odor sealer should be applied to surfaces such as walls and ceilings to permanently encapsulate and seal any remaining residual odors. Fixtures such as teller's desks, counters that are exhibiting signs of heat or smoke damage should be removed and replaced with new.

All remaining surfaces in the building, shaded in **GREEN**, shall be HEPA-vacuumed and wet-wiped clean. Areas to be cleaned include the wall systems in the occupied space as well as the plenum space above the ceiling grid.

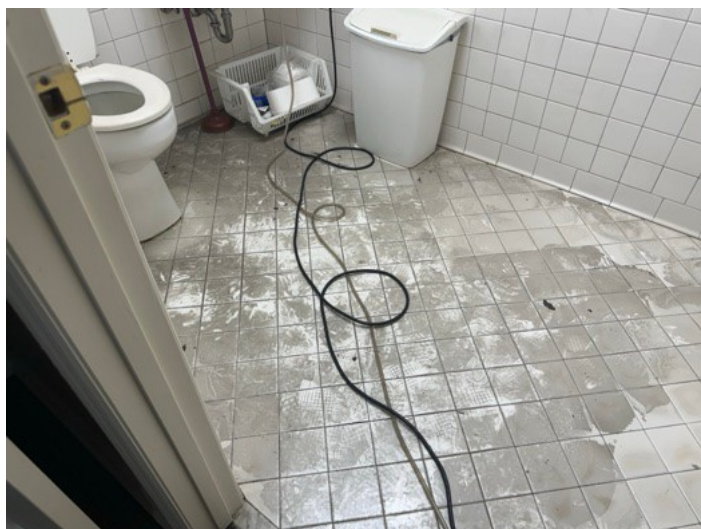
**Main Level Bathrooms:** General condition of rooms

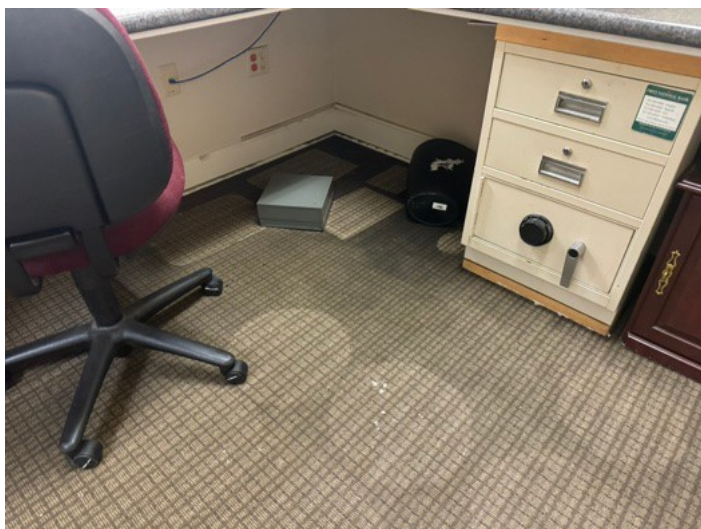
**Main Level Offices:** General condition of carpet

All carpets, associated glues, and mastics within the building shall be removed and disposed of regardless of whether the carpet is located in a severely, moderately, or lightly impacted room.

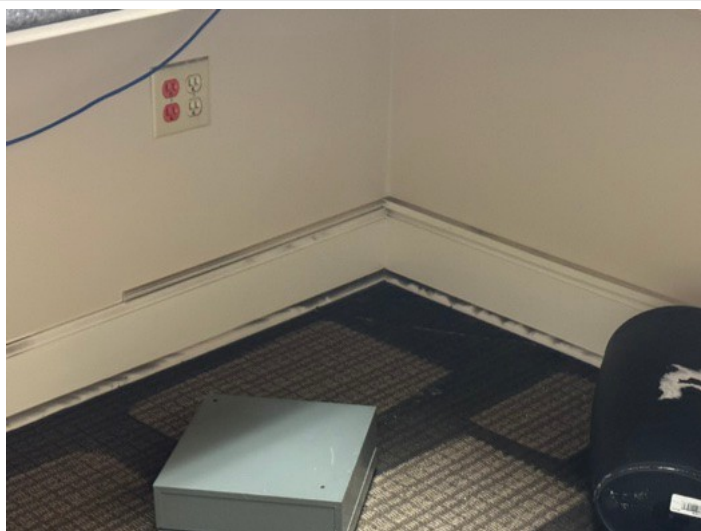
**Main Level:** Soot deposition through the walls

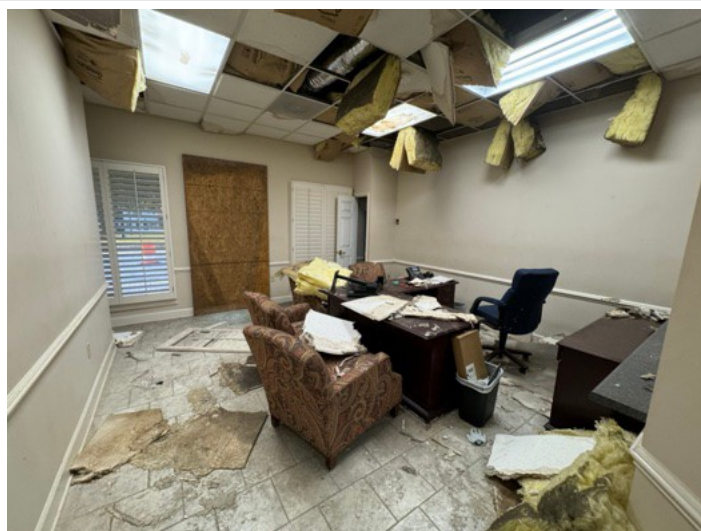
**Conference Room:** General condition of rooms

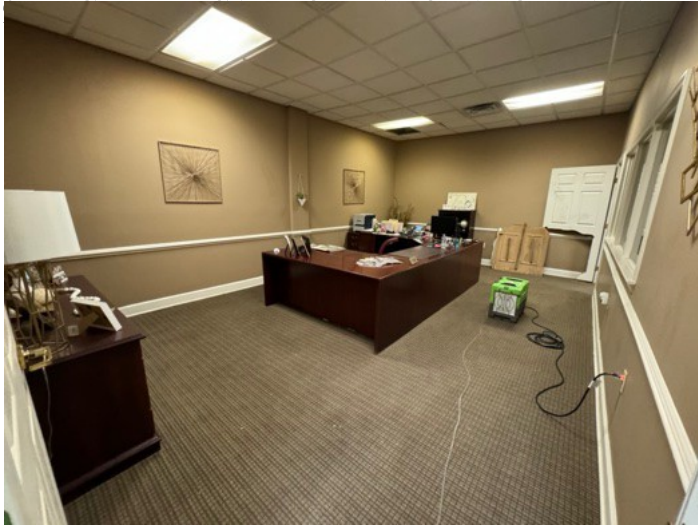
**Main Level Offices:** General condition of offices

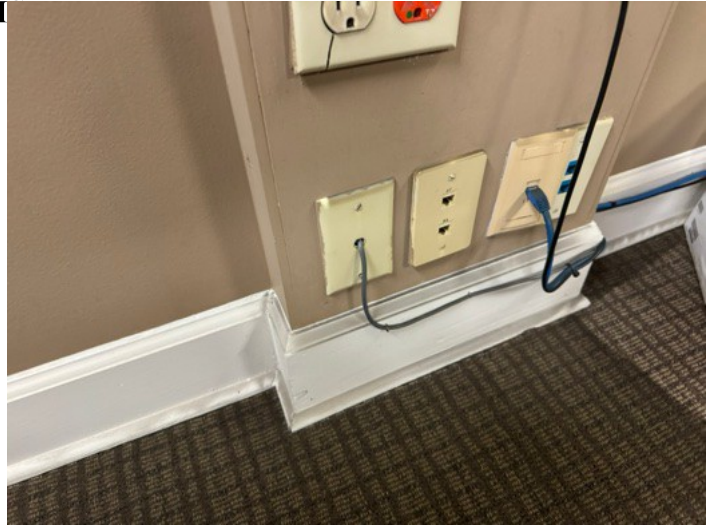
**Main Level Offices:** Soot on switches and outlets

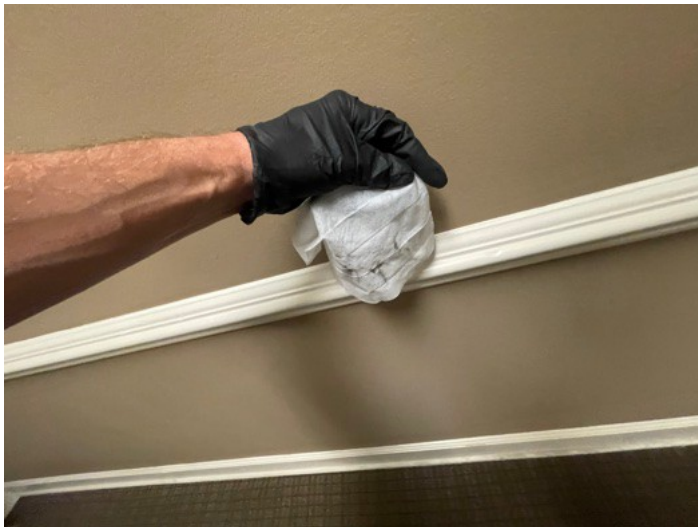
**Main Level:** Soot definition on surfaces.

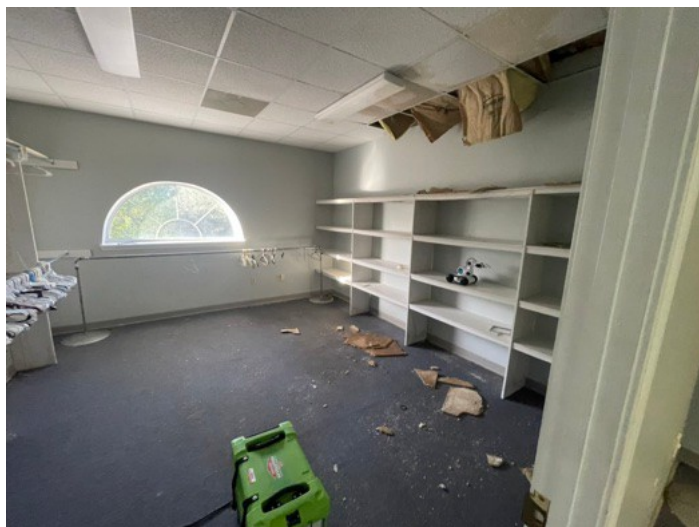
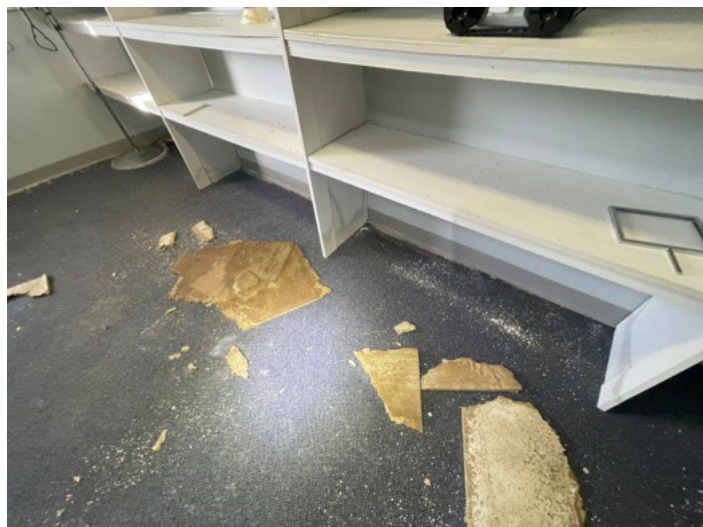
**Upper Level:** General Condition of rooms.

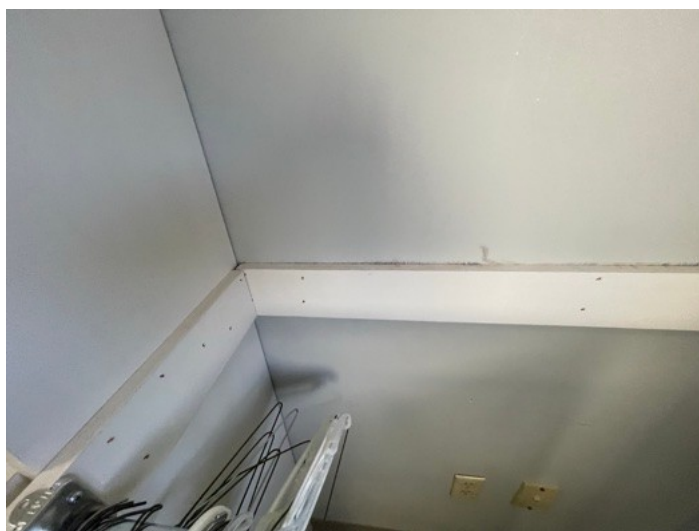
**Upper Level:** Soot deposition on surfaces

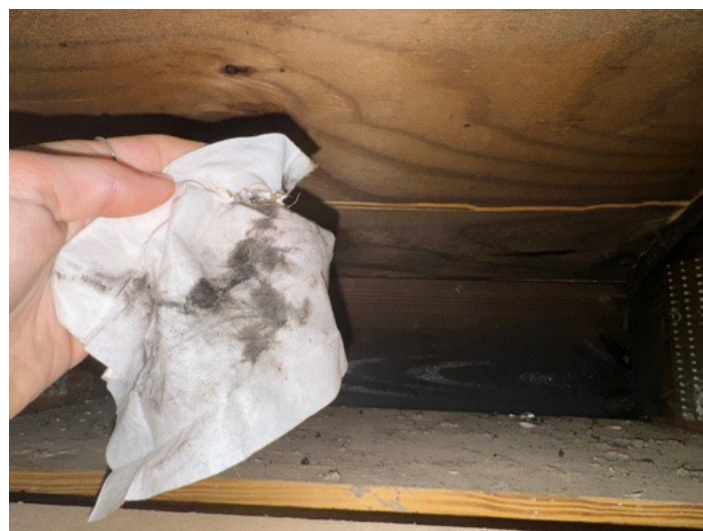
**Upper Level:** Soot deposition in plenum
