Post-Fire Structural Evaluation

Queensborough National Bank
20-28 N Main St.
Metter, GA 30439

Client File No.: FWG6889
SFE File No.: 240019GA1

November 4, 2024

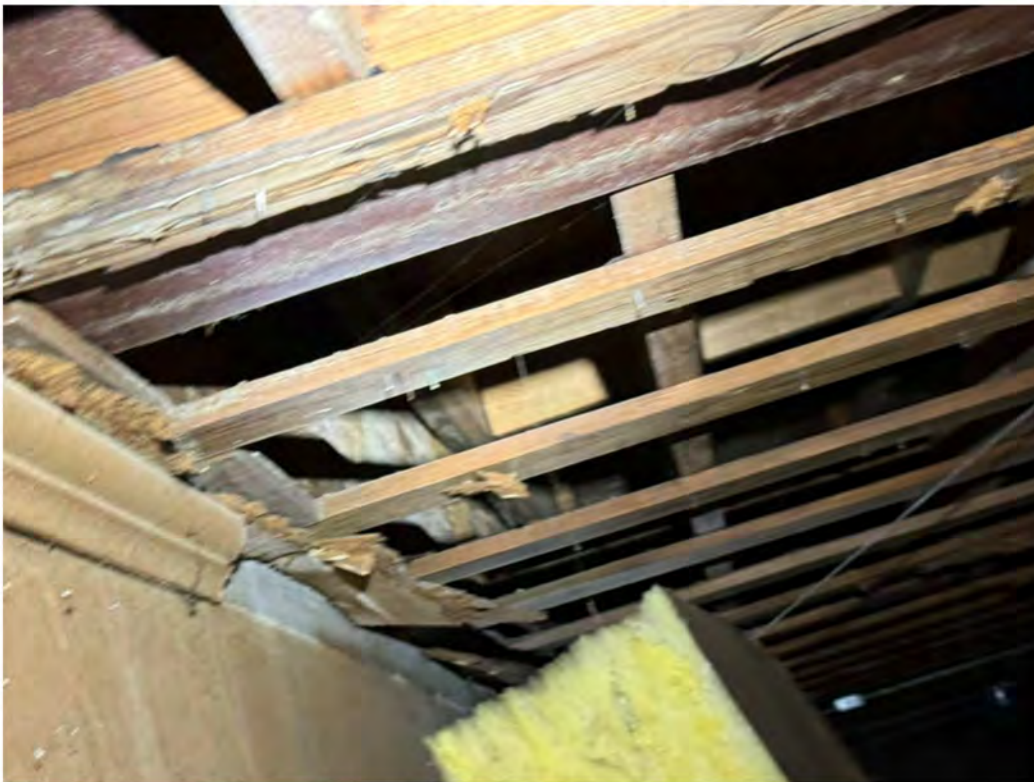
94. Inside the plenum above th first floor.

Inspection of the plenum space above the first floor showed small amounts of soot accumulation in areas where outside air was able to pass through the exterior wall. The steel trusses were not discolored, and the wood floor framing was not charred from the recent fire event. The second-floor framing was not damaged by the recent fire event on October 5, 2024.
