Post-Fire Structural Evaluation

Queensborough National Bank
20-28 N Main St.
Metter, GA 30439

Client File No.: FWG6889
SFE File No.: 240019GA1

November 4, 2024

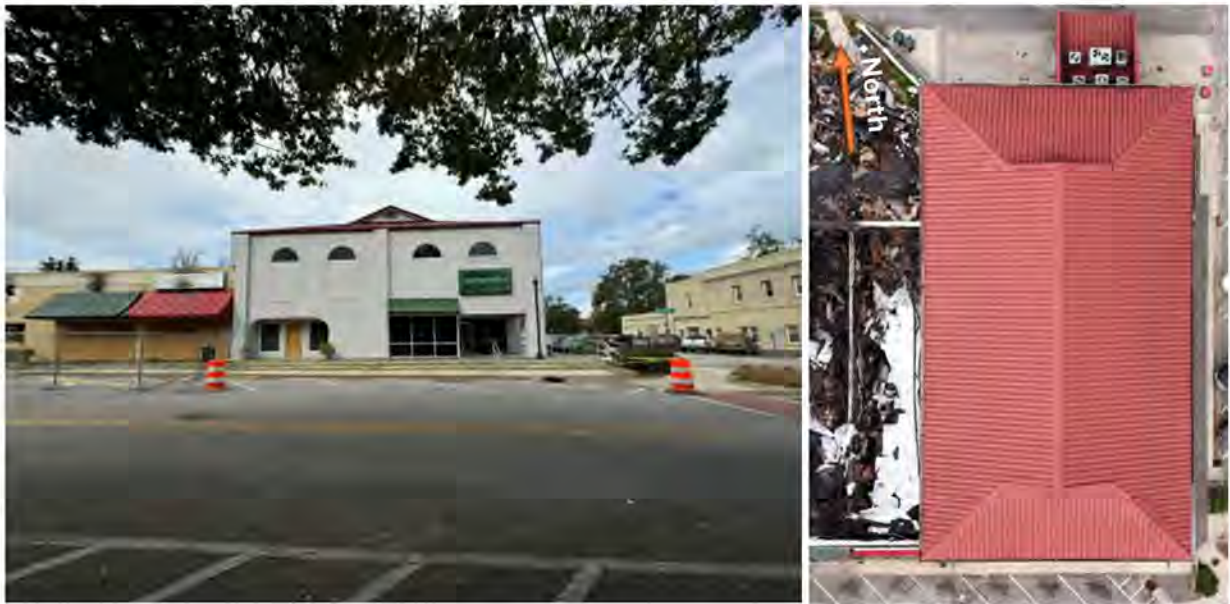
Figure 1 (Left) and Figure 2 (Right). Front Elevation of the Building and Roof Geometry.

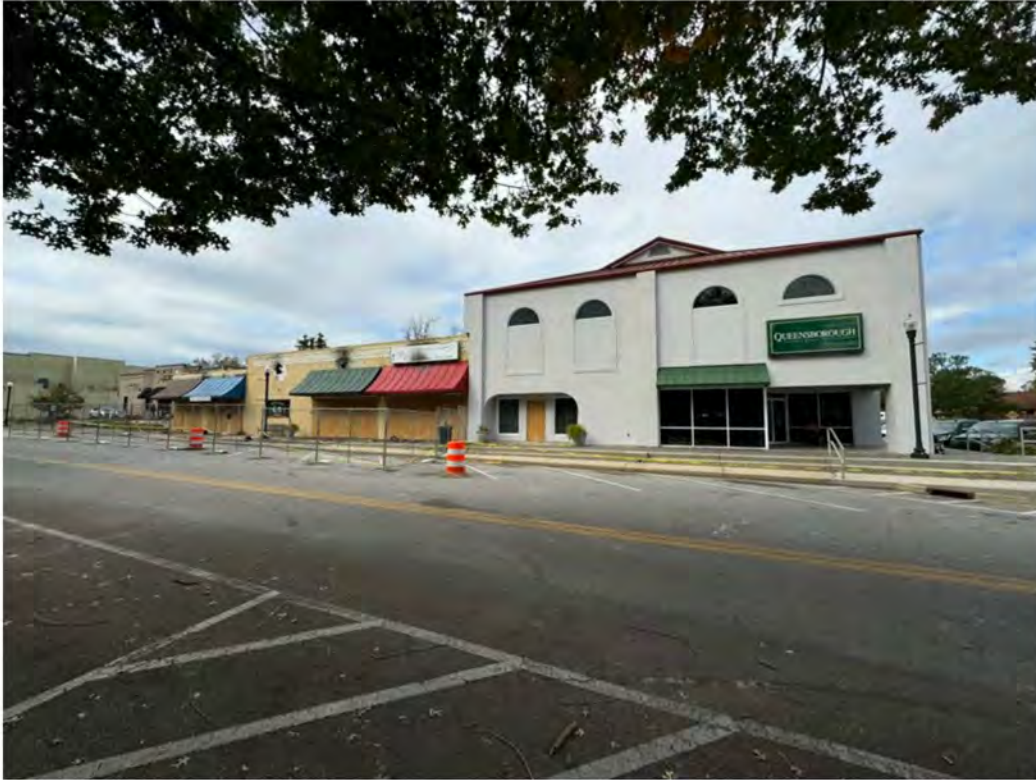
1. South elevation of the building.

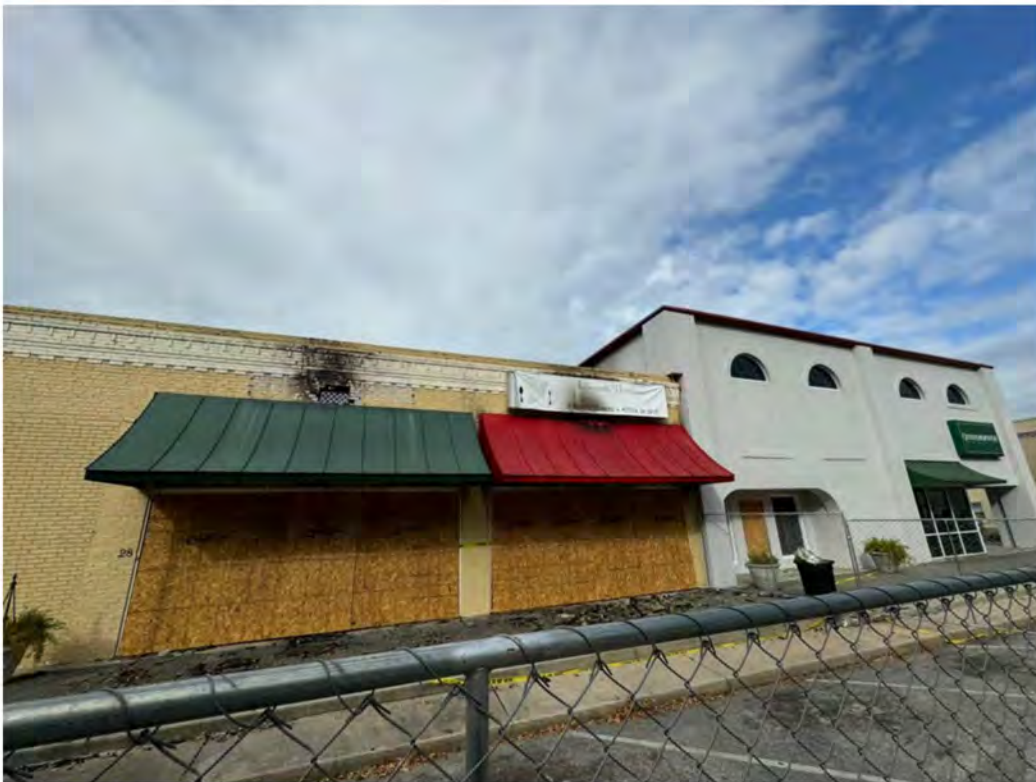
2. South elevation of the building and the adjacent storefronts.

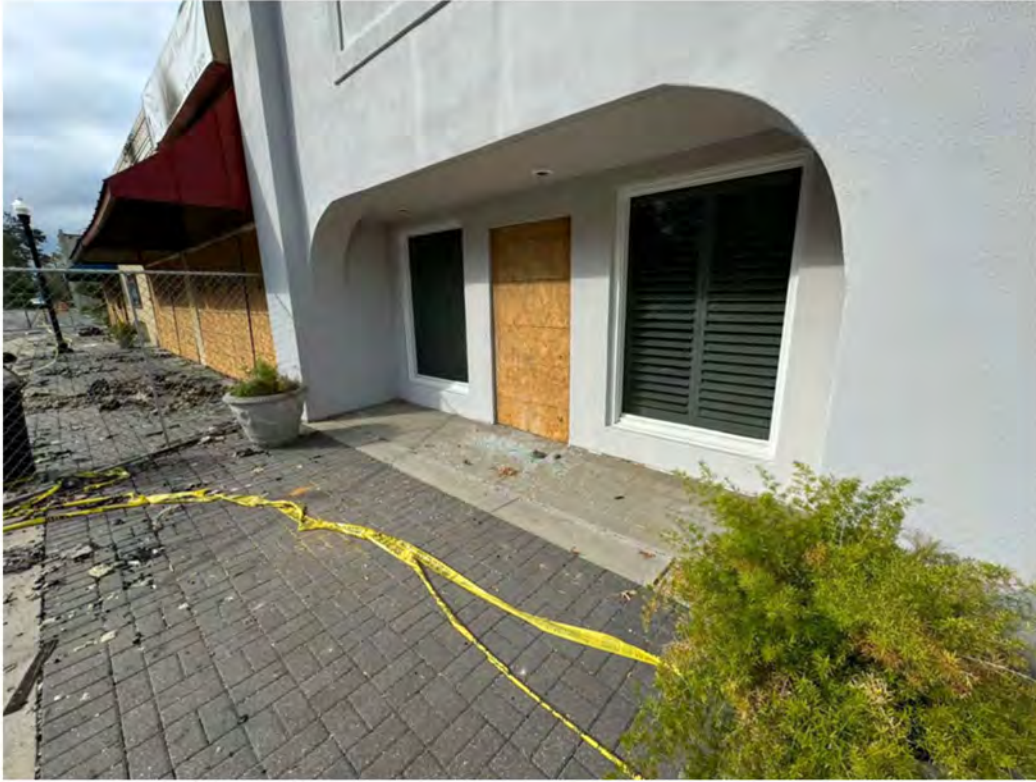
3. South elevation of the building.

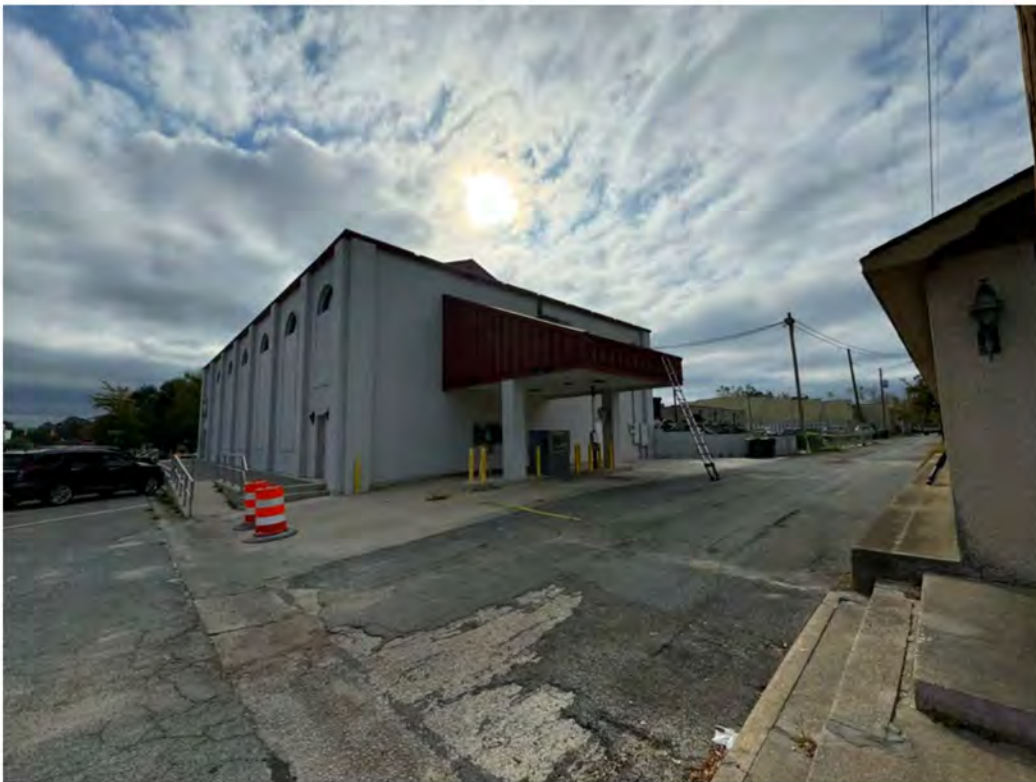
4. North elevation of the building.

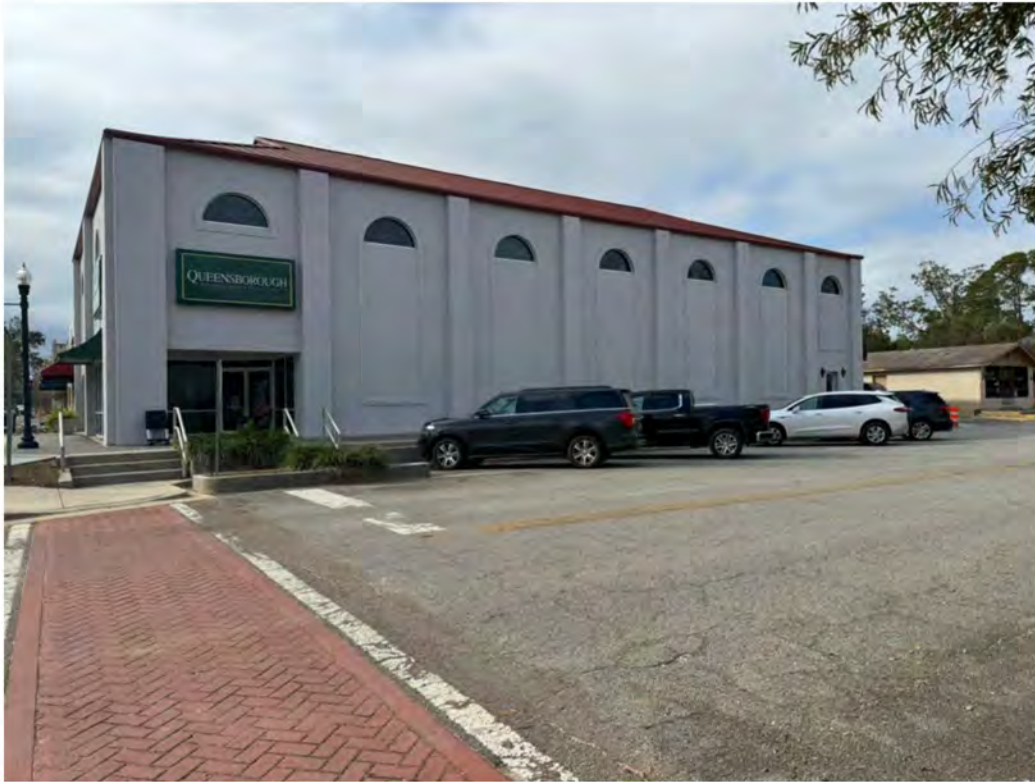
5. East elevation of the building.

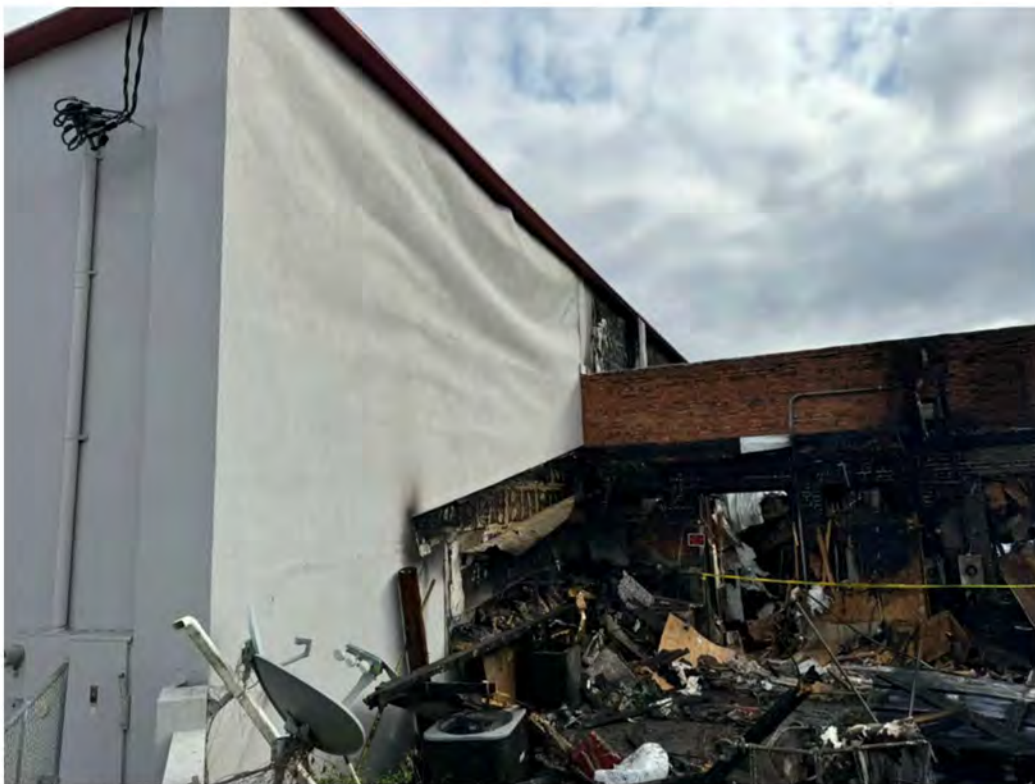
6. West elevation of the building.

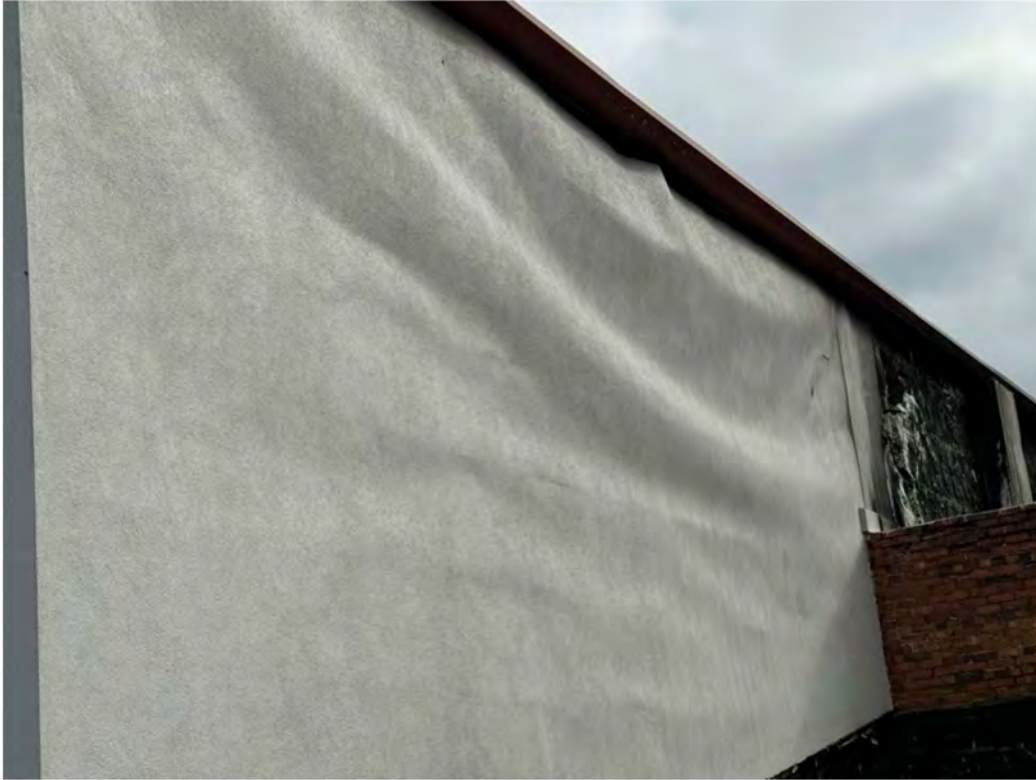
We inspected the western exterior wall, starting with the fiberglass-reinforced plaster exterior wall finish. The majority of the siding had either burned away or had melted and become deformed from the heat of the fire event.

7. Melted fiberglass reinforced plaster siding.

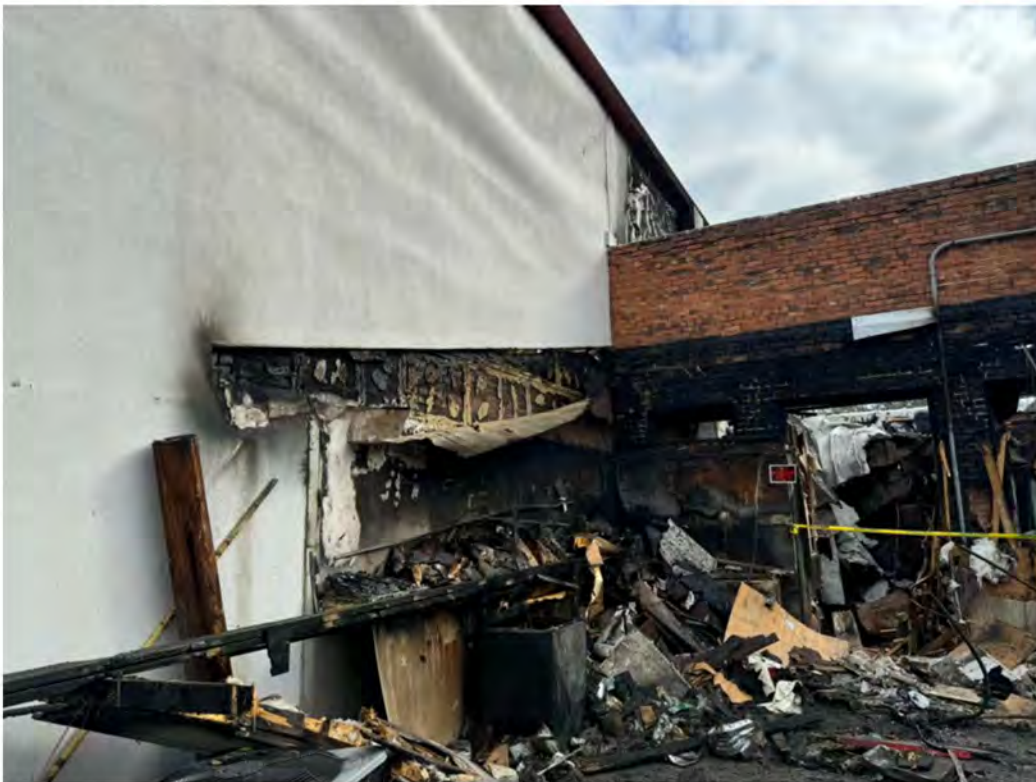
10. Western elevation of the rear portion of the building.

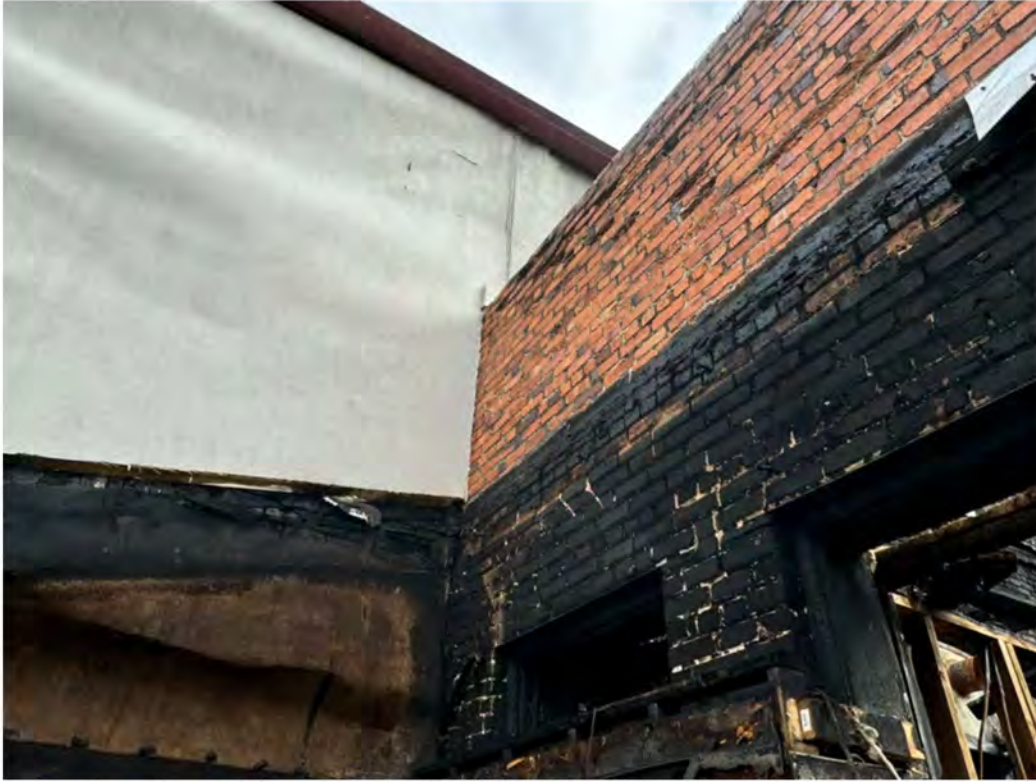
11. Western elevation of the rear portion of the building.

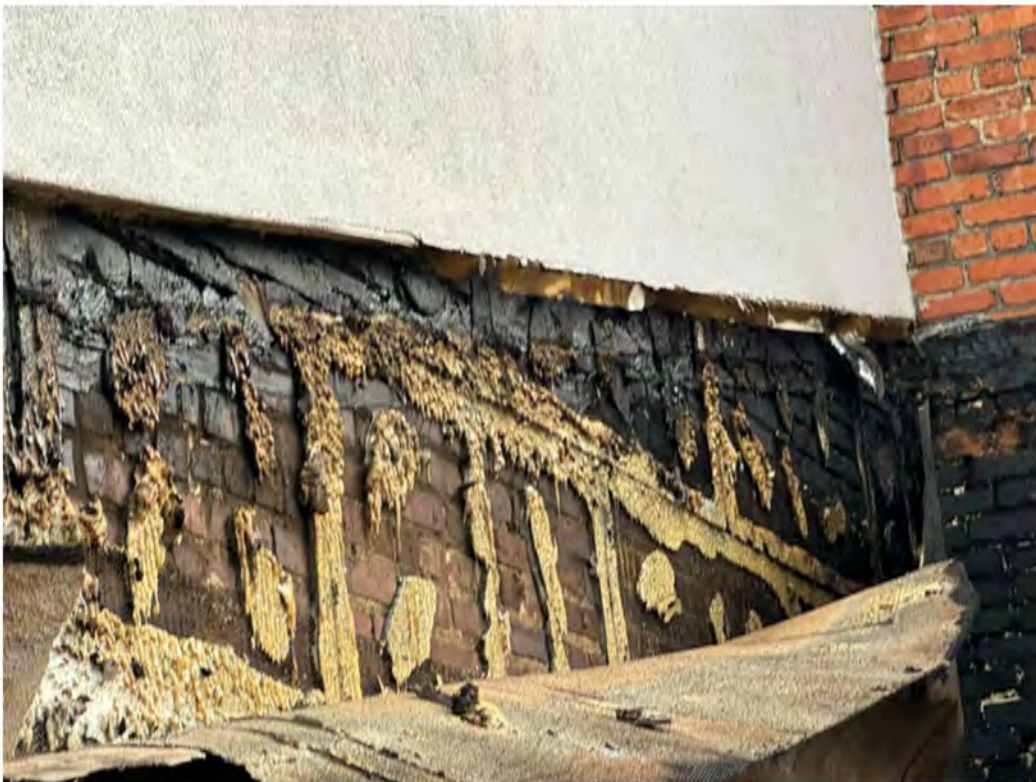
12. Western elevation of the rear portion of the building.

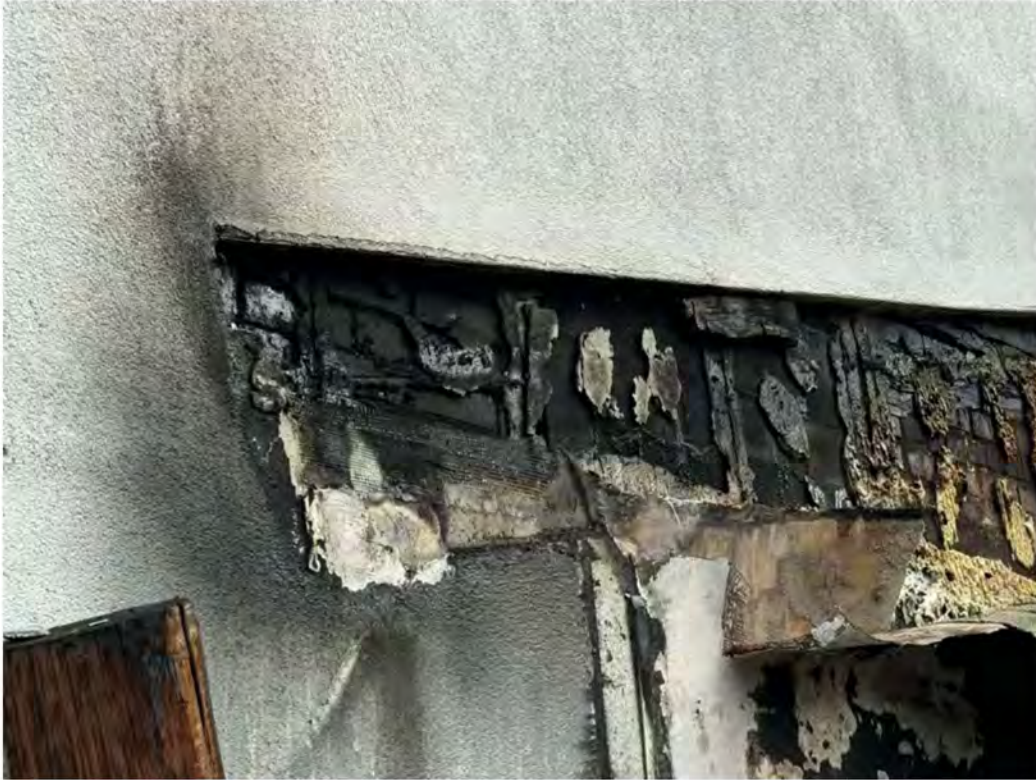
13. Western elevation of the rear portion of the building.

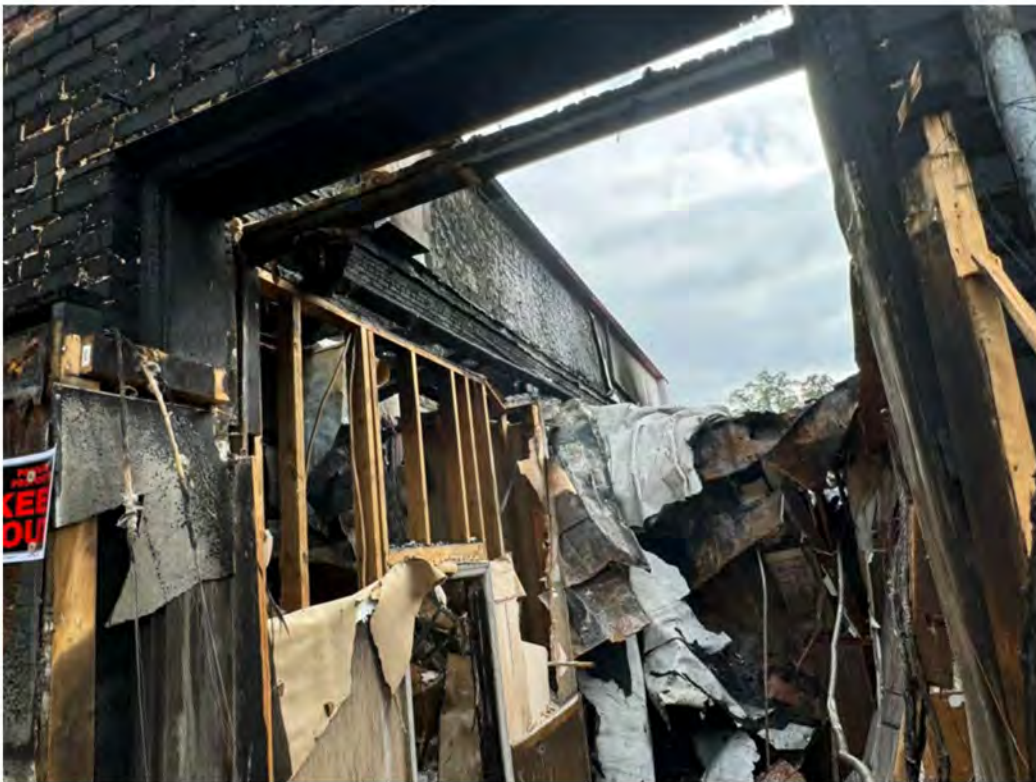
14. Western elevation of the building.

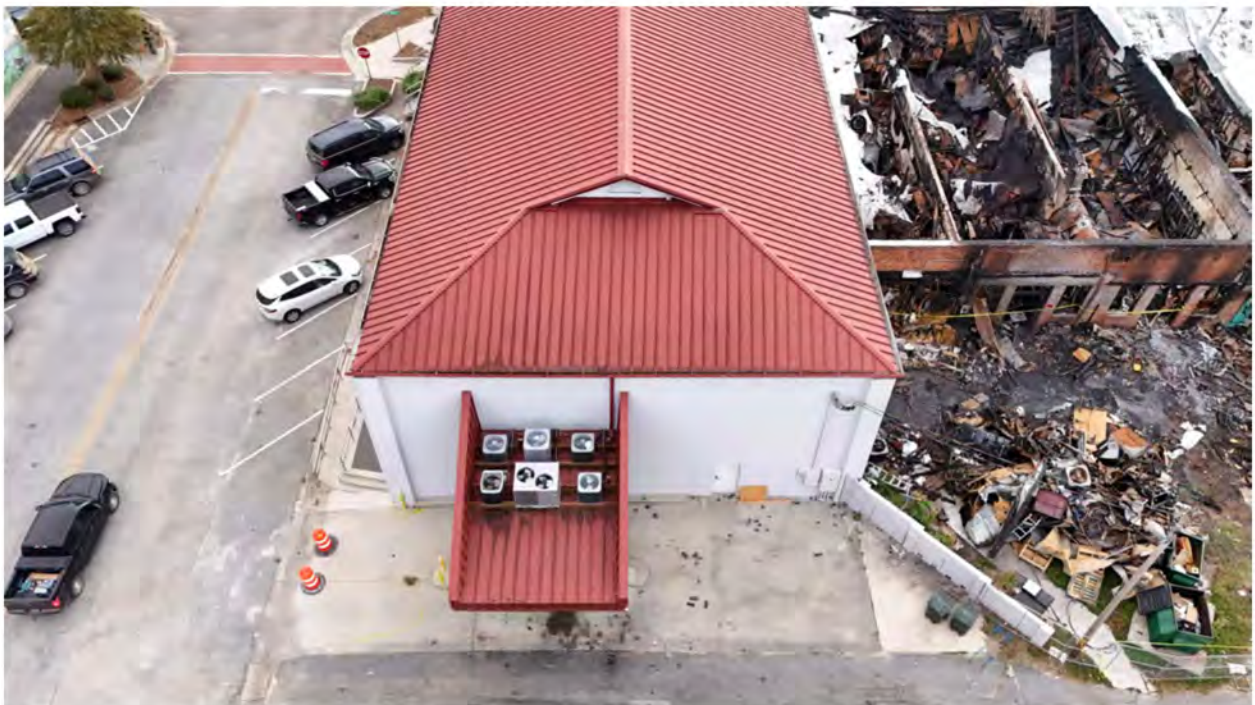
18. Northern elevation of the building.

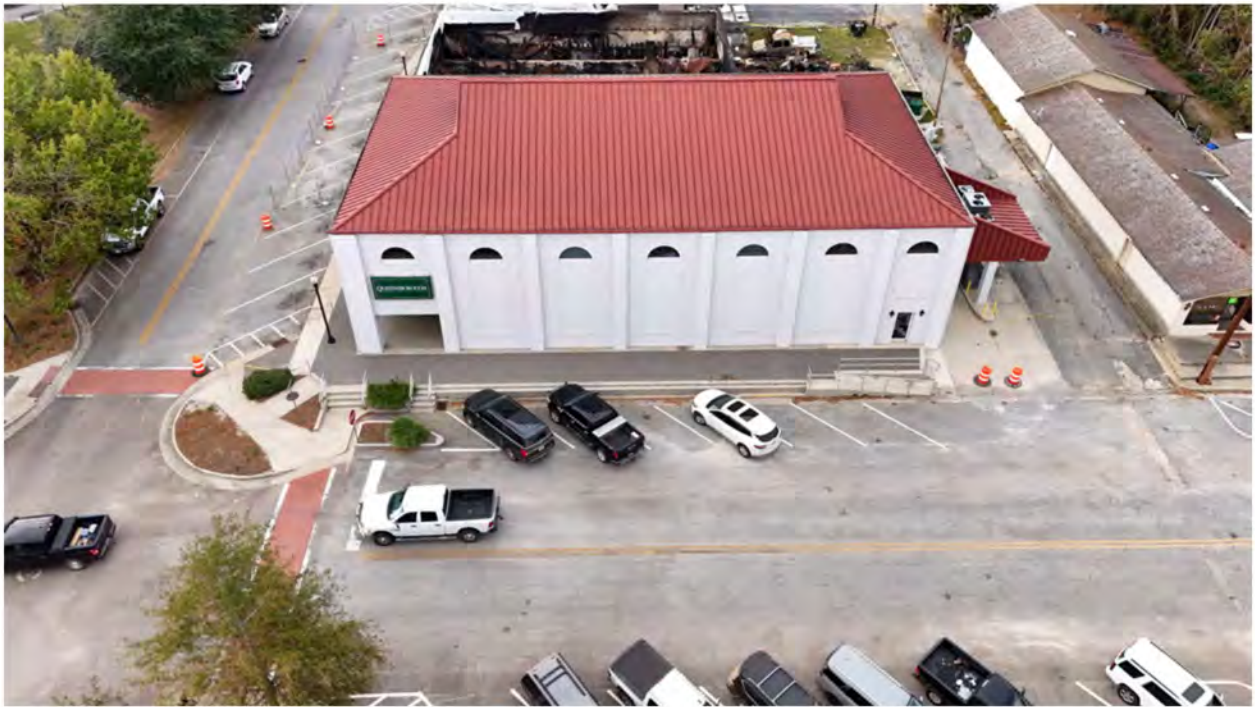
19. Eastern elevation of the building.

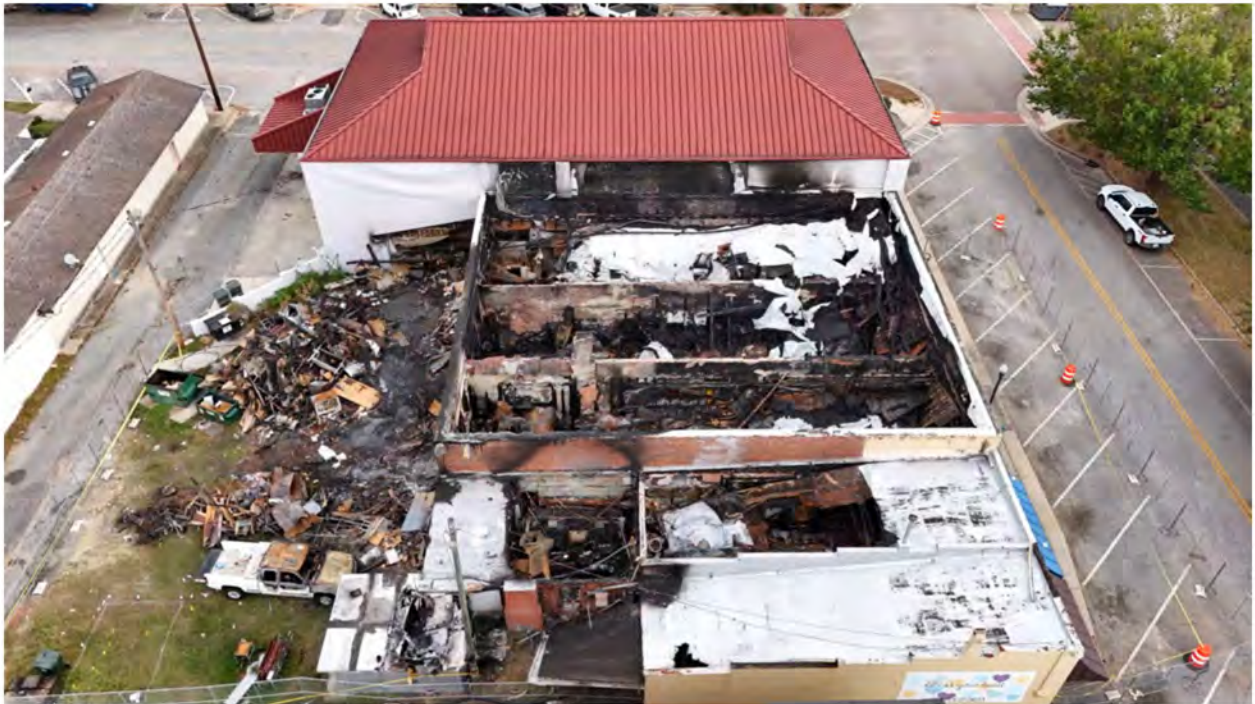
20. Western elevation of the building.

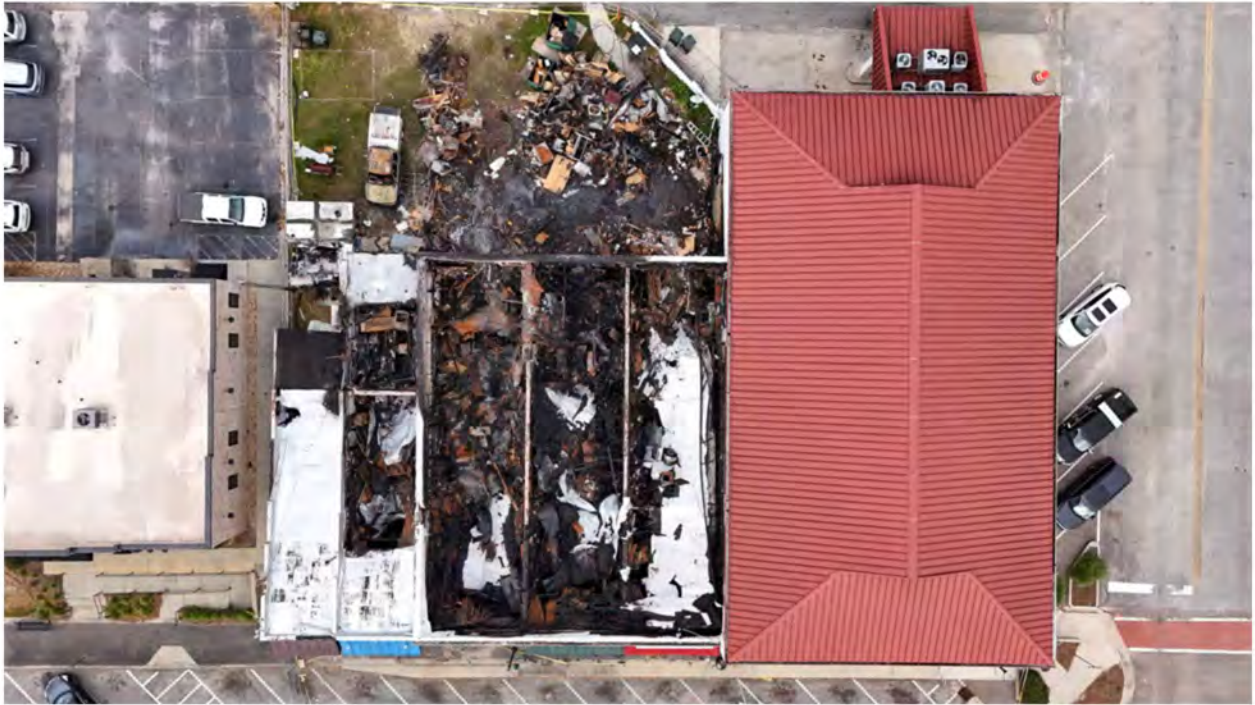
21. Fire overview.

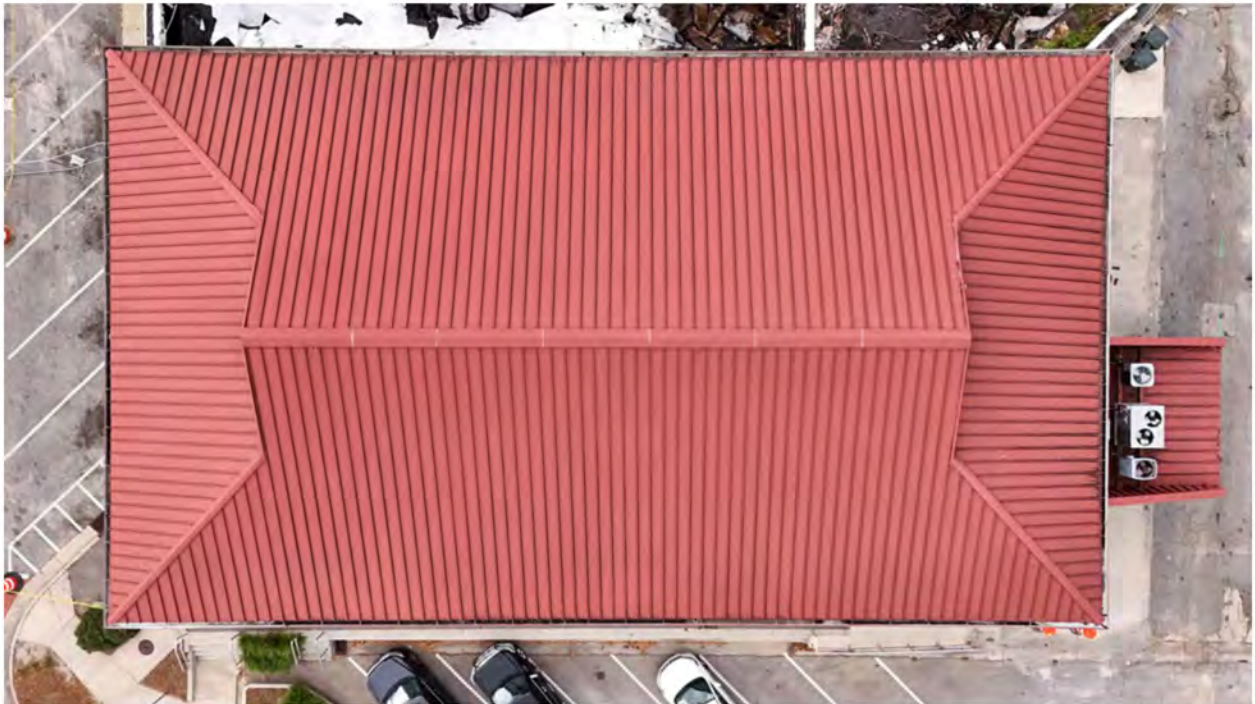
22. Roof overview.

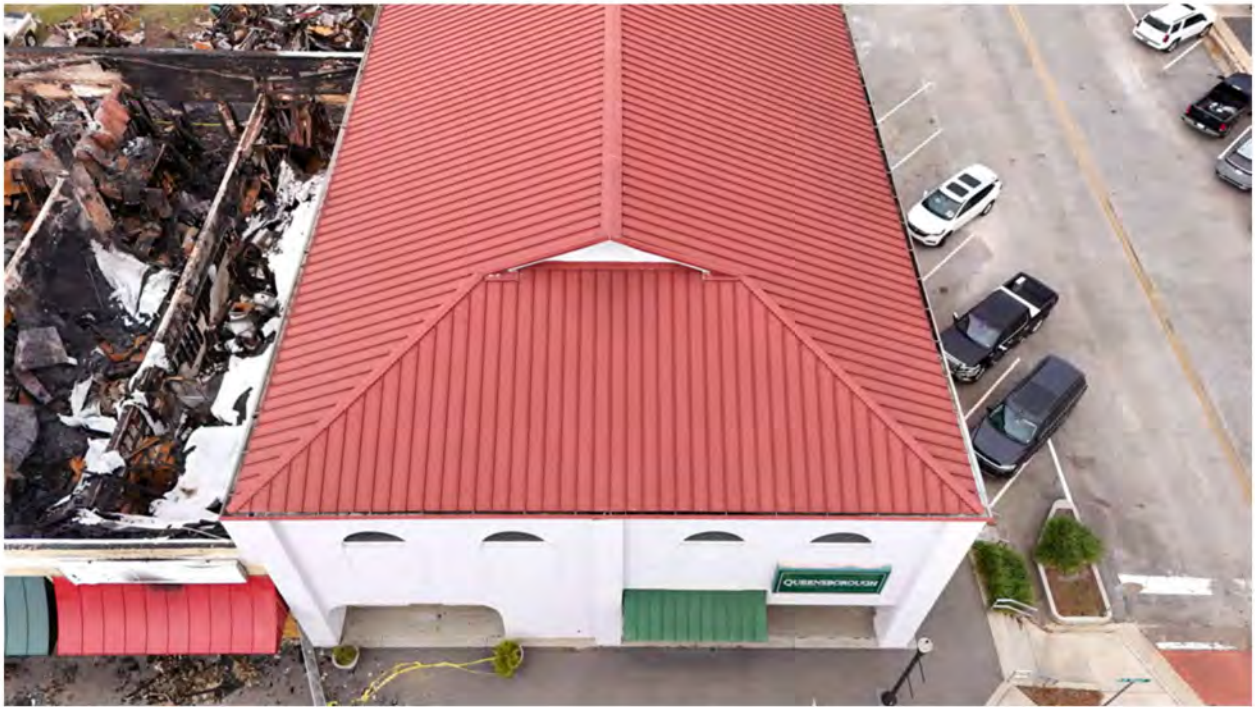
23. Roof overview.

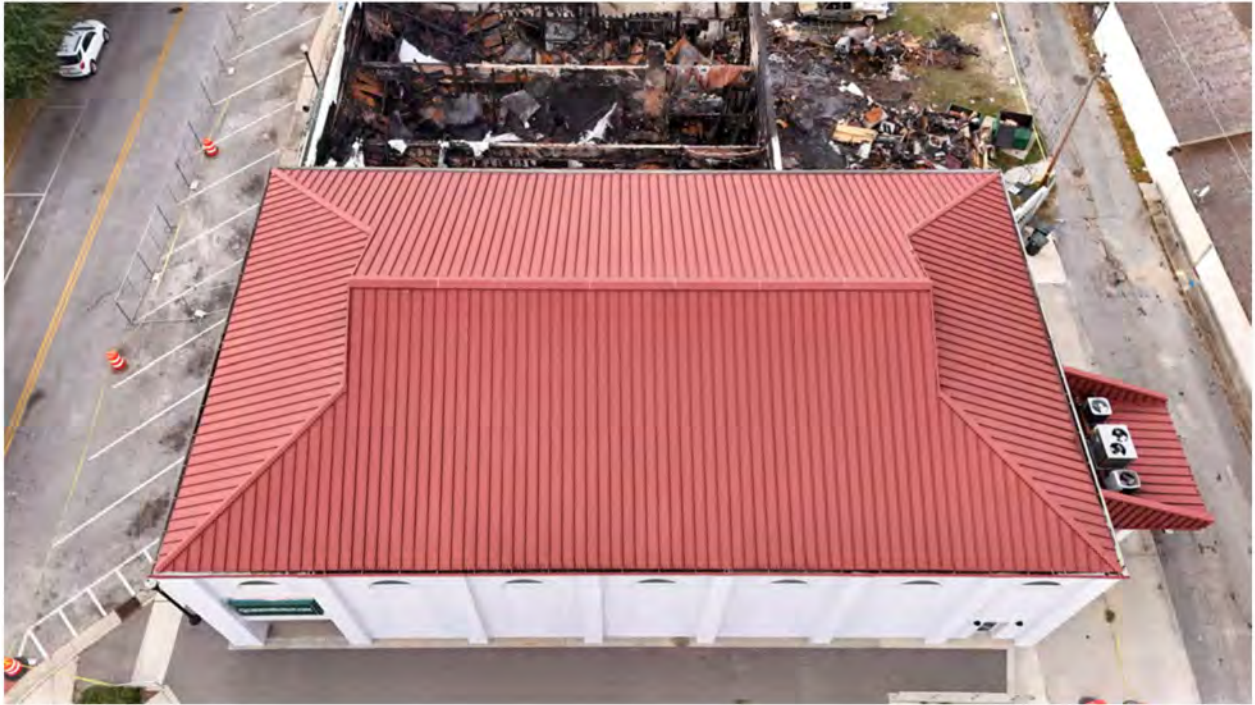
25. Roof overview.

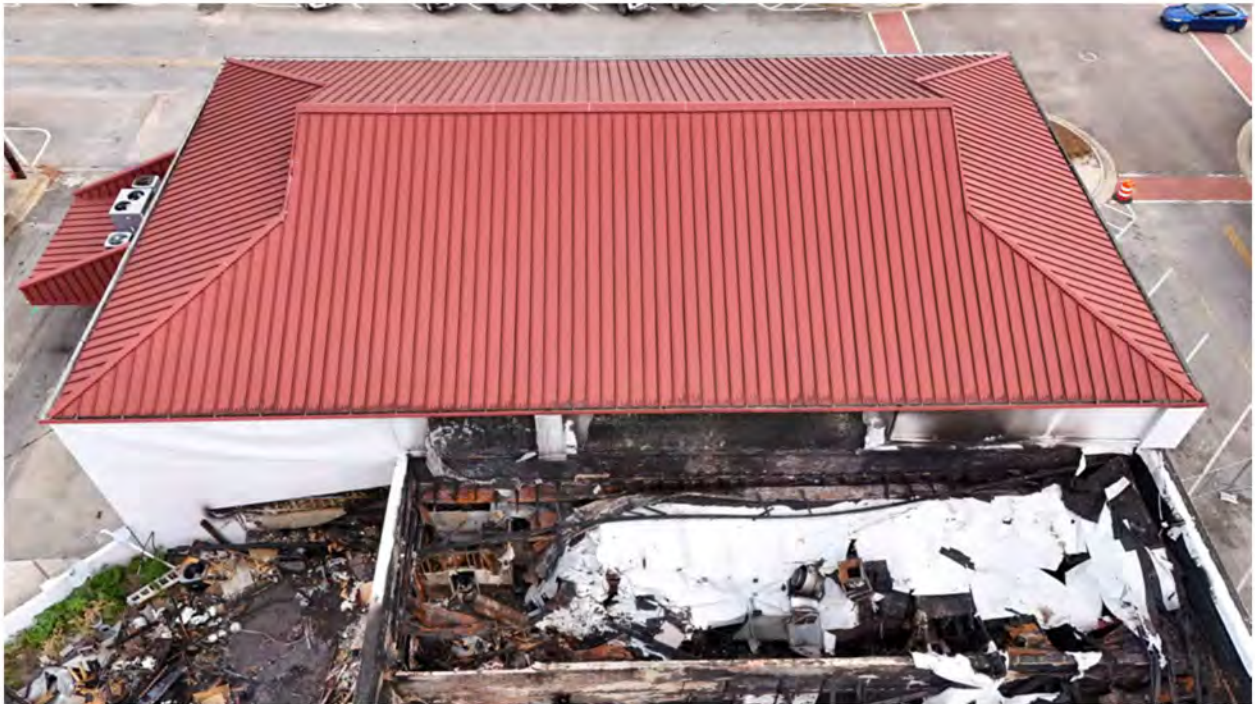
26. Roof overview.

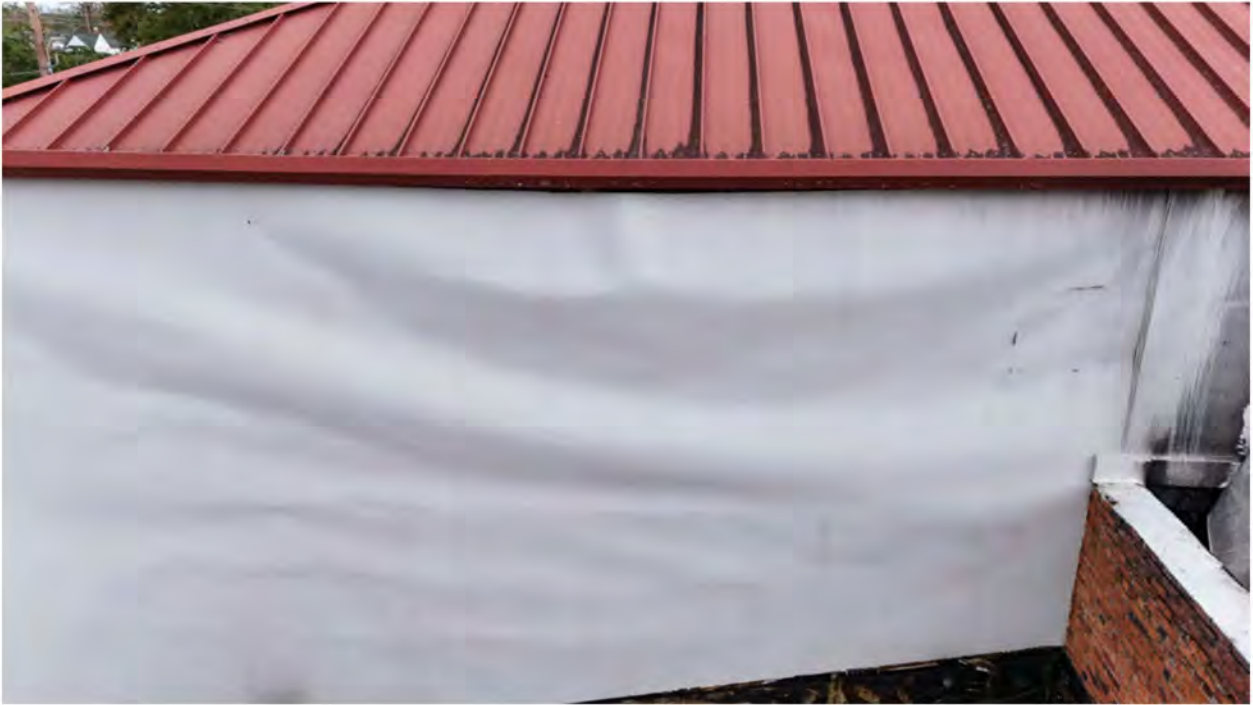
27. Melted reinforced plaster siding.

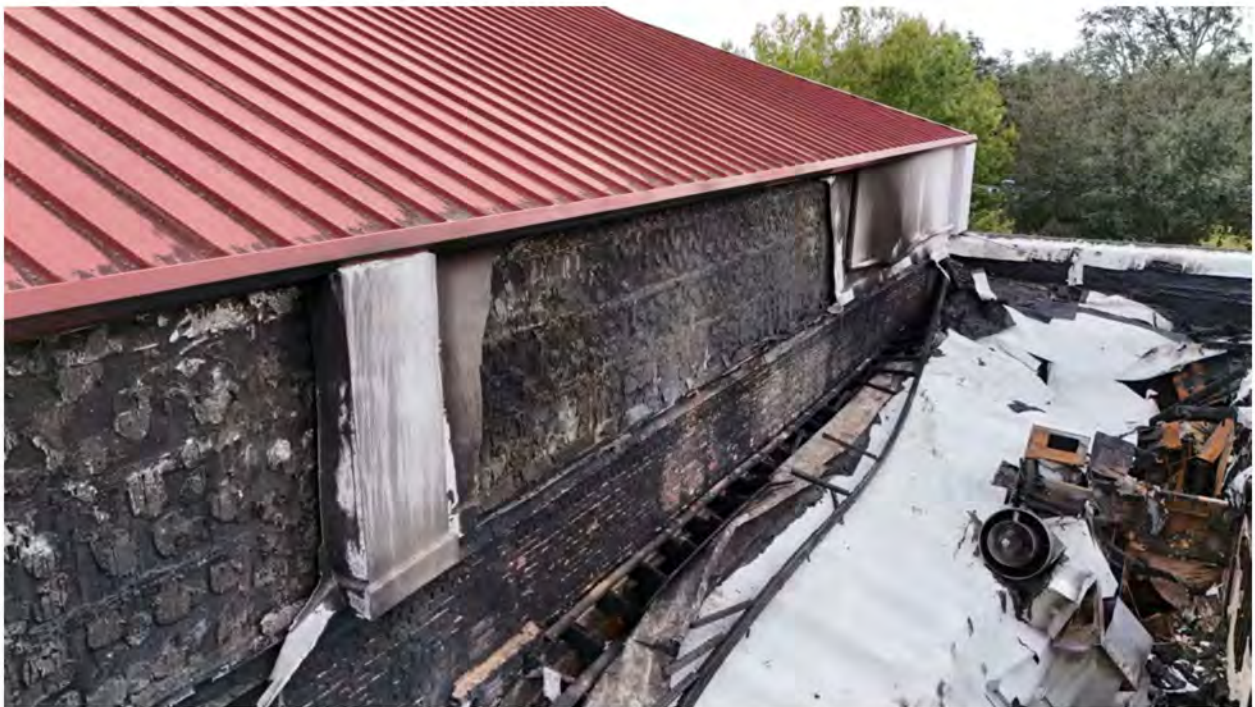
30. Concrete block wall of the second floor.

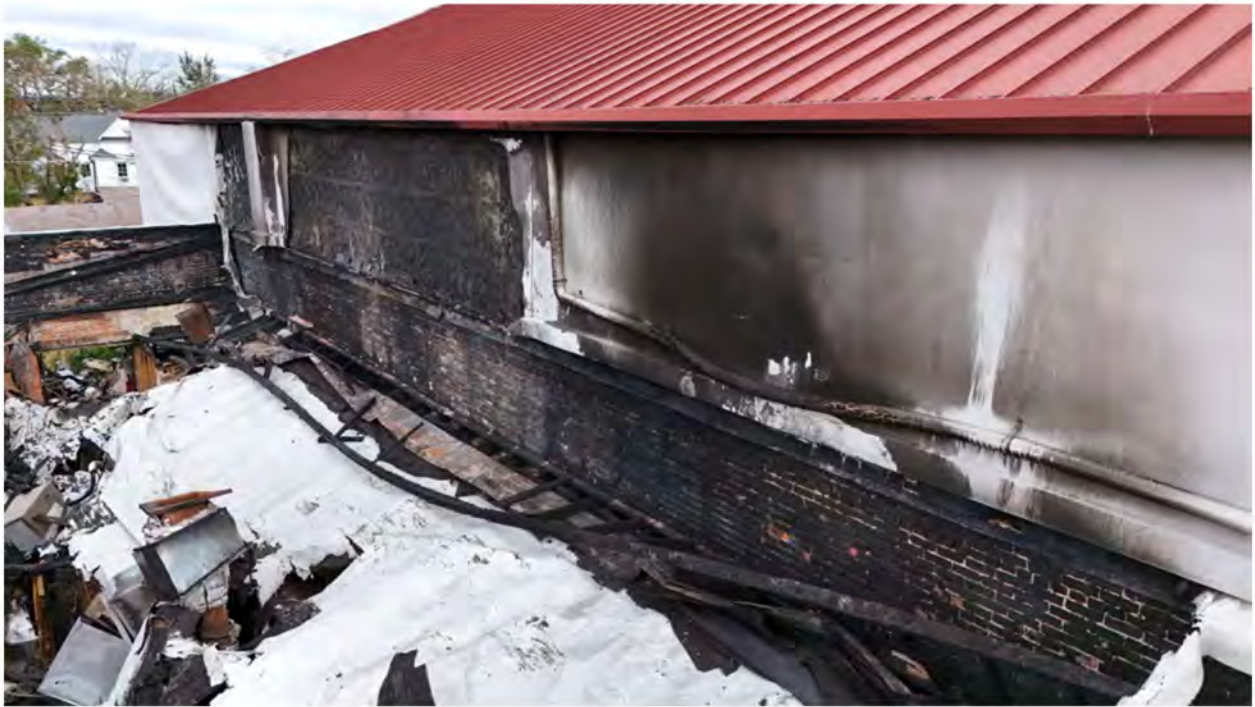
31. Concrete block wall of the second floor.

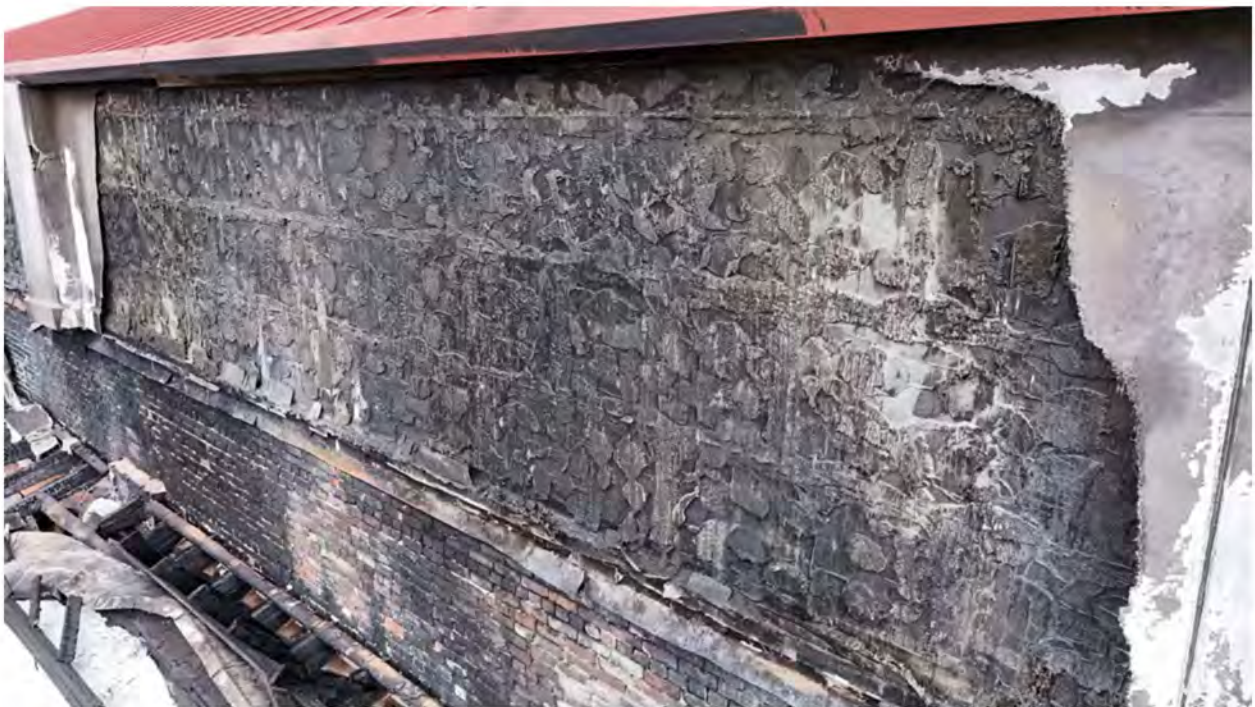
32. Concrete block wall of the second floor.

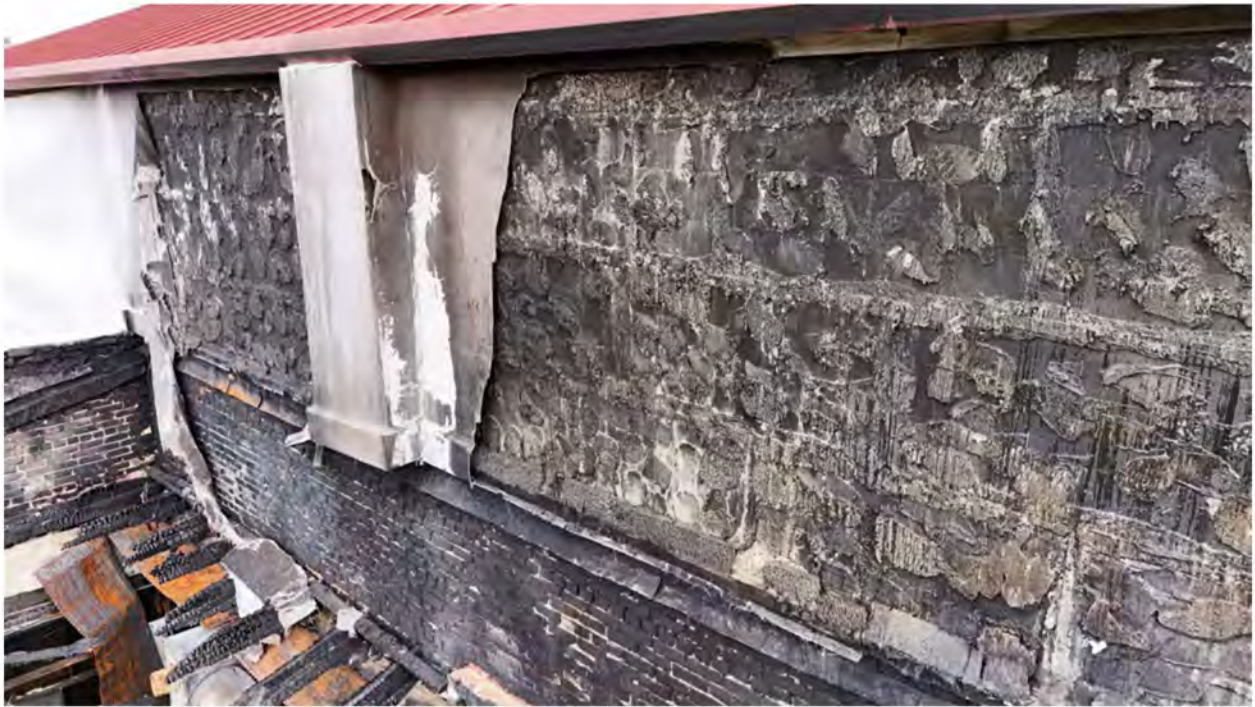
33. Concrete block wall of the second floor.

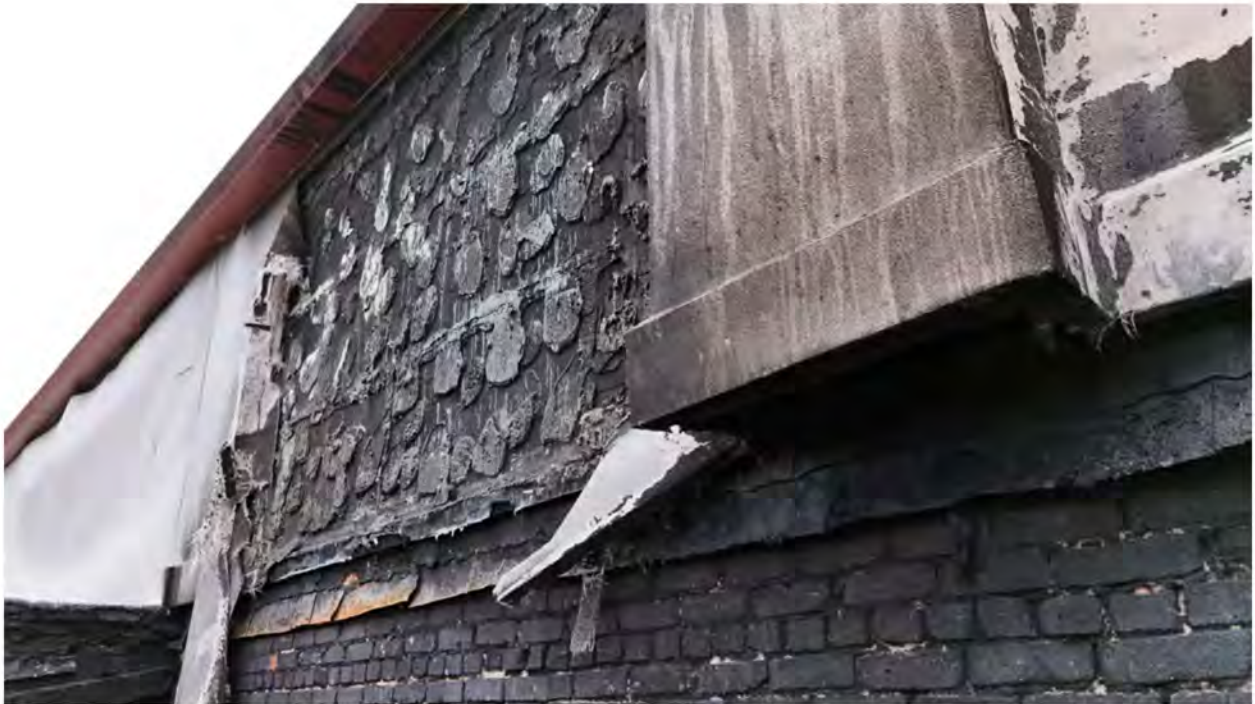
34. Concrete block wall of the second floor.
