Post-Fire Structural Evaluation

Queensborough National Bank
20-28 N Main St.
Metter, GA 30439

Client File No.: FWG6889
SFE File No.: 240019GA1

November 4, 2024

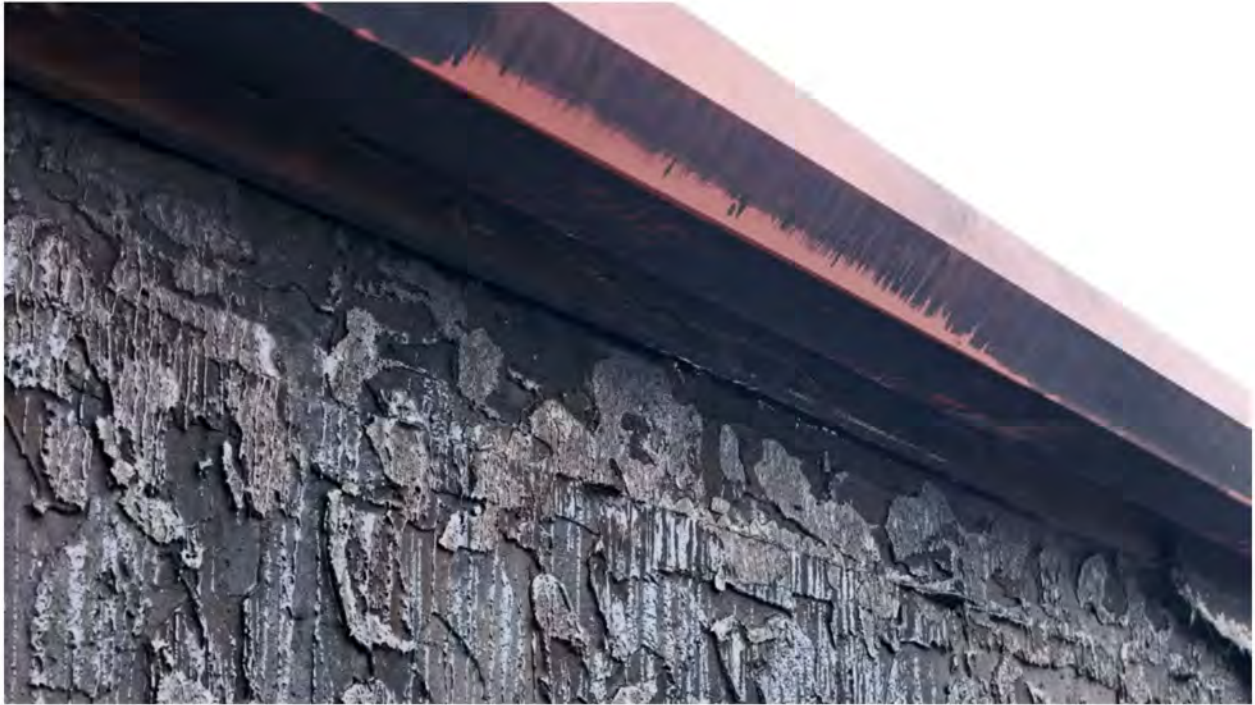
Approximately 50 feet of sub fascia framing was exposed where the plaster siding burned and melted. We observed charring on approximately 25 feet of the sub fascia boards along the west elevation. The remaining portions of the exposed sub fascia framing did not appear to be charred, but were soot-covered.

41. Wood sub-facia member below the gutter.

Inspection of the roof framing system at the Queensborough National Bank showed that approximately 20 linear feet of sub fascia were charred from the October 5, 2024 fire event. This sub fascia can be removed and replaced in kind without removal of the roof trusses, and the decking, or framing, after removal of the deformed western gutter. Additionally, the PVC downspouts can be replaced in kind prior to the removal and replacement of the fiberglass-reinforced plaster siding on the west elevation. It should be noted that upon removal of the sub fascia member, additional replacement considerations should be made for any roof framing members that show charring, which were not visible beforehand.

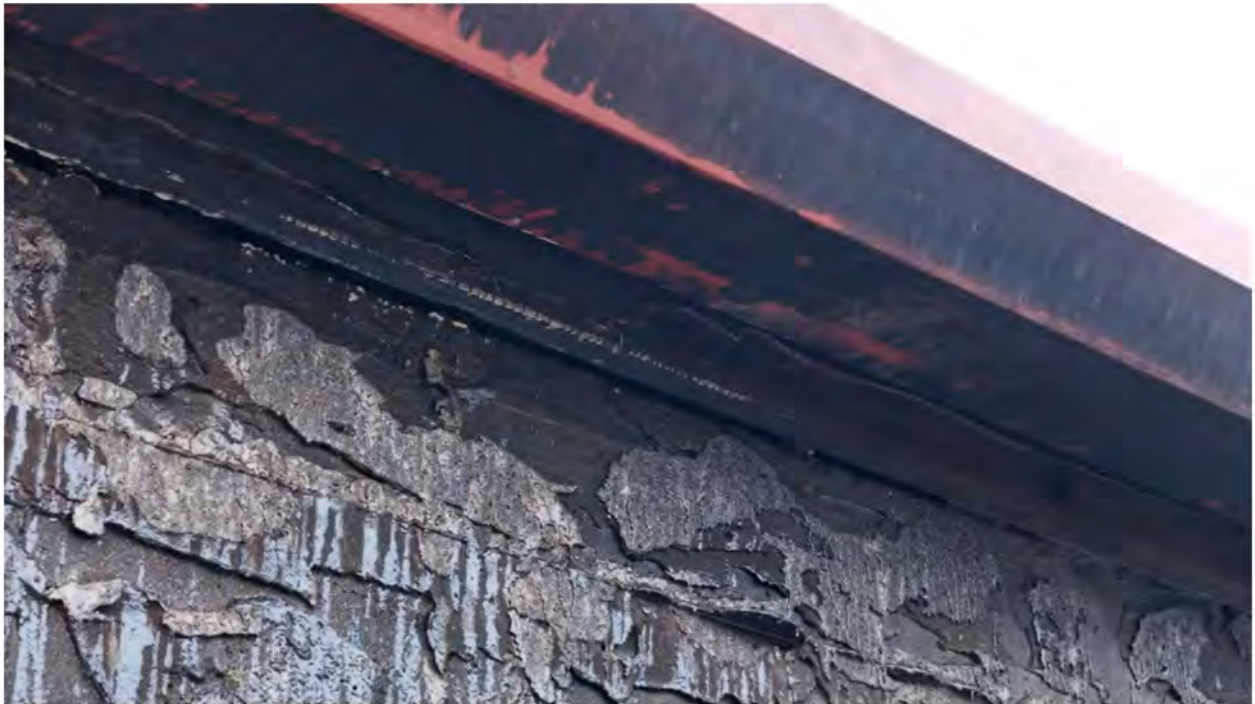
42. Wood sub-facia member below the gutter.

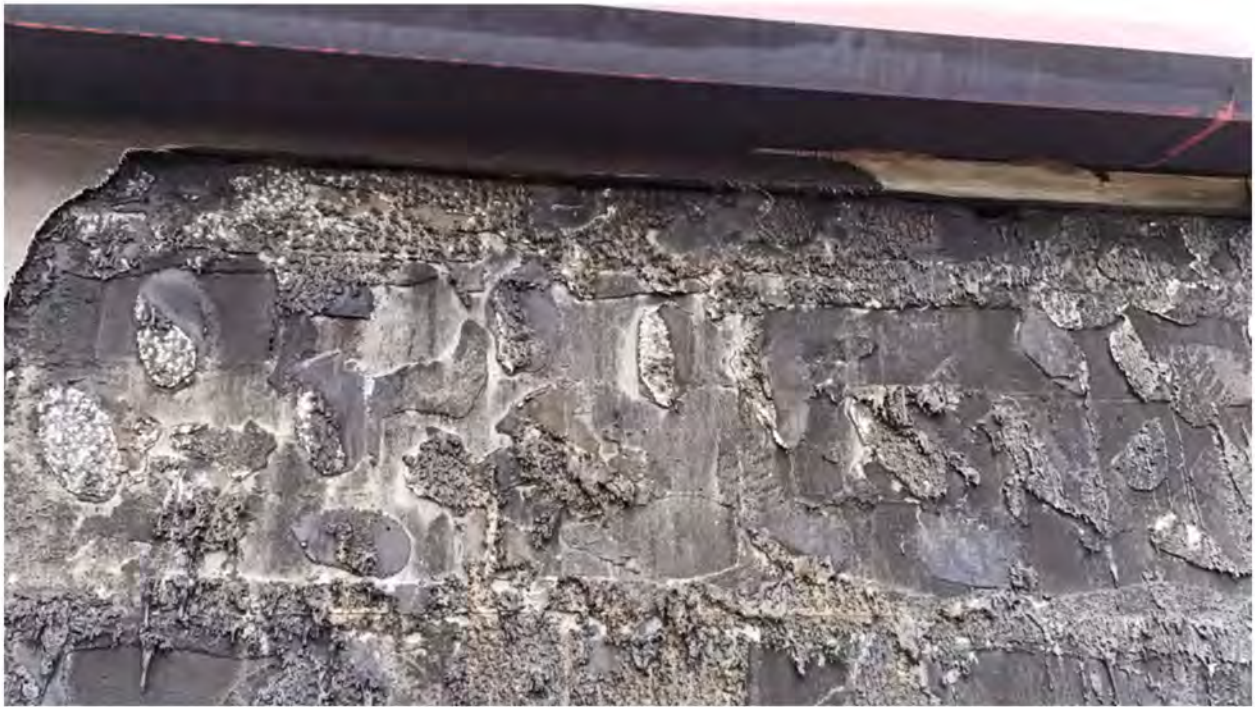
43. Wood sub-facia member below the gutter.

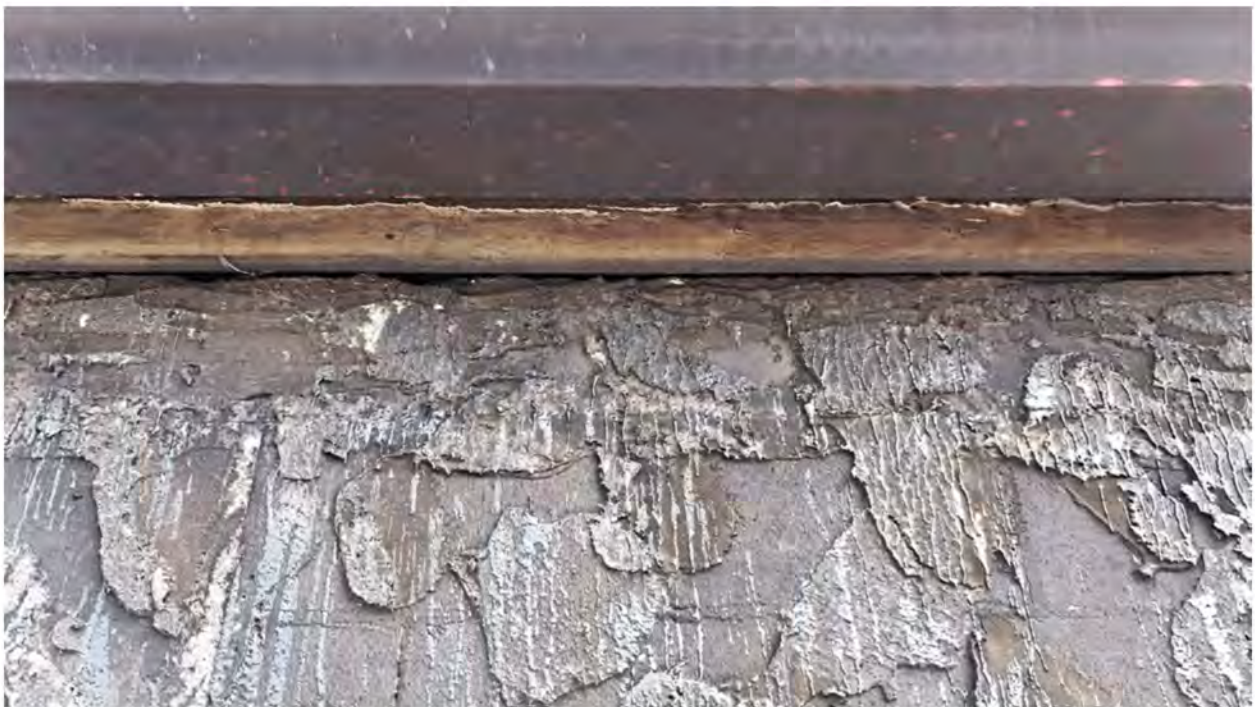
44. Wood sub-facia member below the gutter.

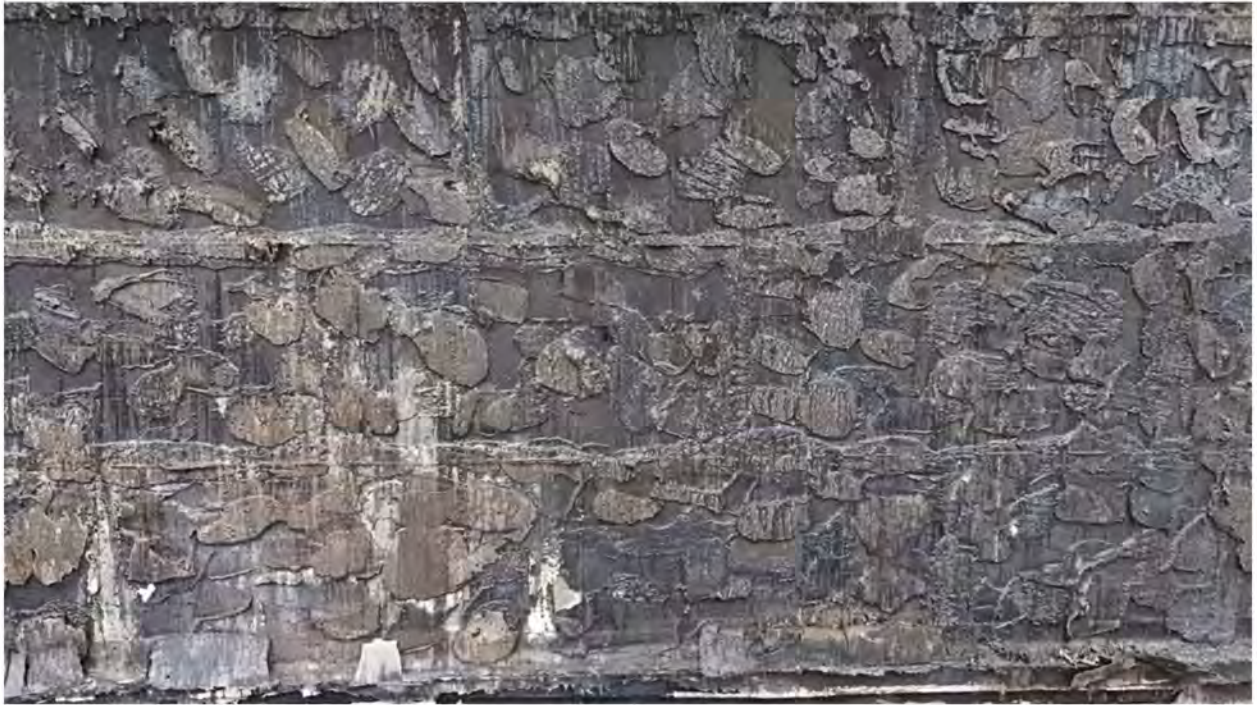
45. Concrete block wall.

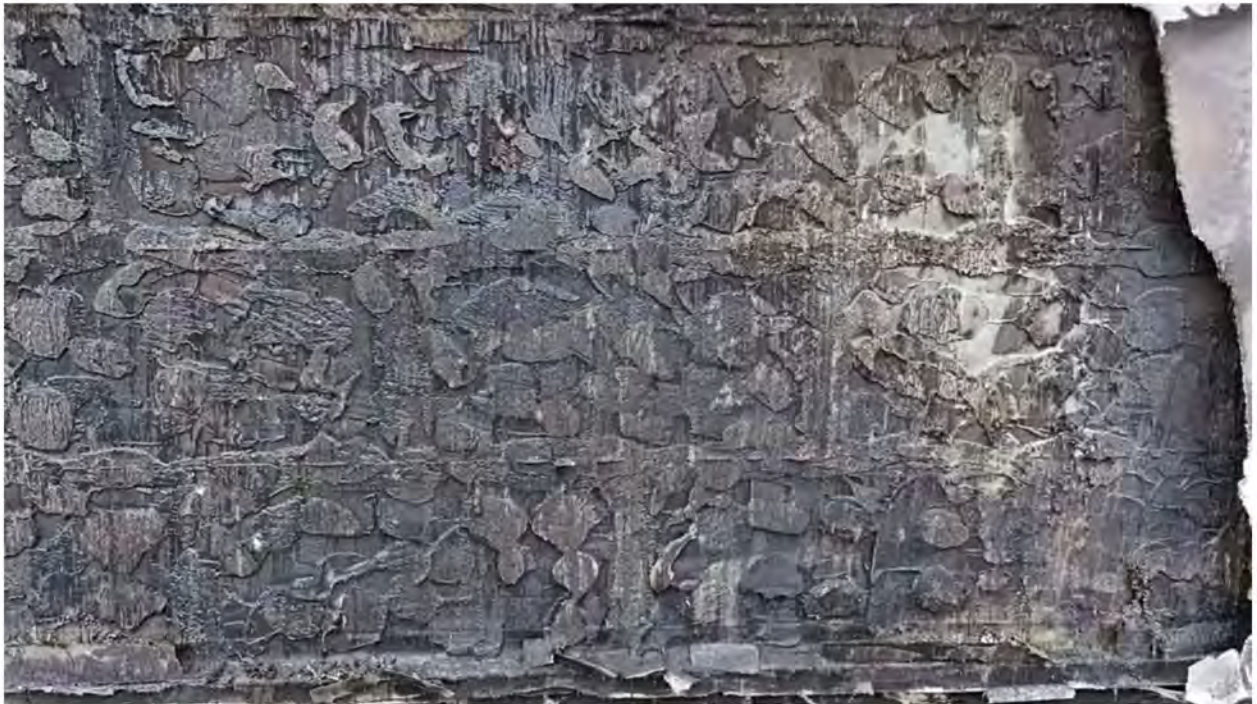
46. Concrete block wall.

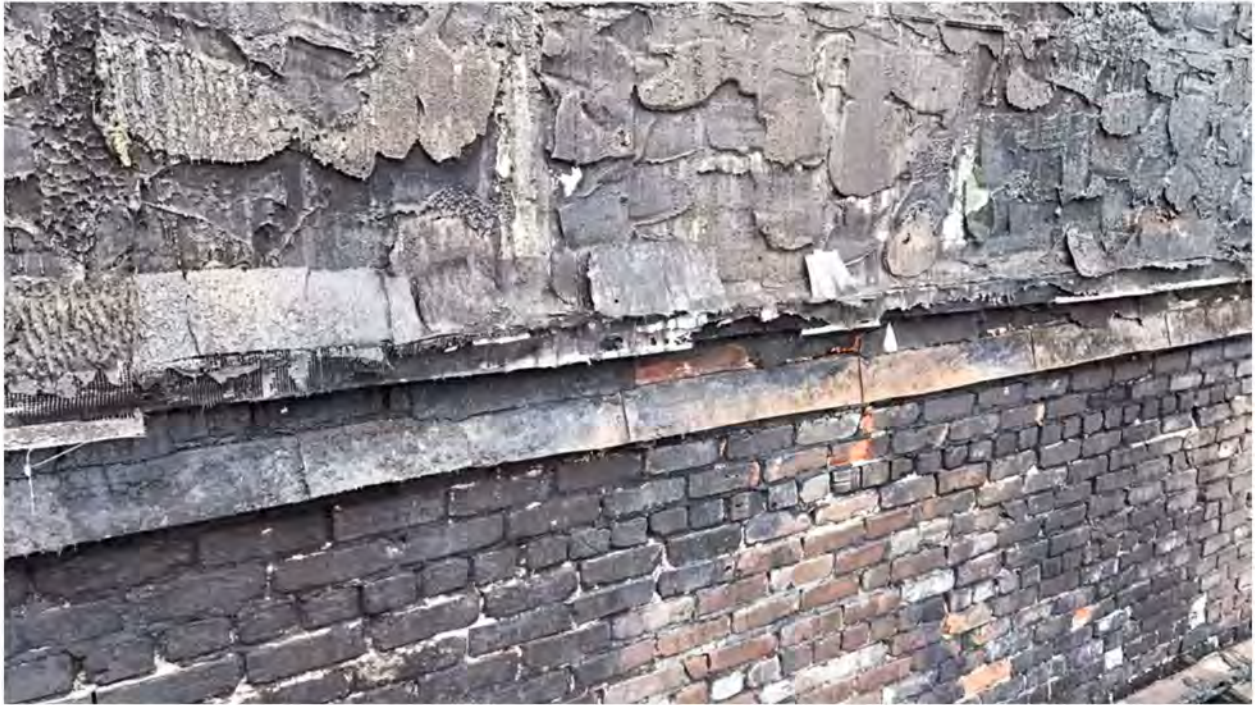
47. Flashing between the first and second floor.

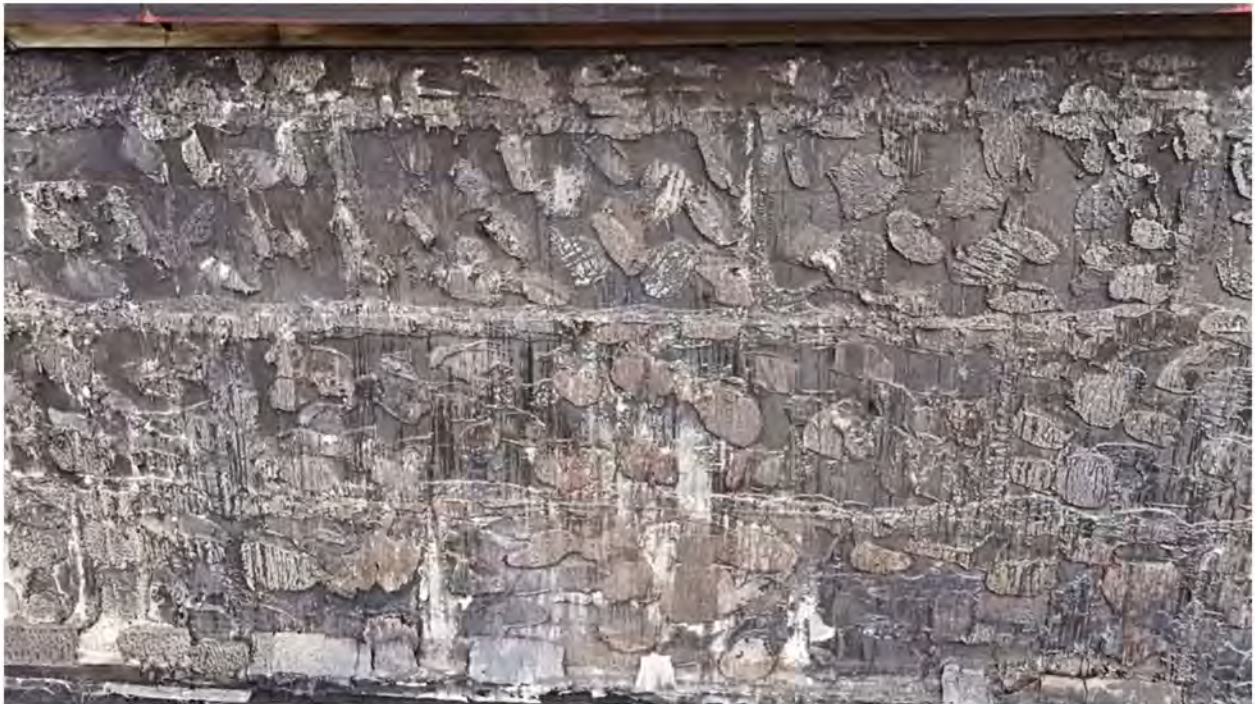
Below the sub fascia, we examined the concrete block wall that had been exposed by the melted fiberglass-reinforced plaster wall. This exposed wall was covered in soot from the fire event. We observed that the adhesive backing used to secure the siding to the concrete block wall was still present, and had not been burned away by the fire. We searched the masonry walls for cracks and spalling associated with heat from the fire event. Cracks and spalling are the result of the expansion of moisture trapped inside the masonry due to the extreme heat associated with fire. Closer inspection of the exposed concrete block wall showed no cracks or spalling consistent with heat from the fire event. We were also able to observe the interior side of the concrete block exterior wall, behind the drywall finishes on the second floor, and found no cracks or spalling associated with the fire. The structural concrete block wall on the second story of the Queensborough National Bank was not damaged by the fire event.

48. Concrete block wall.

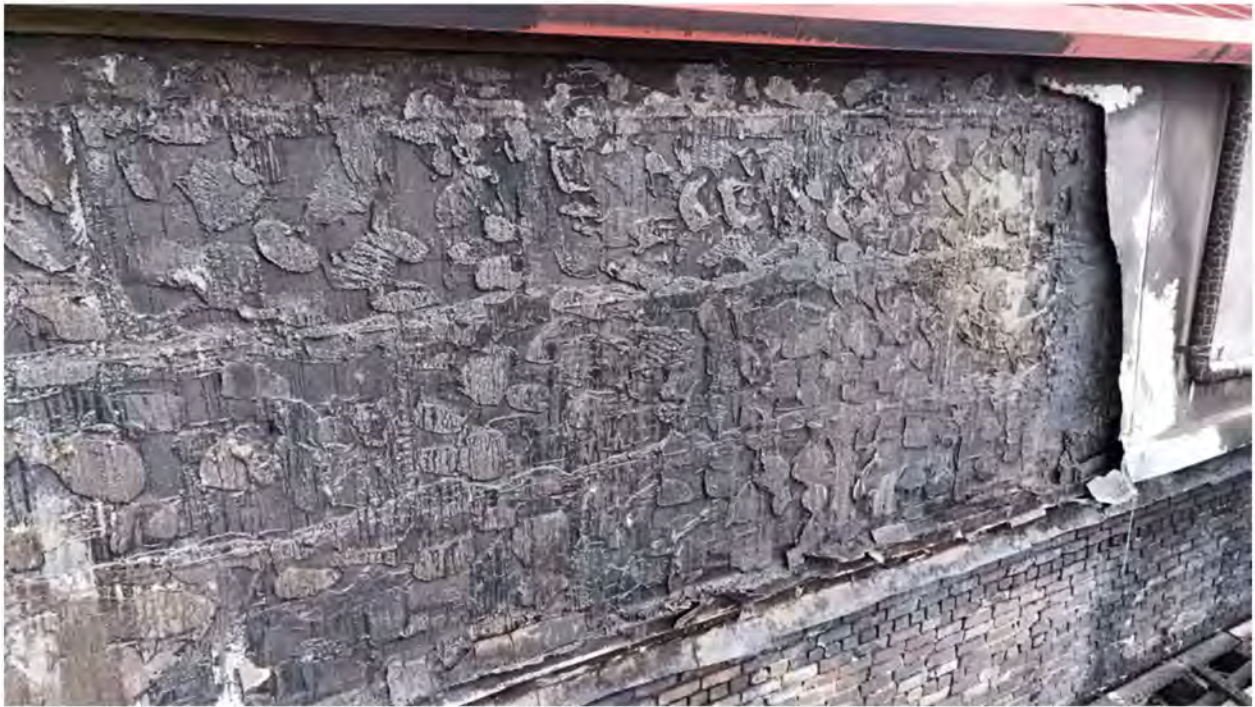
49. Concrete block wall.

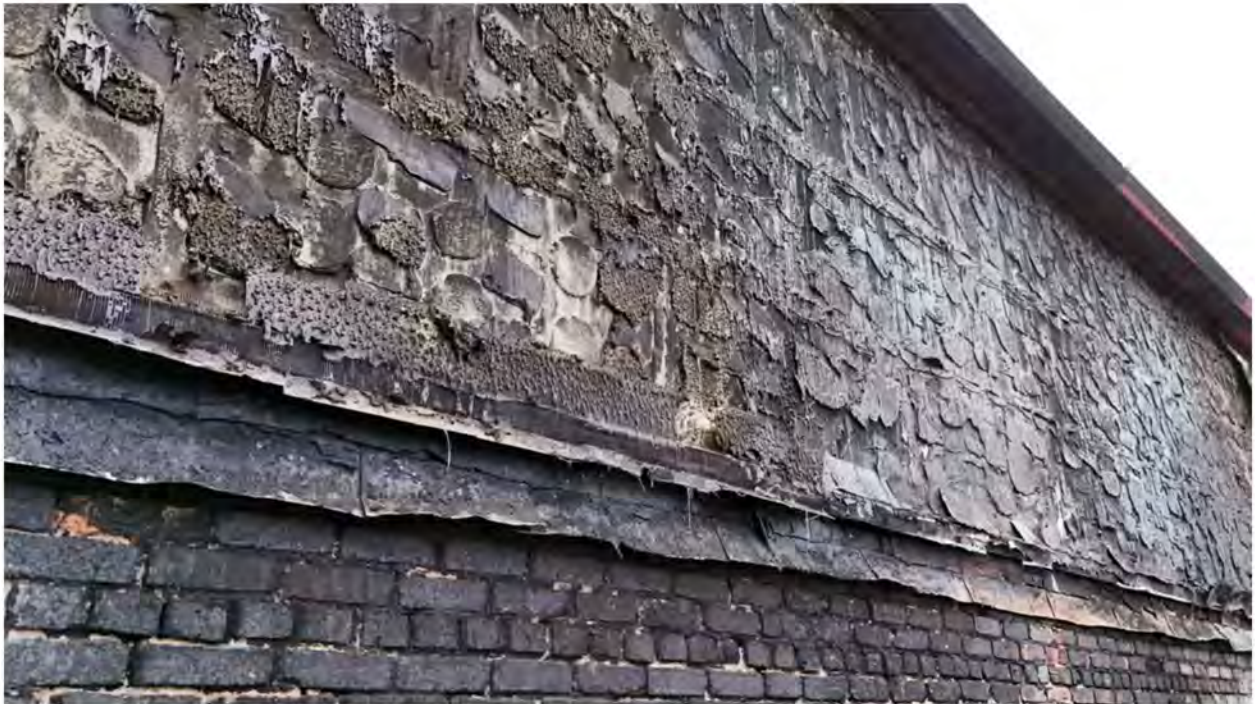
50. Flashing between the first and second floor.

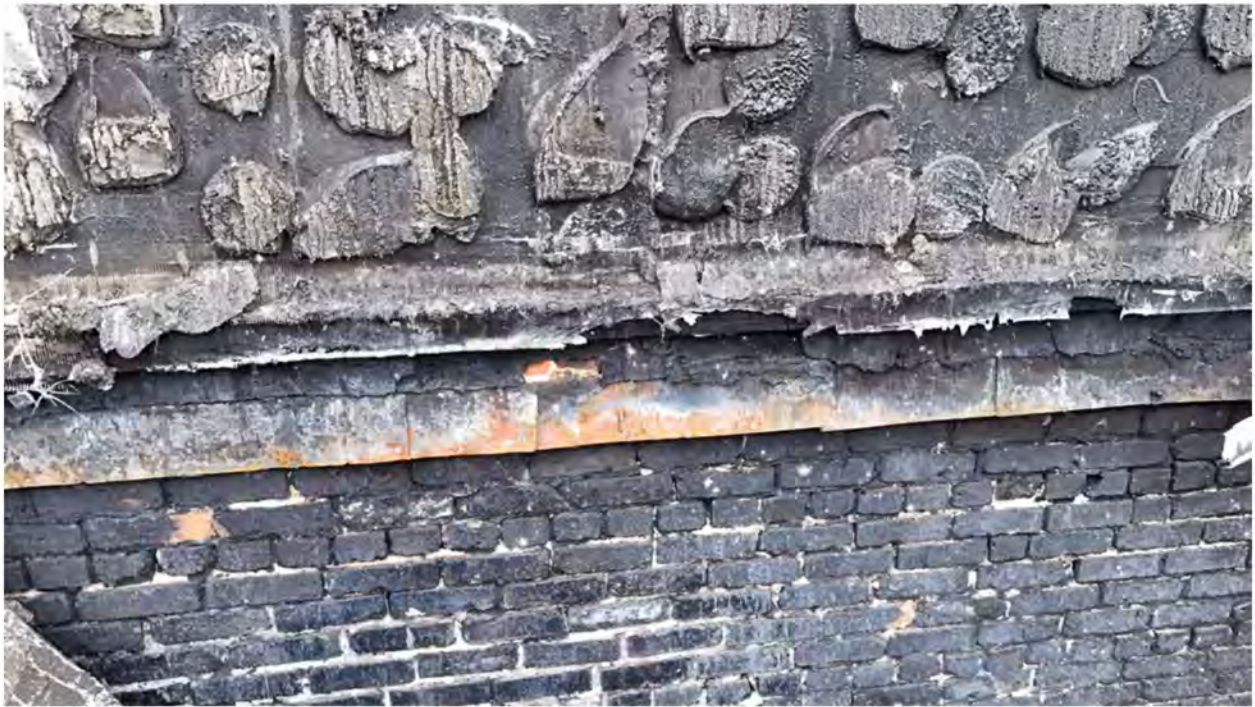
51. Flashing between the first and second floor.

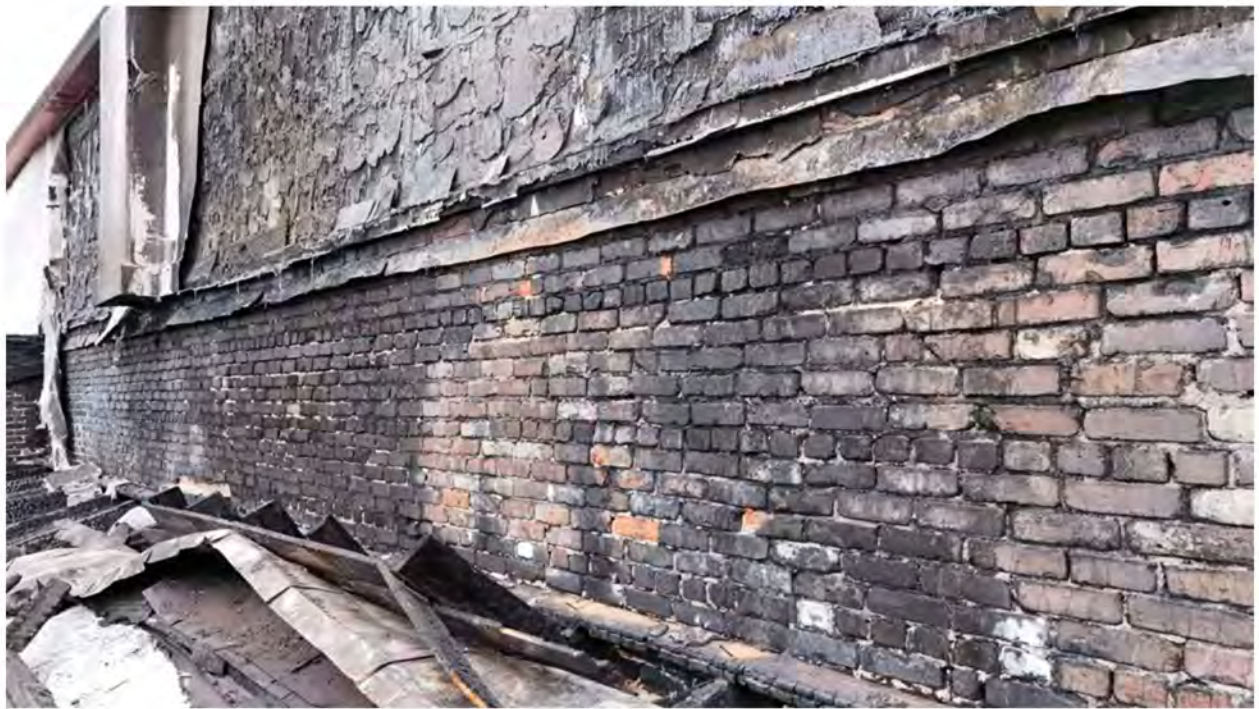
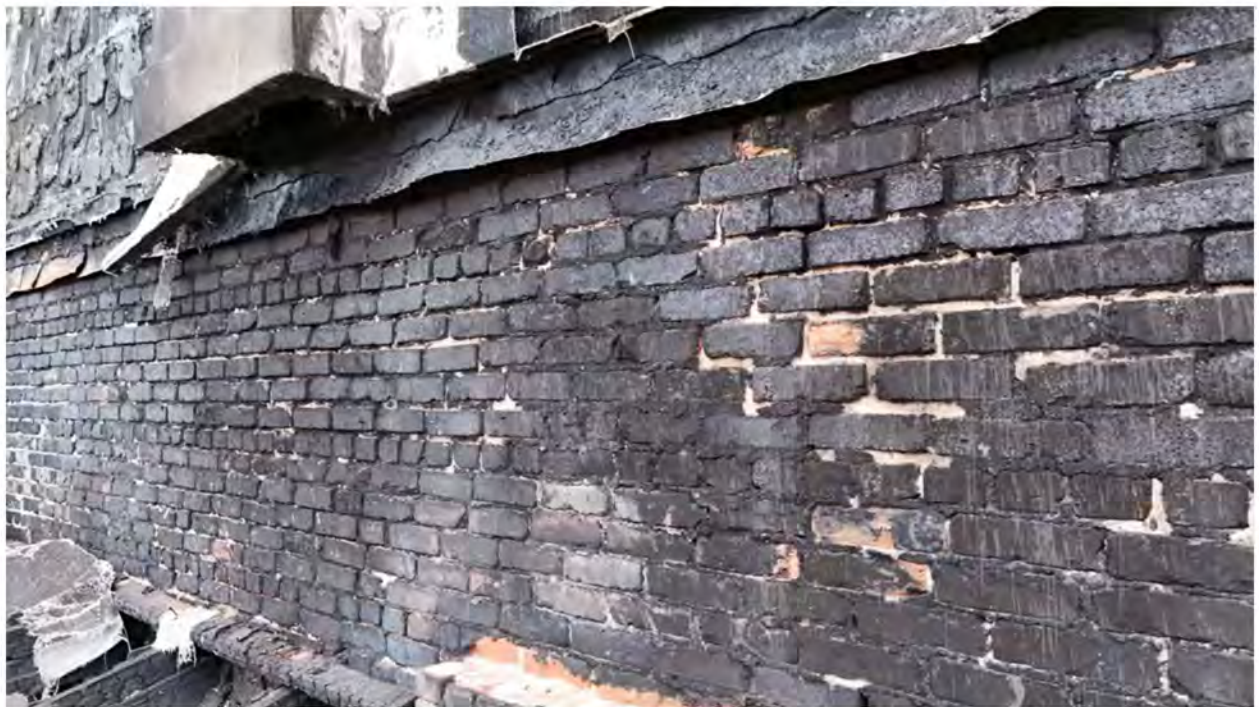
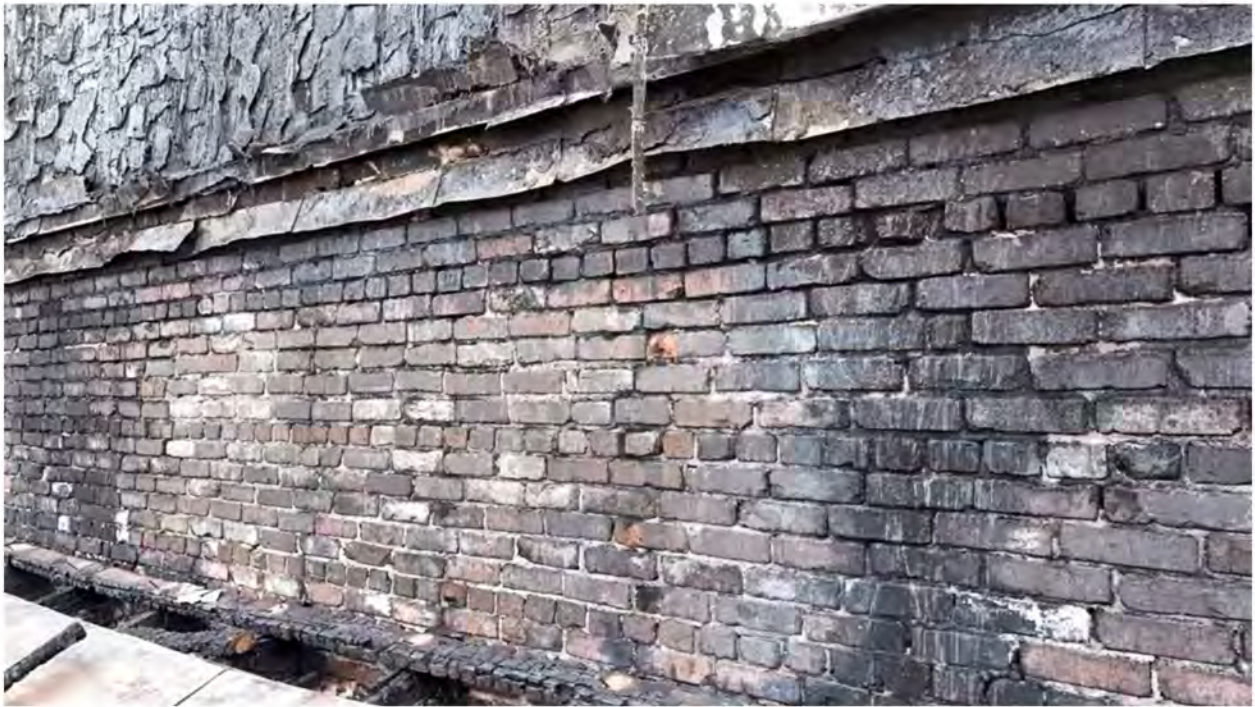
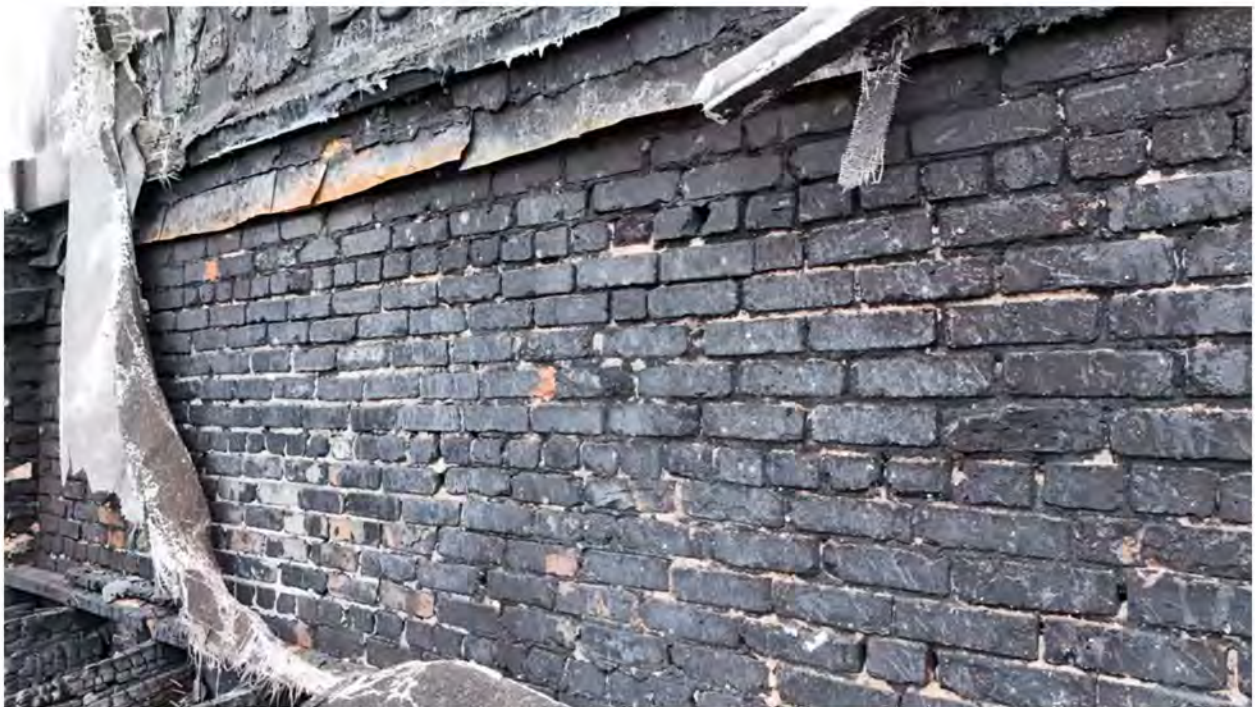
Below the concrete block wall, we closely observed the first-floor shared clay brick wall that of the building. We observed a charred roof framing ledger for the adjacent building, as well as counter flashing details for the adjacent roof that were discolored and deformed. The clay brick wall was also covered in soot. Inspection of the brick wall showed approximately 16 bricks that were spalled, consistent with heat from the fire event. These damaged clay bricks were clearly visible due to the lack of soot accumulation at the areas where the spalling had

Inspection of the Queensborough National Bank showed that approximately 16 clay bricks on the west side of the first-floor exterior wall were spalled, consistent with exposure to heat from the October 5, 2024 fire event. These bricks can be removed and replaced by a licensed and experienced mason. It should be noted that upon removal of the debris from the adjacent storefront, additional spalled or cracked bricks may be discovered. These bricks can also be replaced.

57. Brick wall of the building.

58. Brick wall of the building.

59. Brick wall of the building.

60. Brick wall of the building.
