Post-Fire Structural Evaluation

Queensborough National Bank
20-28 N Main St.
Metter, GA 30439

Client File No.: FWG6889
SFE File No.: 240019GA1

November 4, 2024

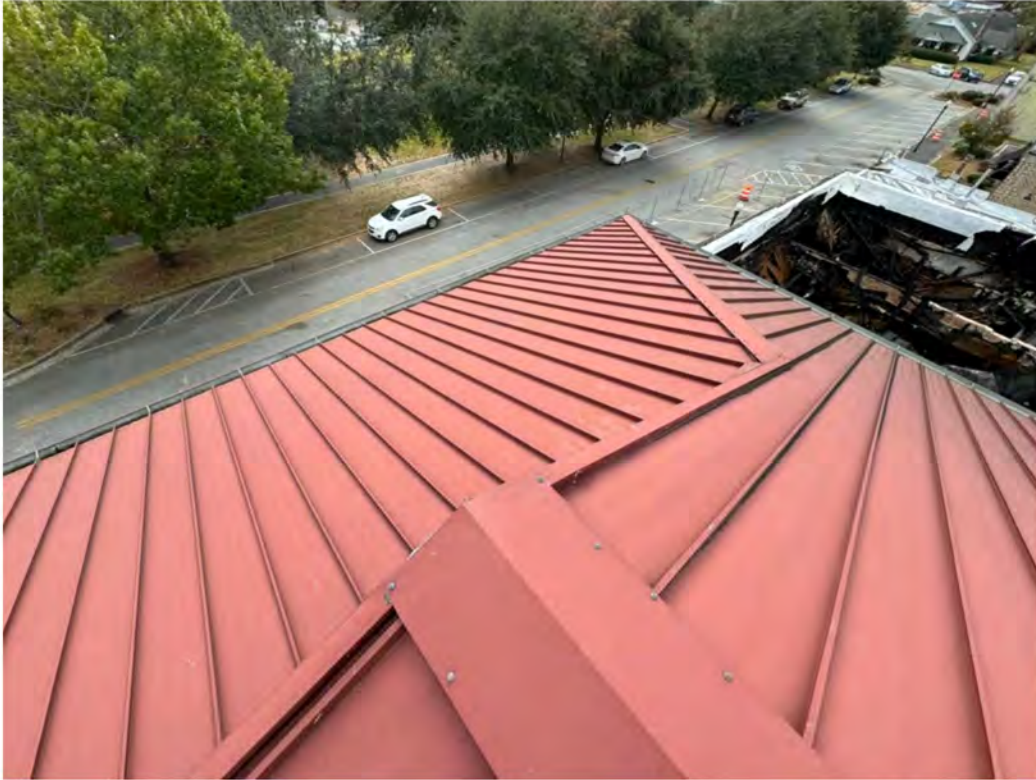
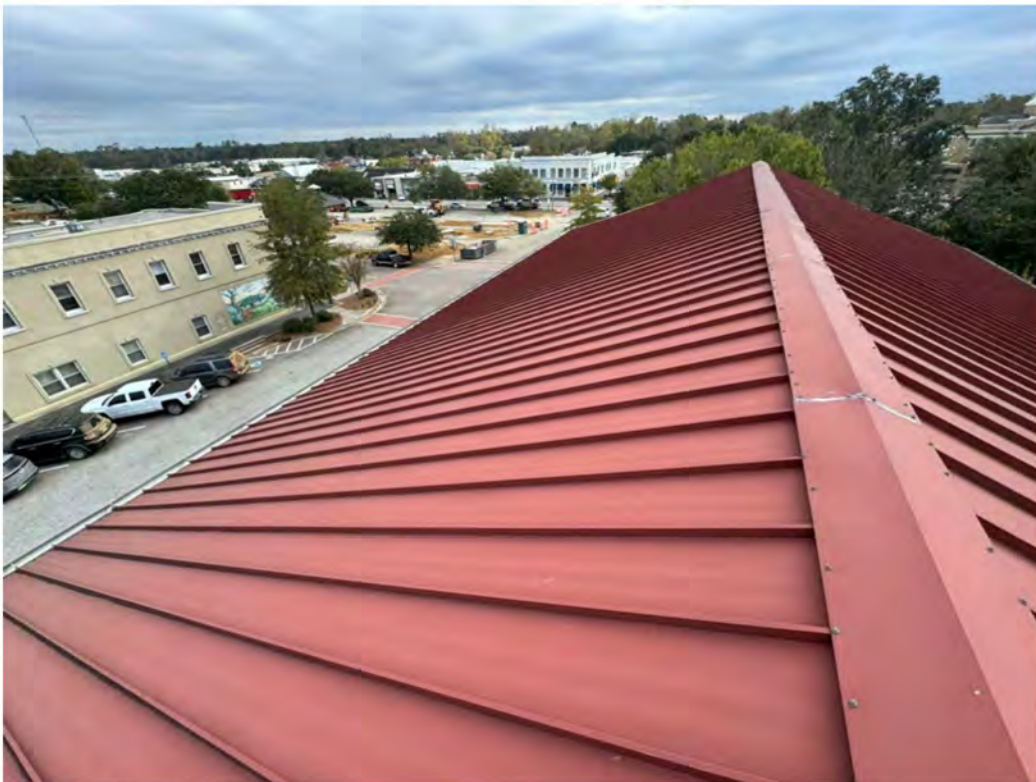
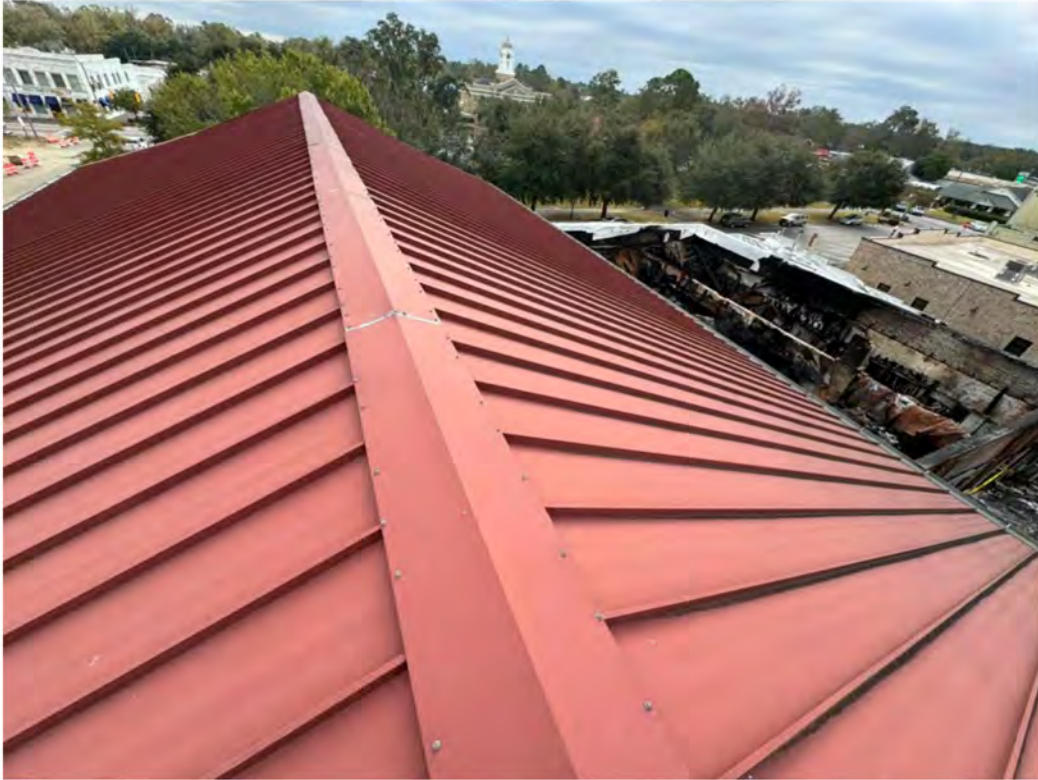
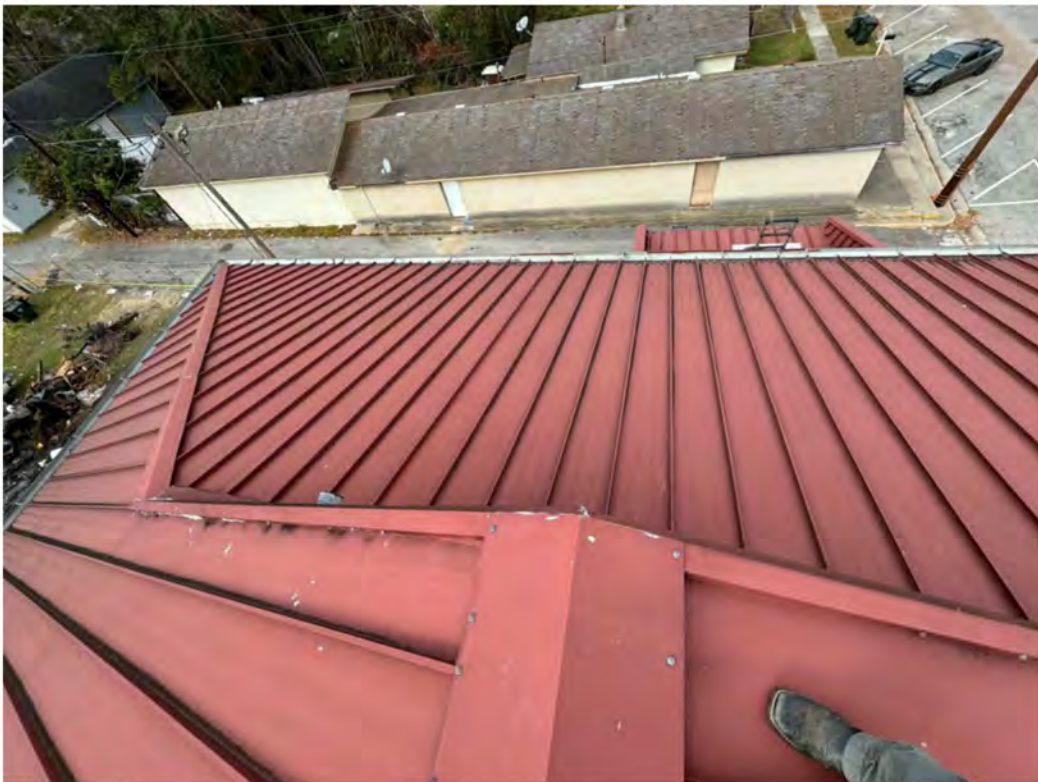
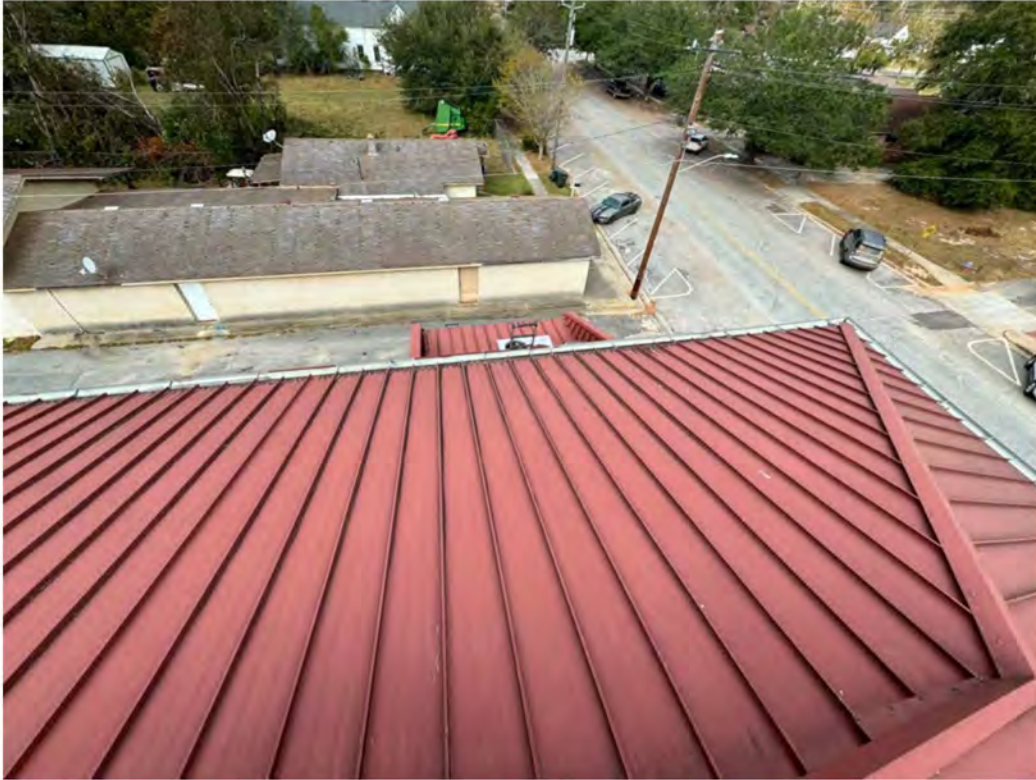
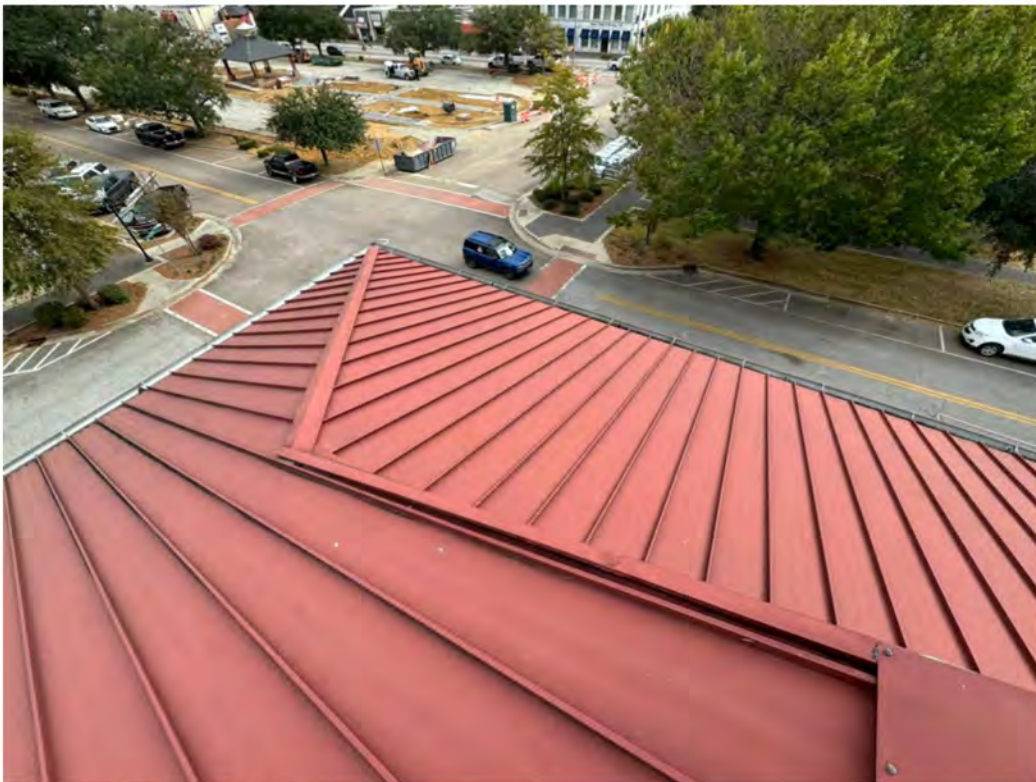
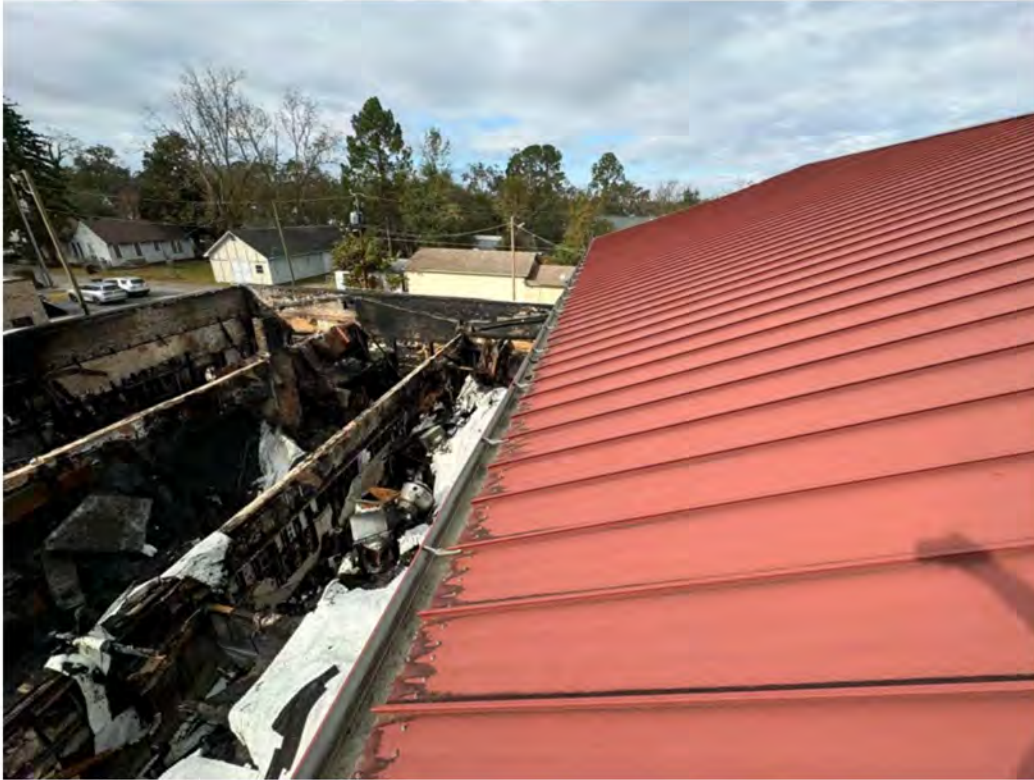
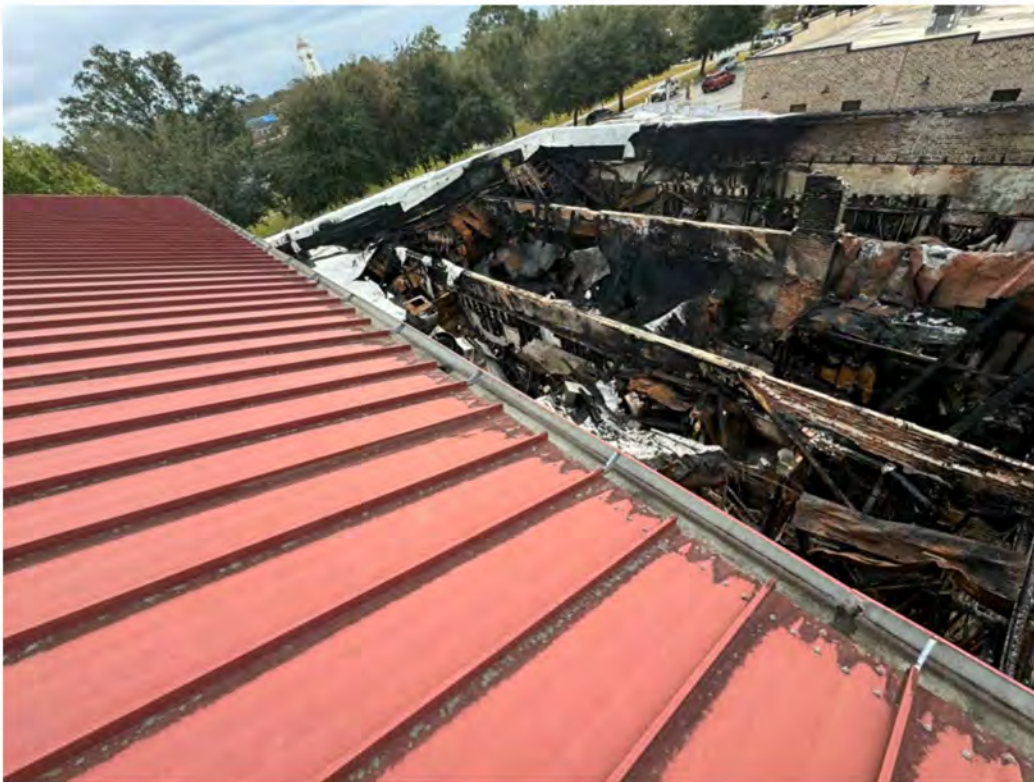
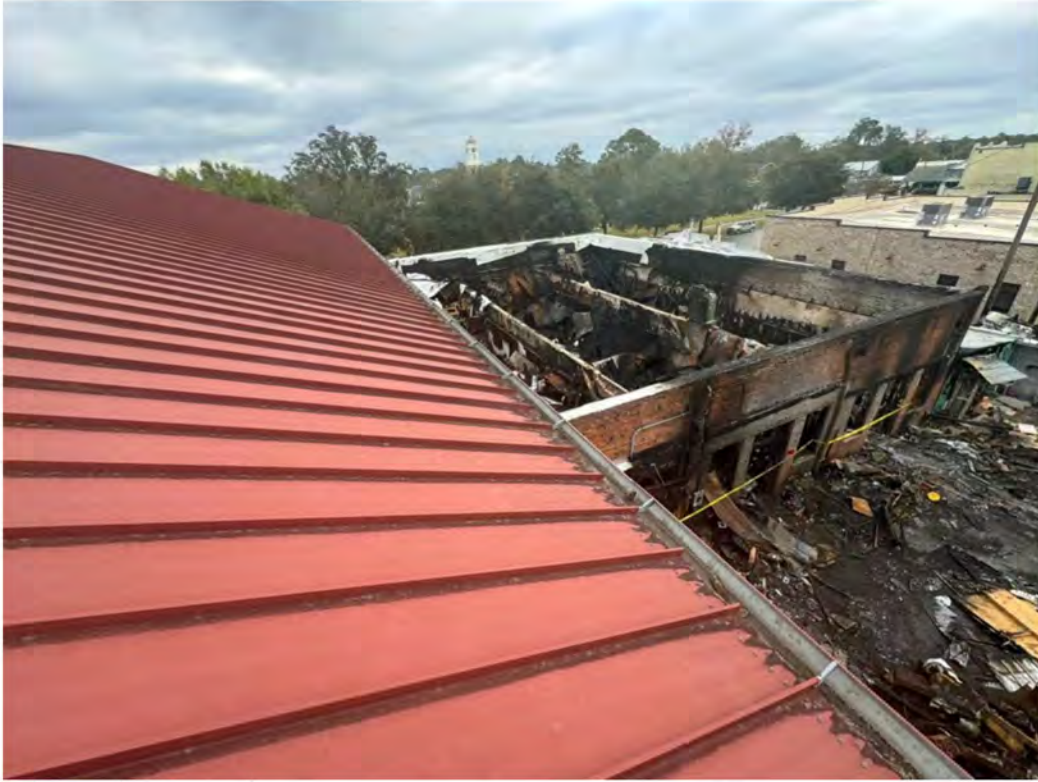
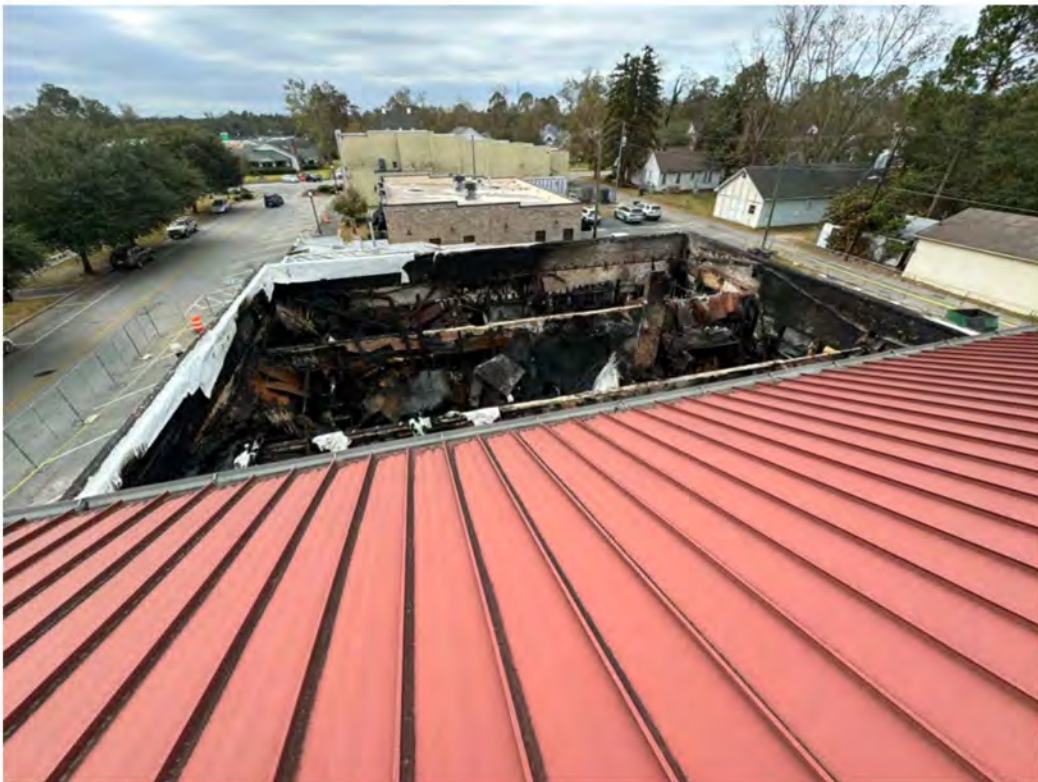
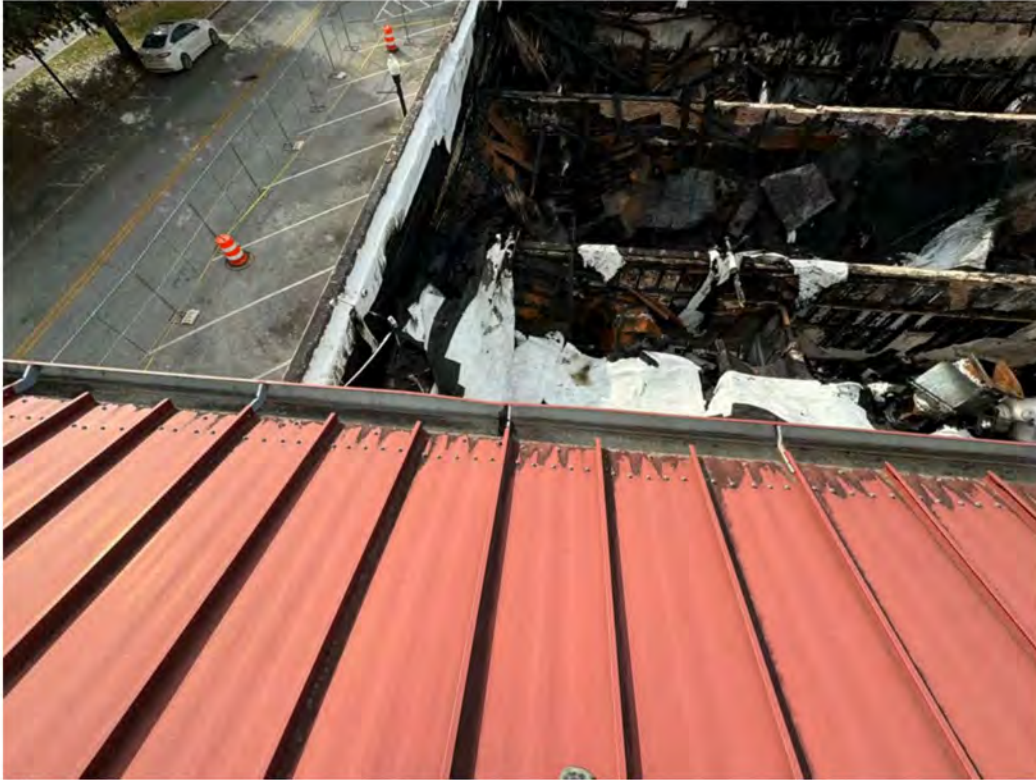
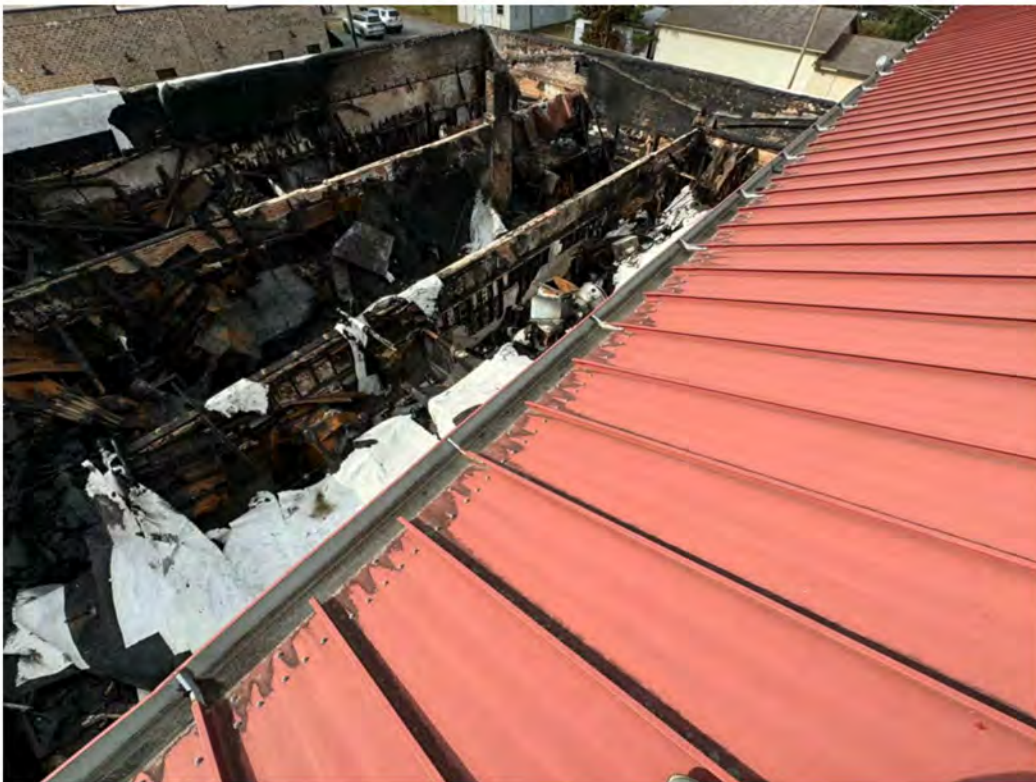
61. Roof covering overview.

62. Roof covering overview.

63. Roof covering overview.

64. Roof covering overview.

65. Roof covering overview.

66. Roof covering overview.

67. Roof covering overview.

68. Roof covering overview.

69. Roof covering overview.

70. Roof covering overview.

71. Roof covering overview.

72. Roof covering overview.

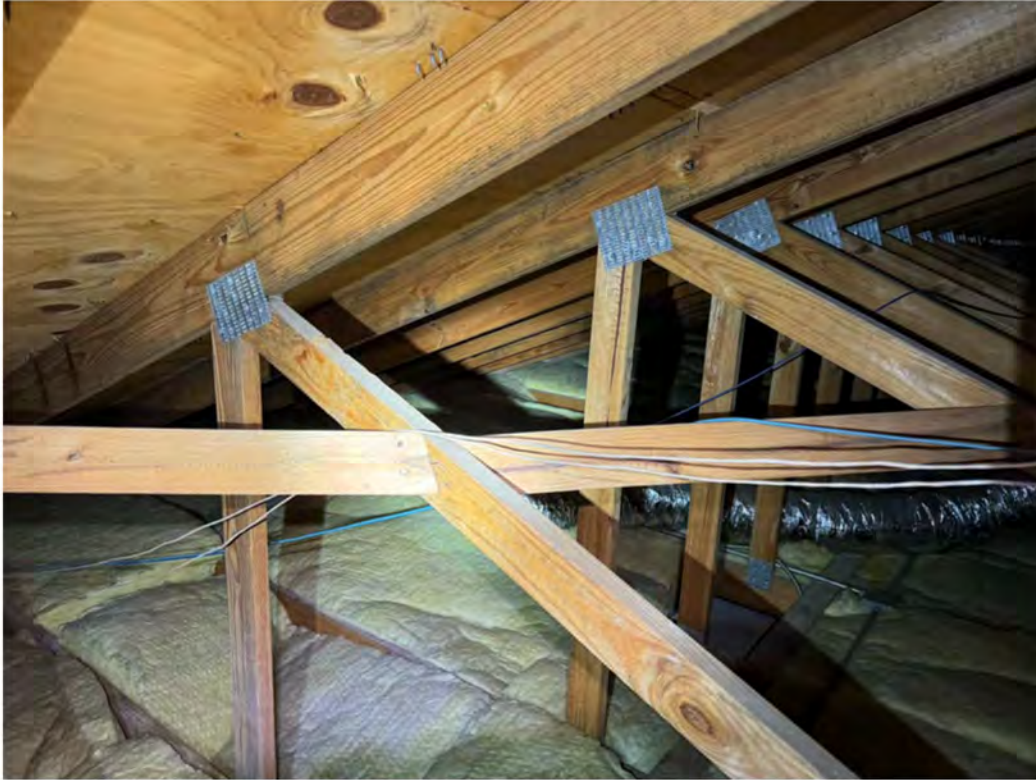
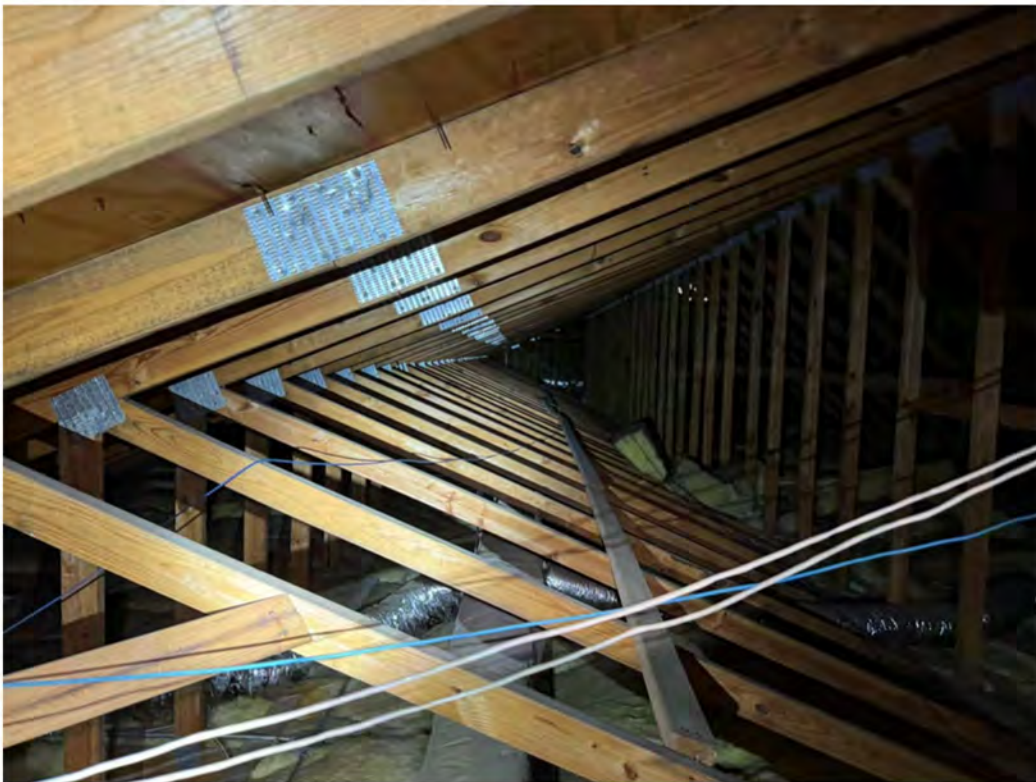
Inspection of the attic space of the Queensborough National Bank showed soot accumulation on the roof decking and on the tips of the roof trusses along the entire western wall. Closer inspection of the roof framing showed small areas where the interior side of the sub fascia was charred. These charred locations were near the center of the 20 linear feet of visible charring on the exterior elevation. We closely examined the tips of the roof trusses at these locations, where there was soot buildup, and found no charring. While it is possible that there was minimal charring in the tips of the trusses not visible during our inspection, we found no charred truss members that would compromise the structural integrity of the roof system. Approximately 20 linear feet of sub-fascia was damaged by the October 5, 2024 fire event. The roof trusses and the roof decking at the Queensborough National Bank were not damaged by the October 5, 2024 fire event.

73. Western portion of the attic space.

74. Western portion of the attic space.

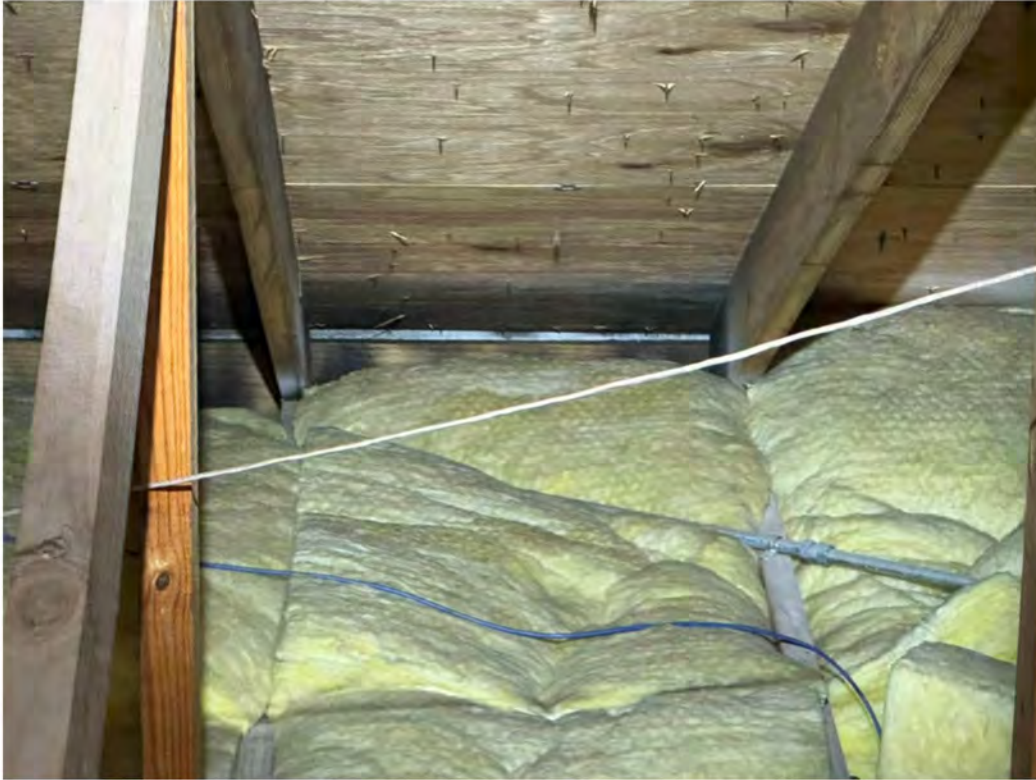
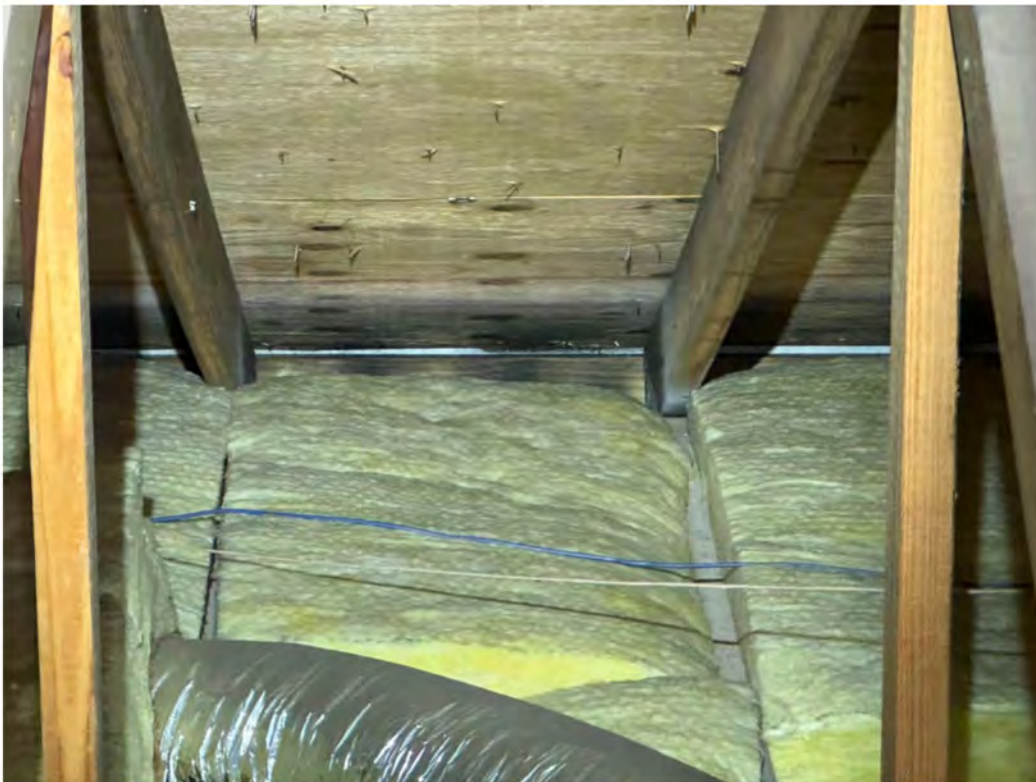
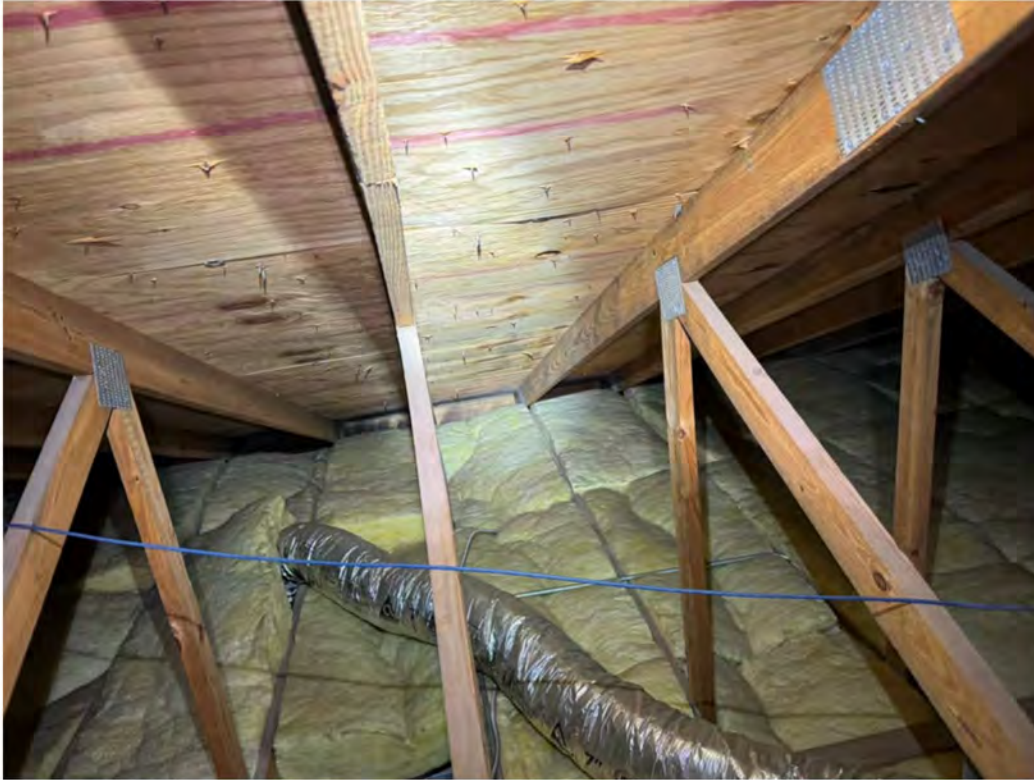
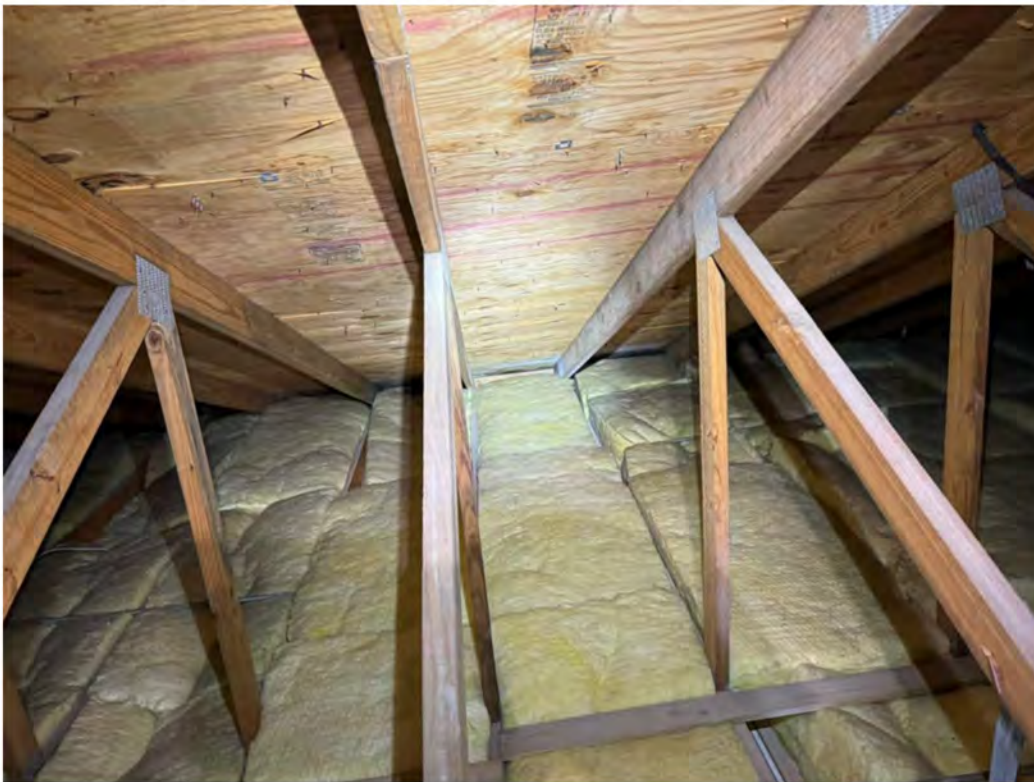
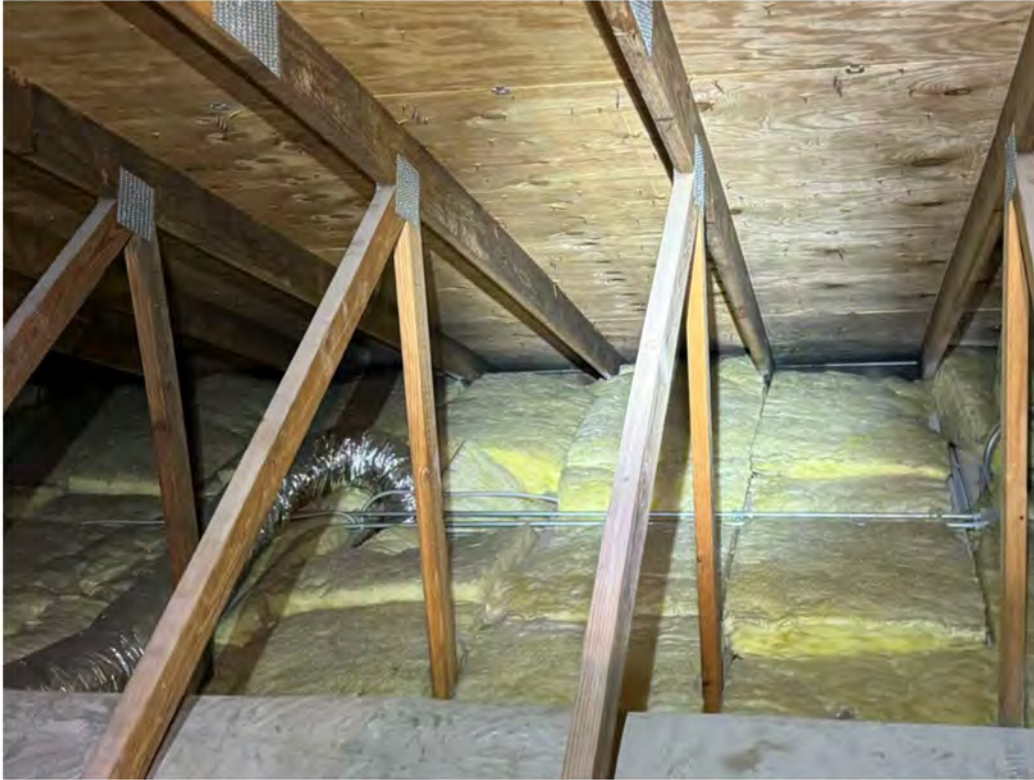
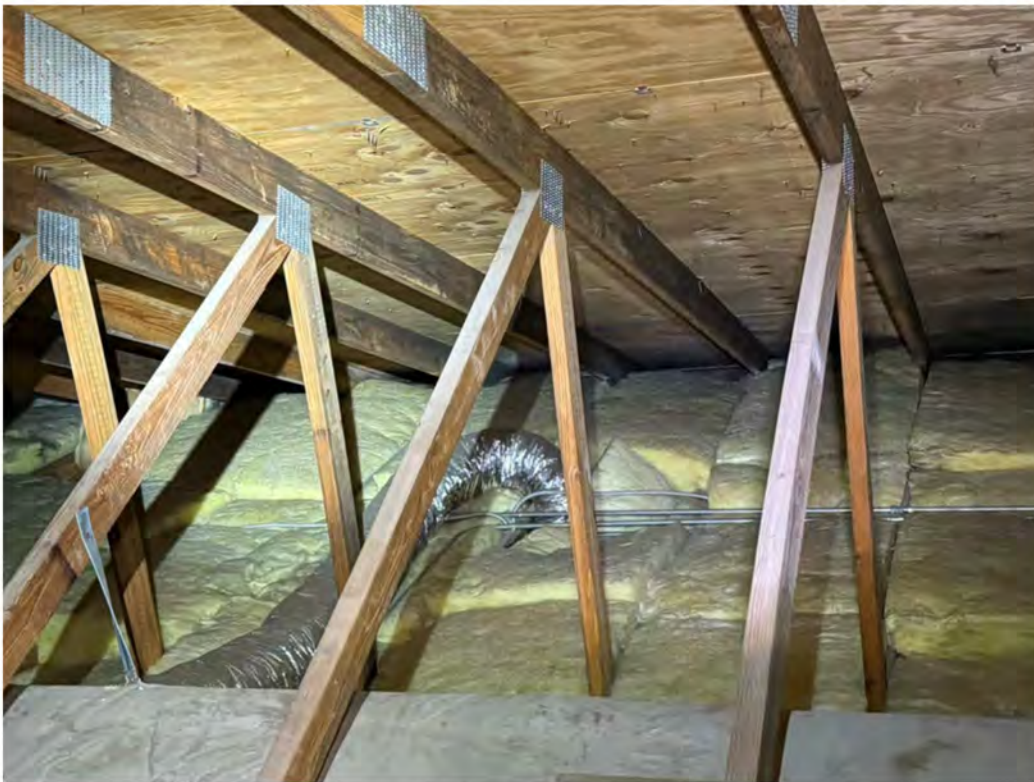
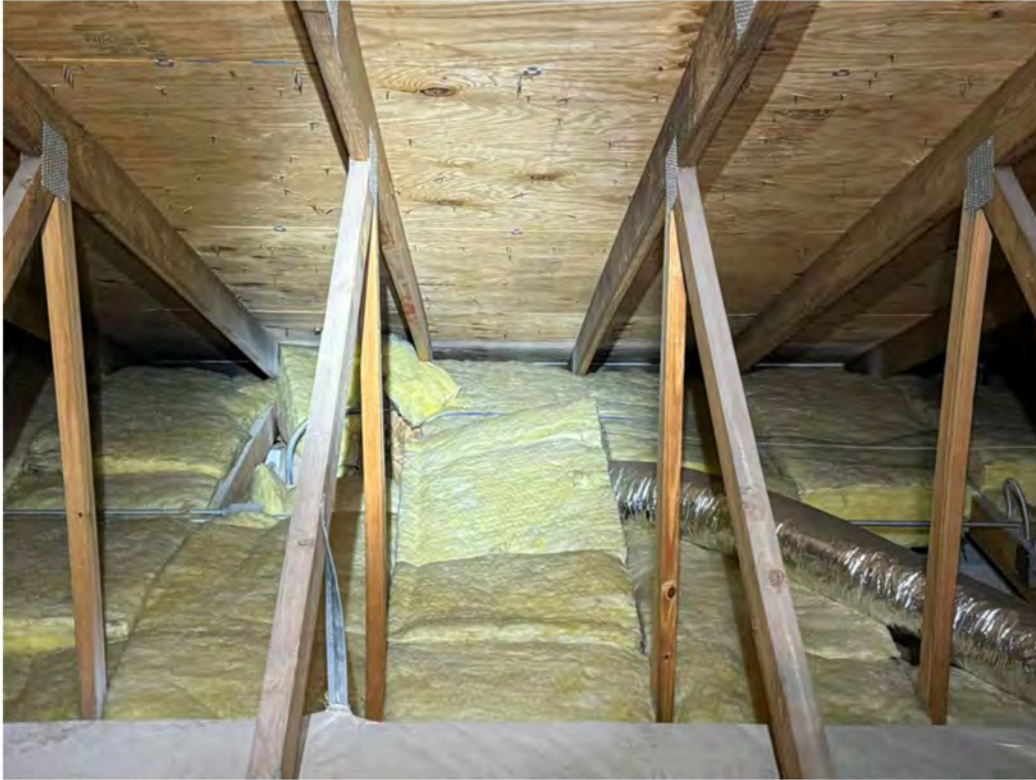
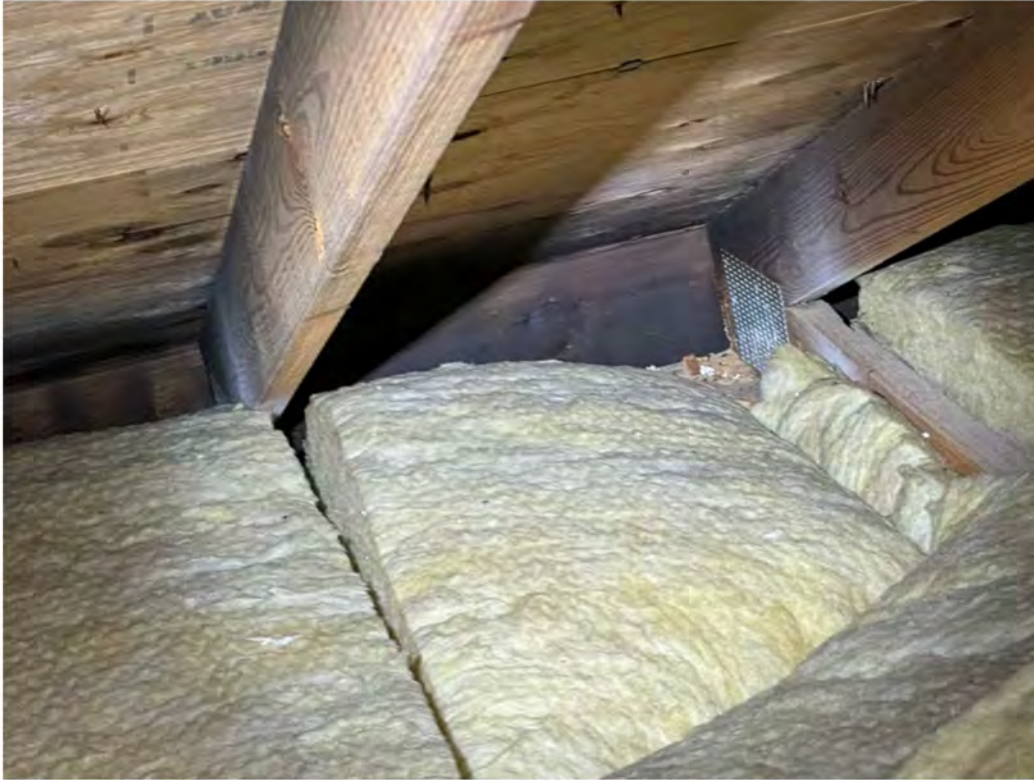
75. Soot accumulation above the western wall.

76. Soot accumulation above the western wall.

77. Soot accumulation above the western wall.

78. Soot accumulation above the western wall.

79. Soot accumulation above the western wall.

80. Soot accumulation above the western wall.

81. Soot accumulation above the western wall.

83. Soot accumulation above the western wall.

Additional framing members, roof decking, and interior finishes with soot accumulation can be scrubbed by a licensed and experienced technician. The structural components with soot accumulation will continue to function as intended and were not damaged by the October 5, 2024 fire event.

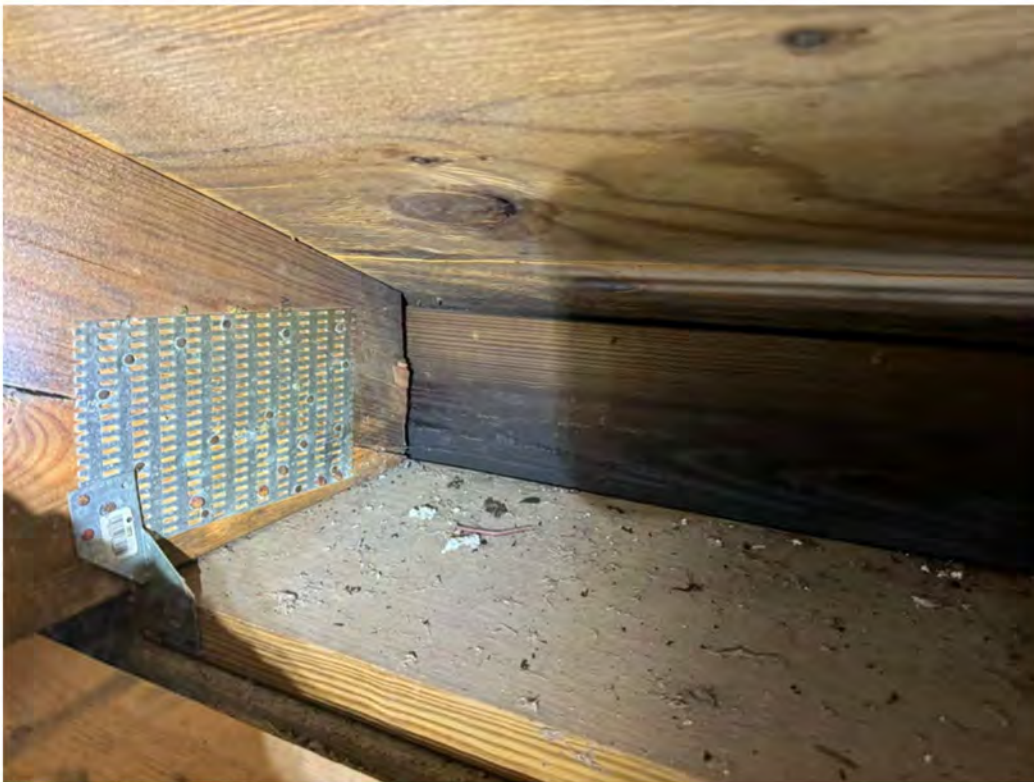
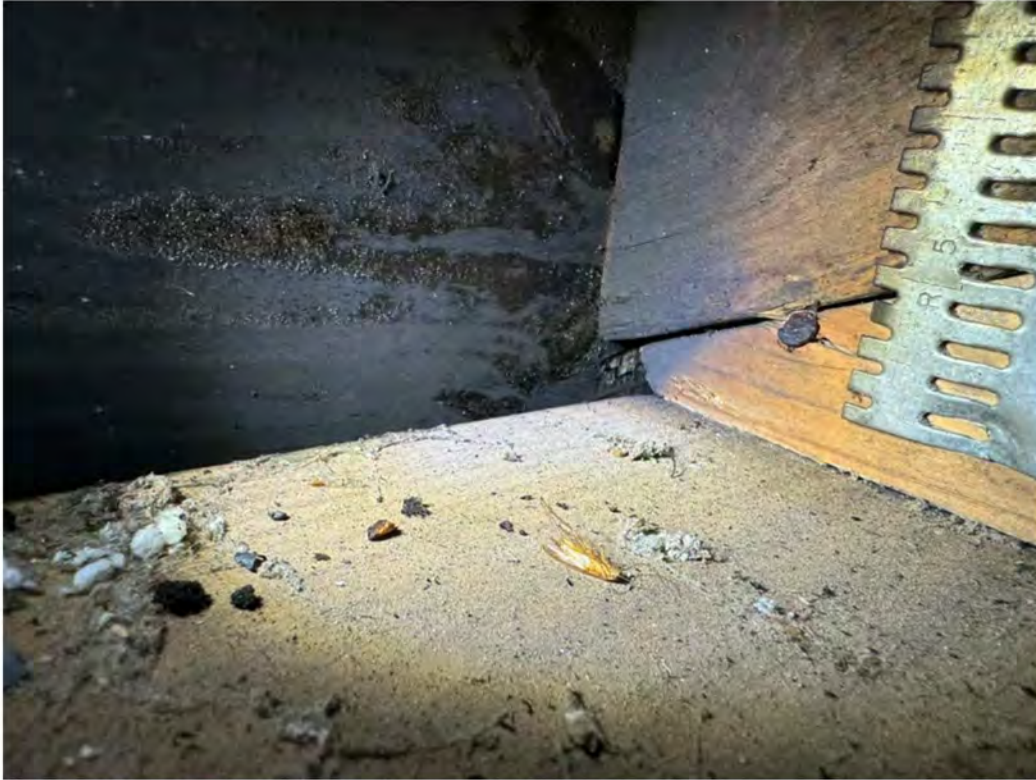
Approximately 50 feet of sub fascia framing was exposed where the plaster siding burned and melted. We observed charring on approximately 25 feet of the sub fascia boards along the west elevation. The remaining portions of the exposed sub fascia framing did not appear to be charred, but were soot-covered.

Inspection of the roof framing system at the Queensborough National Bank showed that approximately 20 linear feet of sub fascia were charred from the October 5, 2024 fire event. This sub fascia can be removed and replaced in kind without removal of the roof trusses, and the decking, or framing, after removal of the deformed western gutter. Additionally, the PVC downspouts can be replaced in kind prior to the removal and replacement of the fiberglass-reinforced plaster siding on the west elevation. It should be noted that upon removal of the sub fascia member, additional replacement considerations should be made for any roof framing members that show charring, which were not visible beforehand.

84. Light charring on the sub-fascia.

85. Light charring on the sub-fascia.

- Approximately 30 linear feet of PVC downspout along the western elevation
2. The charred sub-fascia can be removed and replaced upon removal of the deformed gutter, and the spalled and cracked bricks can be removed and replaced in kind by a licensed and experienced mason.

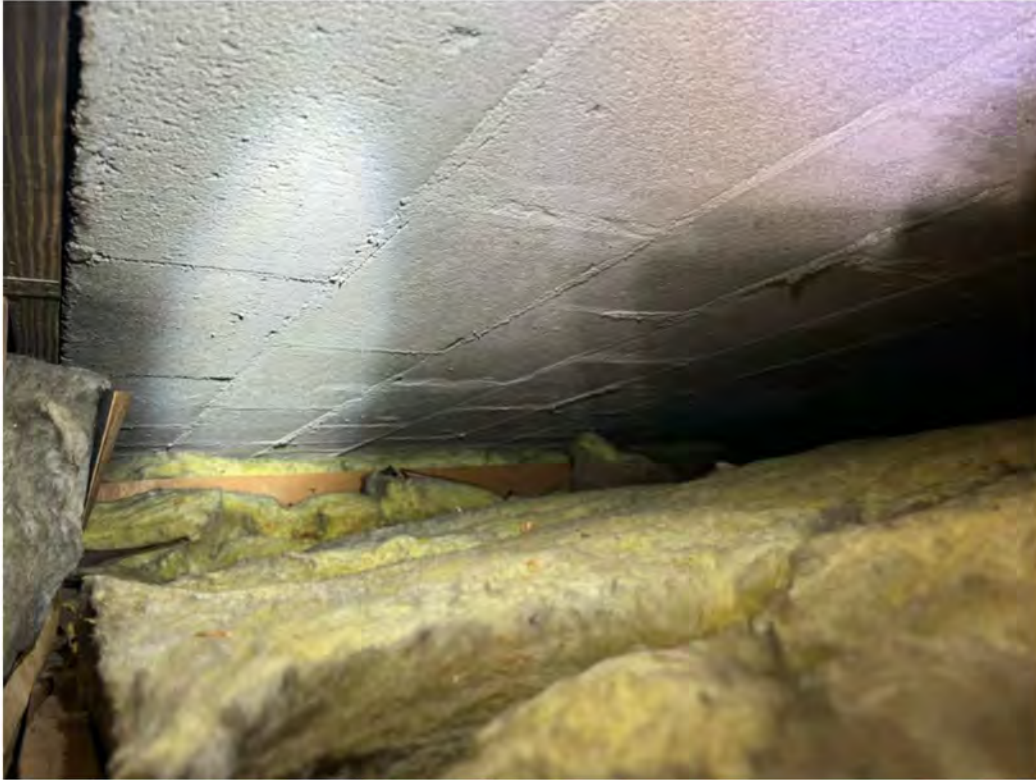
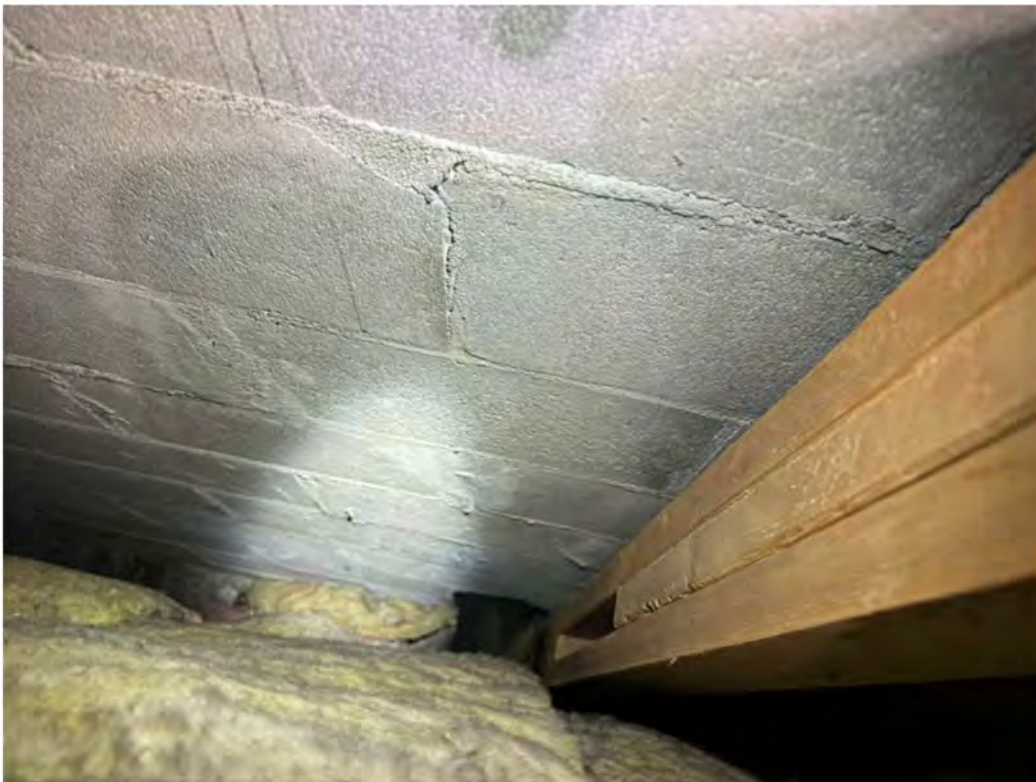
87. Interior side of the concrete block wall.

88. Interior side of the concrete block wall.
