Post-Fire Structural Evaluation

Queensborough National Bank
20-28 N Main St.
Metter, GA 30439

Client File No.: FWG6889
SFE File No.: 240019GA1

November 4, 2024

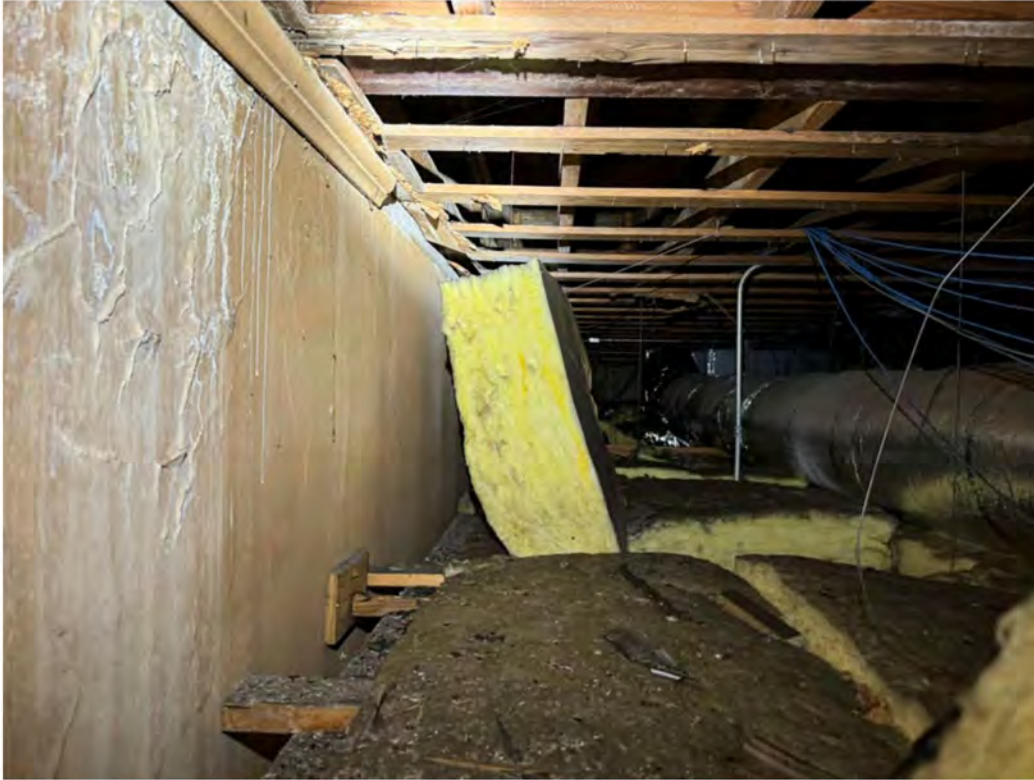
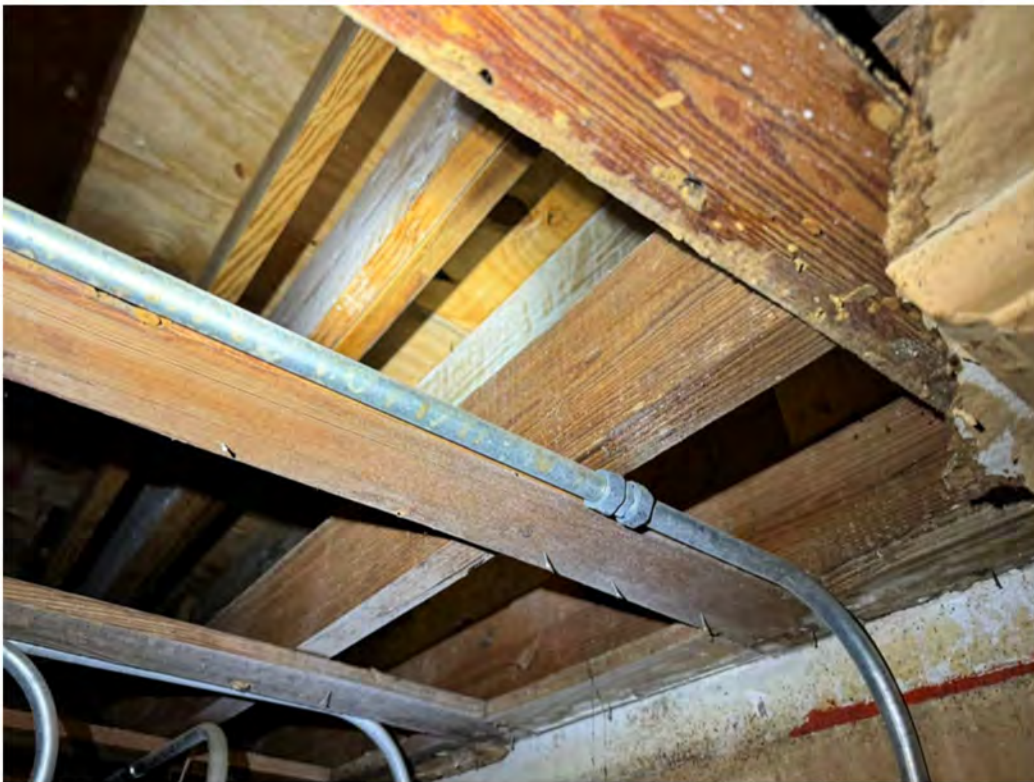
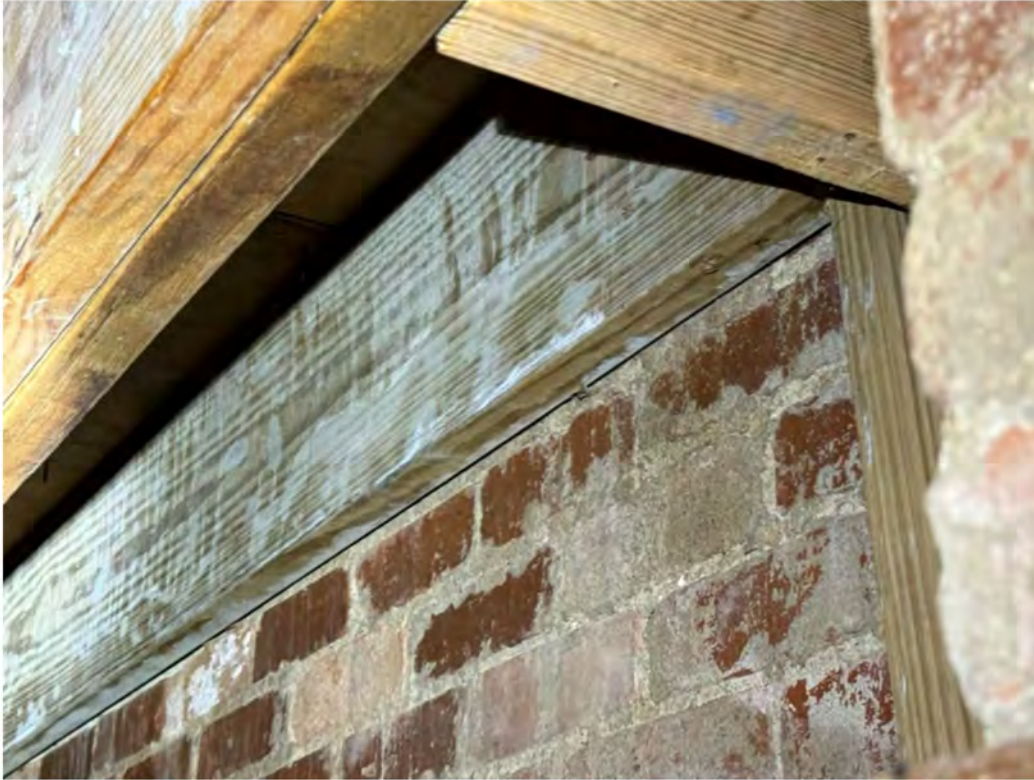
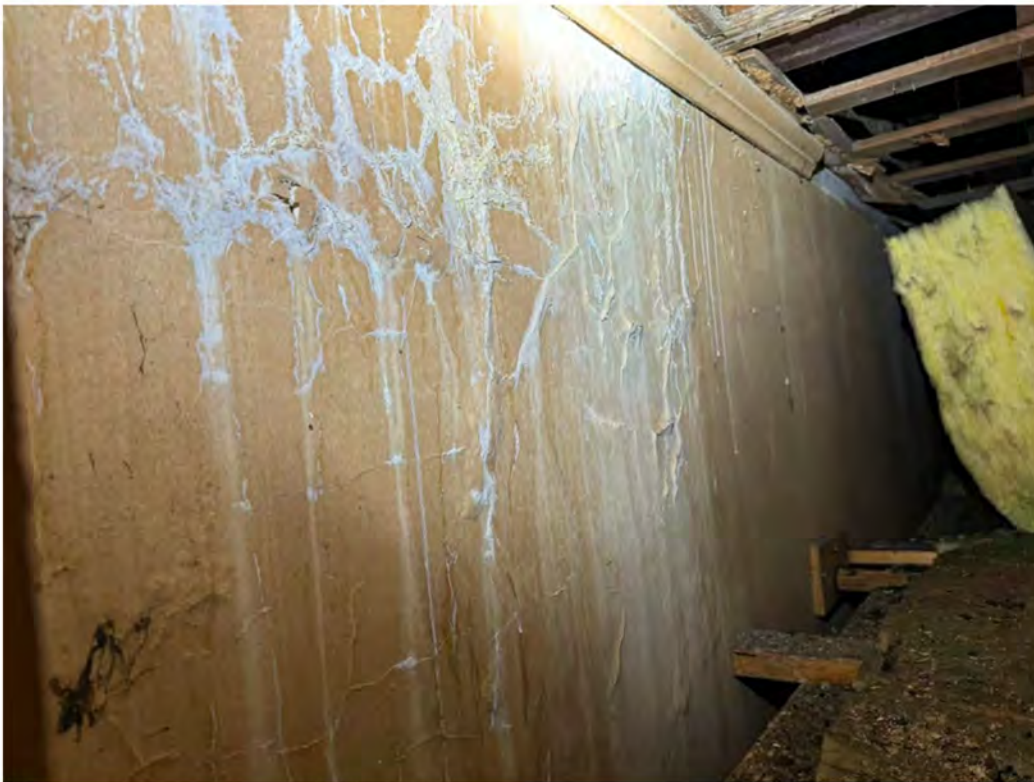
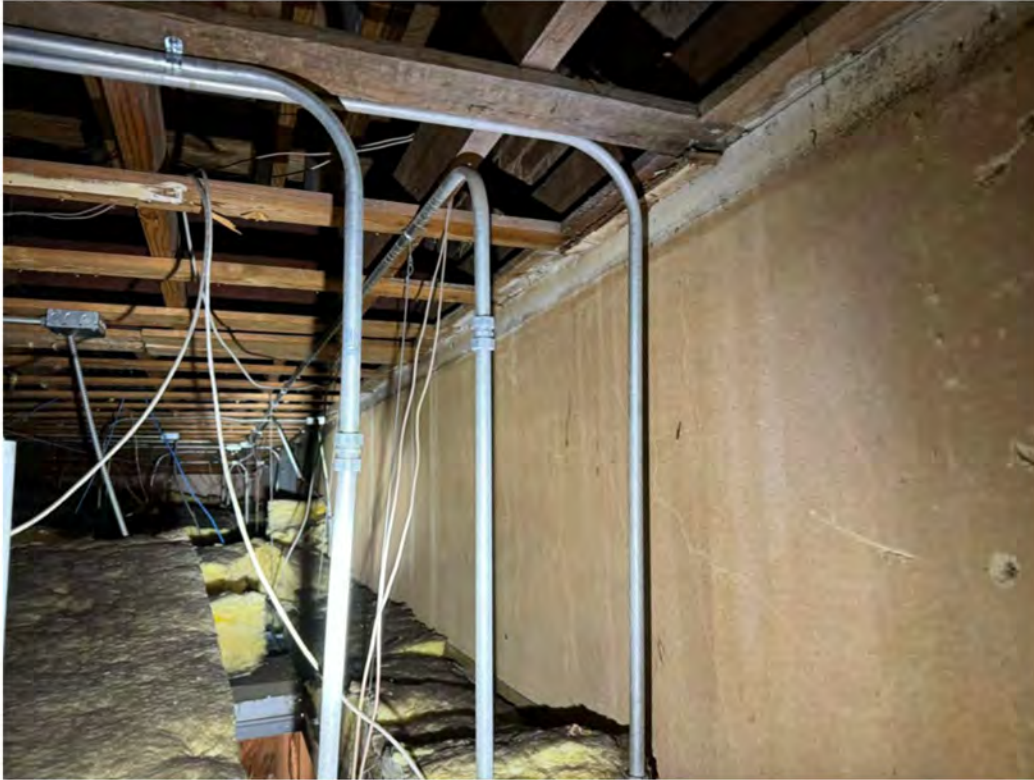
Inspection of the plenum space above the first floor showed small amounts of soot accumulation in areas where outside air was able to pass through the exterior wall. The steel trusses were not discolored, and the wood floor framing was not charred from the recent fire event. The second-floor framing was not damaged by the recent fire event on October 5, 2024.

89. Inside the plenum above th first floor.

90. Inside the plenum above th first floor.

91. Inside the plenum above th first floor.

92. Inside the plenum above th first floor.

93. Inside the plenum above th first floor.

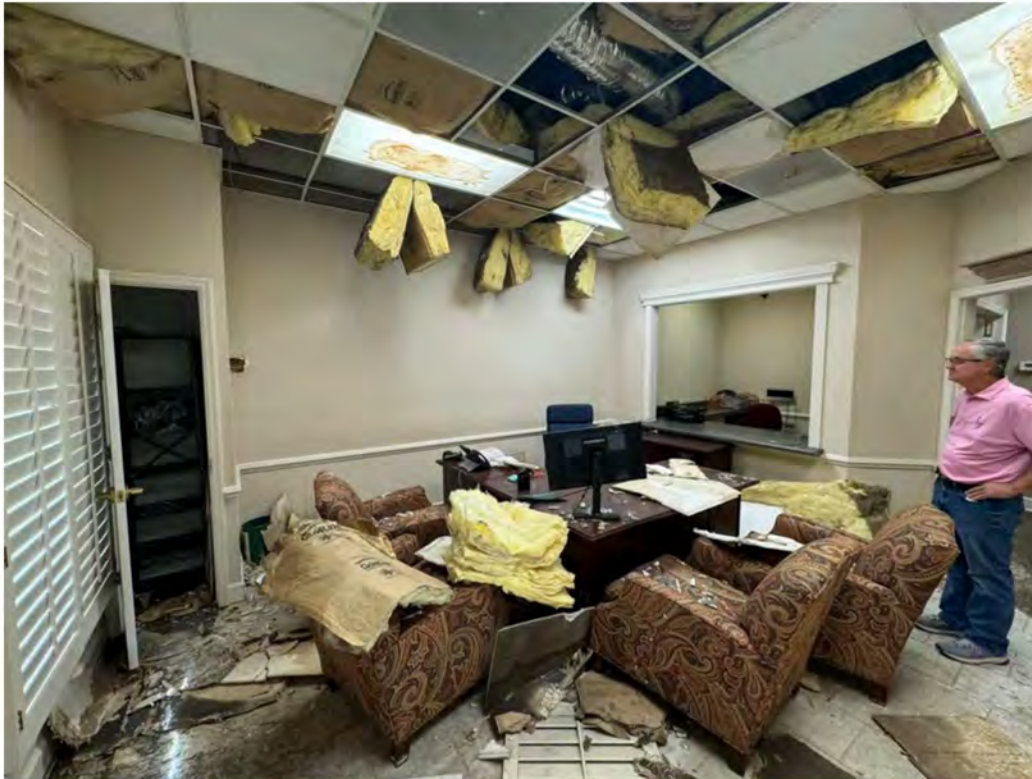
95. Interior finishes along the western wall.

Inspection of the first and second floors showed areas where soot accumulation occurred where air was able to enter through the exterior; however, there were no burn holes charring, or discoloration on the drywall associated with the fire event. Furthermore, there were no charred or damaged drop ceiling tiles consistent with the fire event.

Additional framing members, roof decking, and interior finishes with soot accumulation can be scrubbed by a licensed and experienced technician. The structural components with soot accumulation will continue to function as intended and were not damaged by the October 5, 2024 fire event.
